# Rescuing a Spreading Roof

by Dennis Gehman

A horizontal beam and steel tie rods resist rafter thrust with little disruption to the rest of the structure

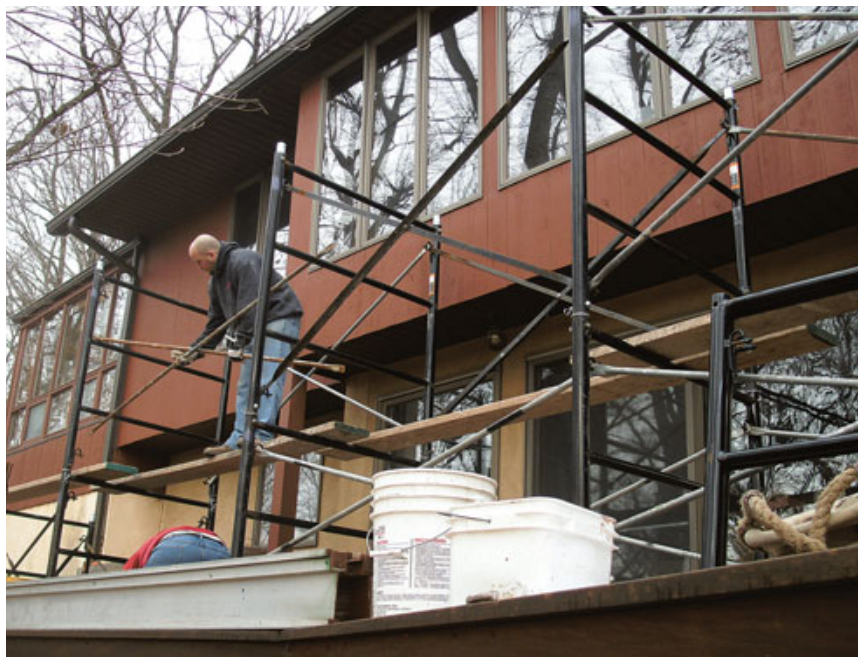
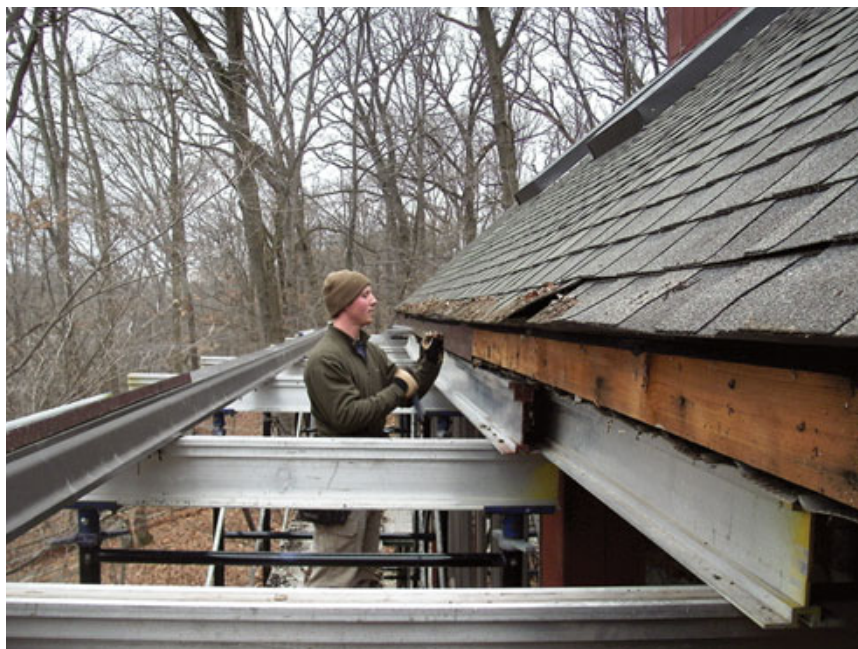
**Figure 1.** Heavy-duty pipe staging (top) equipped with steel cradles (above) supported a grid of aluminum I-beams used to lift the rafters off the wall. Shoring jacks at the base and adjustment screws at each cradle allowed the roof to be raised carefully and remain level.

To start with, the weight of the roof would have to be lifted off of the exterior wall before we could pull the wall back into plumb. Again, we considered a number of options — including a temporary exterior wall — but Dick came up with a better idea: Lift and support the wall with a temporary aluminum I-beam supported by heavy-duty steel scaffolding (**Figure 1**).

The important thing to understand about this technique is that you can't use a standard scaffold; instead, you need one that's specifically designed for jacking. We called a scaffold company, which

sent someone out to evaluate the job and decide exactly what was needed. The scaffold's feet consisted of heavy-duty screw jacks — also called shoring jacks — that could be turned to raise the scaffold and lift the rafters. Cradles at the top of the scaffolding, which held short perpendicular I-beams, also had adjustment screws for fine-tuning the lifting process.

We had to place some of the scaffold's feet on a wood deck, which our engineer determined was plenty strong for the job. To keep the feet from marring the deck and to distribute the load across more than one deck joist, we set the feet on double 2x10s, laid on the flat.

After removing the vented aluminum soffit covering, we lifted the roof just enough to get a Sawzall blade between the rafters and the wall plate — about  $\frac{1}{4}$  to  $\frac{1}{2}$  inch — then cut the nails that held them together. We were now ready to install the horizontal beam.

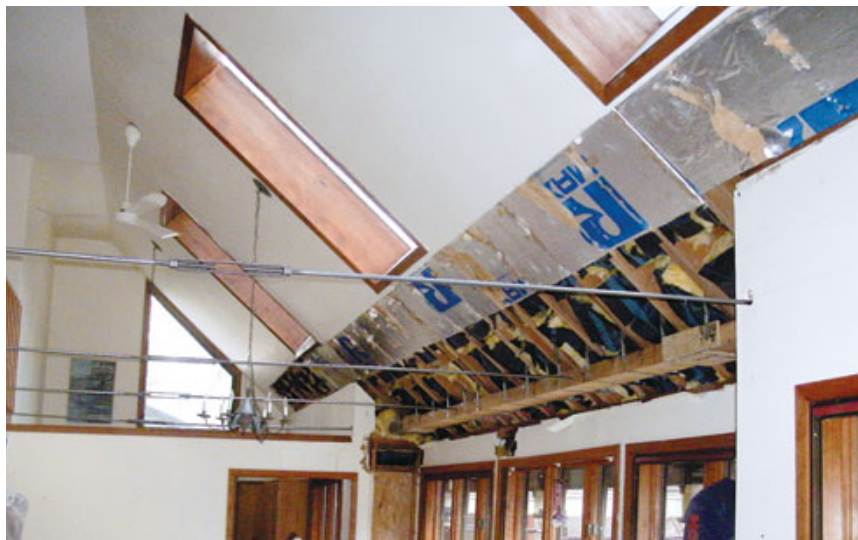
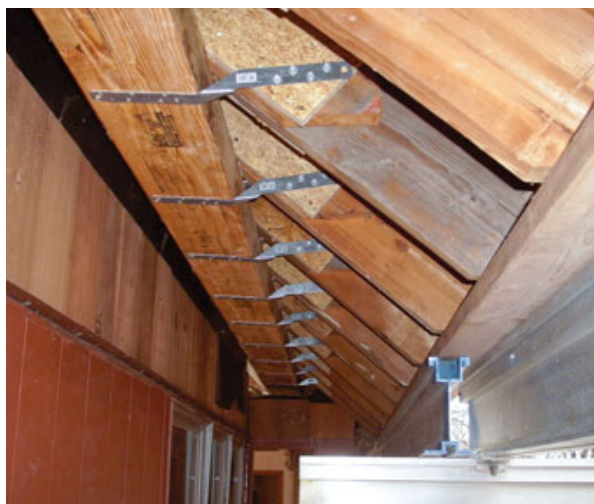
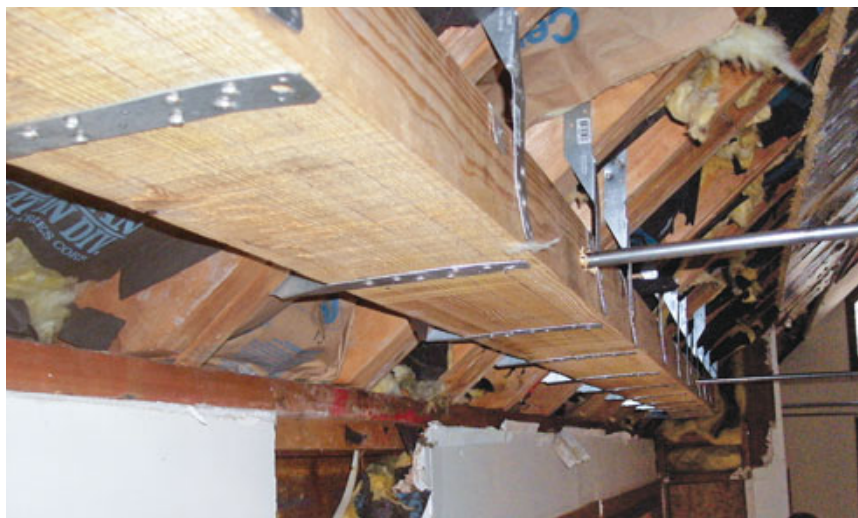
**Figure 2.** Six steel tie rods connect the horizontal glulam beam at the exterior wall top plate to the floor diaphragm beneath the balcony (above). The beam is attached with twist straps to AdvanTech gussets nailed to the sides of the rafters (left). Part of the beam is in the exterior soffit and part of it is inside the 20-foot box bay (below).

The horizontal beam was a  $3\frac{1}{2}$ -inch-by- $7\frac{1}{4}$ -inch stock glulam. (A Parallam would also have been appropriate for this purpose, but would have necessitated a larger beam.) We supported the glulam on its side and secured it horizontally and vertically to every rafter with Simpson twist straps (Figure 2).

The beam was actually installed in three different sections, placed end-to-end and spliced together with  $\frac{3}{4}$ -inch AdvanTech plywood gusset plates. (Our engineer was specific about using strong panel material for the various gussets and splices in this job and recommended against standard OSB, which bends more easily than plywood or AdvanTech.) While important for keeping the ends of the individual glulam members in alignment, the splices didn't weaken the structure because each of the three sections was designed to handle the rafter forces independently. Beam deflection was limited to  $L/600$ . As mentioned

above, the plan called for a total of six tie rods, or two rods per glulam section.

Installing the beam required a bit of disassembly in and around the bump-out. We had to remove the windows along the sides of the bay to keep them from cracking when the wall was pulled in, and we had to remove some of the drywall ceiling so that we could attach the glulam beam to the rafters above the bump-out. Rather than replacing and finishing new drywall, however, we decided to enclose the beam in a soffit. That enclosure and the six steel rods, which would also be enclosed, were the only apparent changes to the home's architecture at the end of the job.

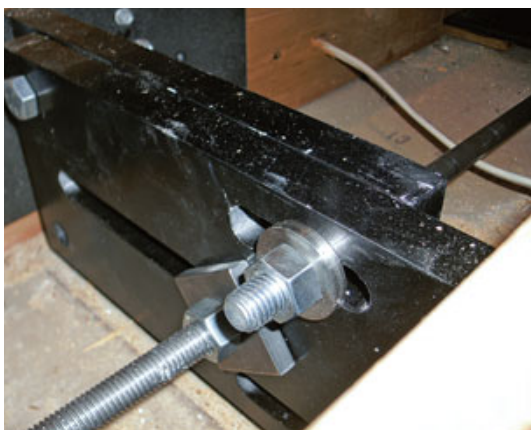
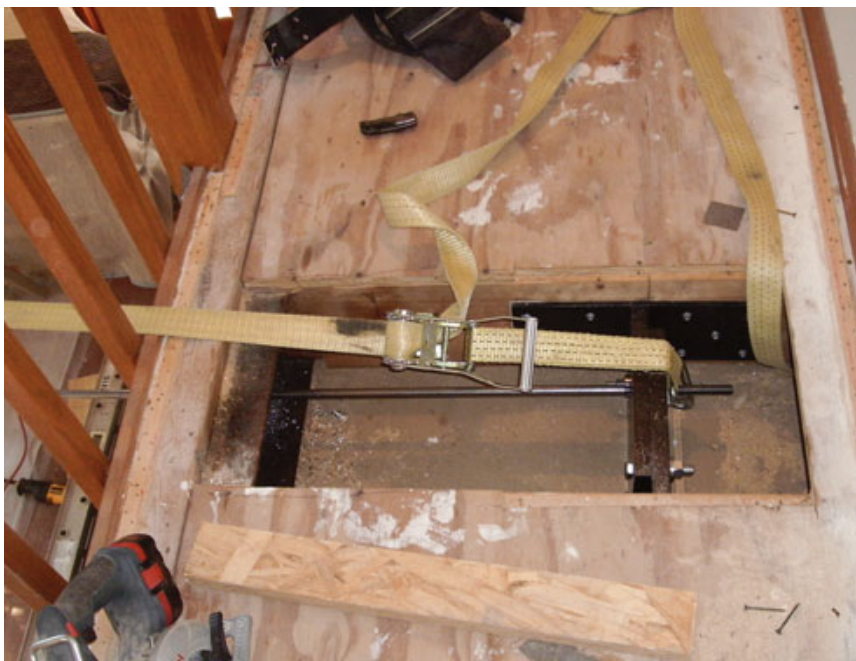
**Figure 3.** Heavy steel H-brackets installed between the second-story floor joists receive the interior ends of the tie rods (above and left). The two-part brackets have sliding adjustment slots to allow for variation in the width of the joist bays. Because the weight of the roof was being carried by scaffolding, nylon ratchet straps (below) hooked to the steel brackets were sufficient for pulling in the leaning wall.

To attach the rods to the beam, we bored horizontal holes through the beam, inserted the rods through these holes, and then fastened them in place with nuts and large washers. At the center of the house, along the balcony, we installed custom-made 1-inch-thick steel H-brackets between the floor joists, and fastened the ends of the rods to these brackets (**Figure 3**). Some of the joists were twisted or cupped,

so in order to get a solid connection we had to shim between the brackets and the joists with thin metal plates. Turnbuckles in the middle of the span would allow us to make final adjustments.

With the beam, ties, and hardware in place and the floor nailed off, it was time to pull the wall back into plumb. This proved quite easy with the weight of the roof off the wall: We used a couple of nylon ratchet straps, attaching them to the H-brackets at one end and wrapping them around the wall plate at the other. Once the wall was plumb, we turned the screw jacks on the scaffold to lower the rafters, used the turnbuckles at the center of the rods to make final adjustments to the tension, then fastened the rafters to the wall with hurricane clips.

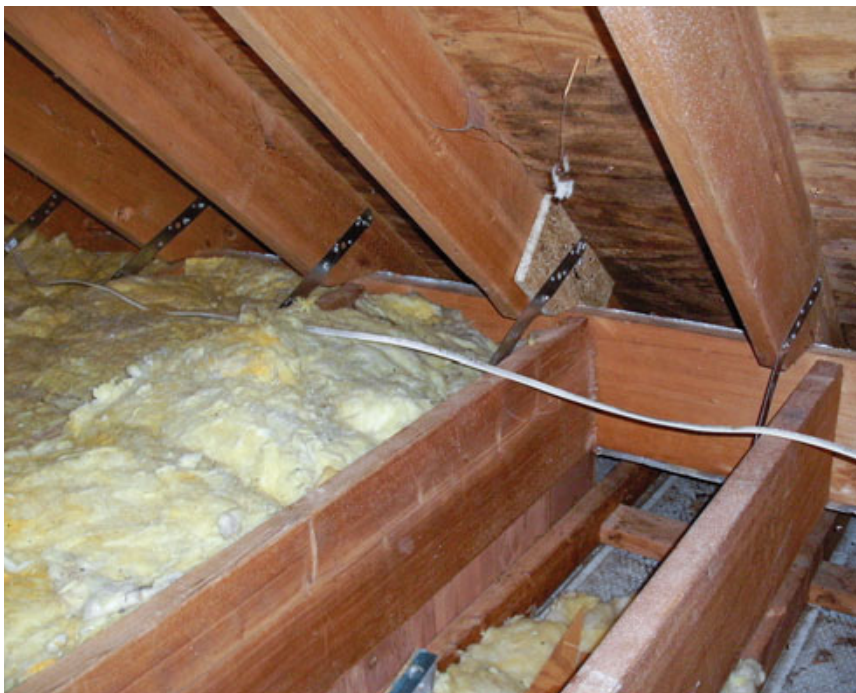
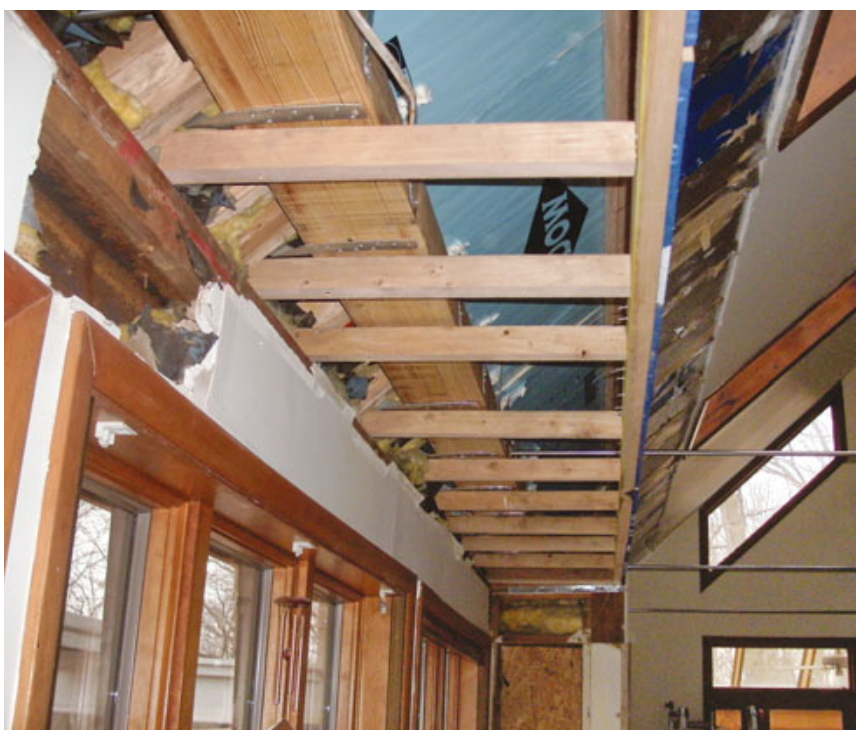
**Figure 4.** Hurricane clips tie the rafters to the floor joists at the front of the house; shown here is a section of the attic behind a knee wall (top). A new soffit hides the horizontal glulam beam where it runs through the cathedral bump-out (above); the tie rods were later hidden in false pine beams.

We also used hurricane straps to secure the ceiling joists above the second-floor bedrooms to the rafters along the front wall of the house. Where necessary we added AdvanTech spacers to bring the rafter bottoms into better alignment with the floor joists (**Figure 4**). This completed the engineer's design, effectively tying opposing rafters to one another through the tie rods and the second-floor diaphragm.

Although we finished the structural work in about five weeks, the entire job took about two months, with the remainder of the time spent putting the soffits back together, finishing the bump-out, and trimming out the tie rods with false beams made of 1-by-pine.
