# Stabilizing a Hillside Foundation

## Helical piers anchor a house on a sliding slope

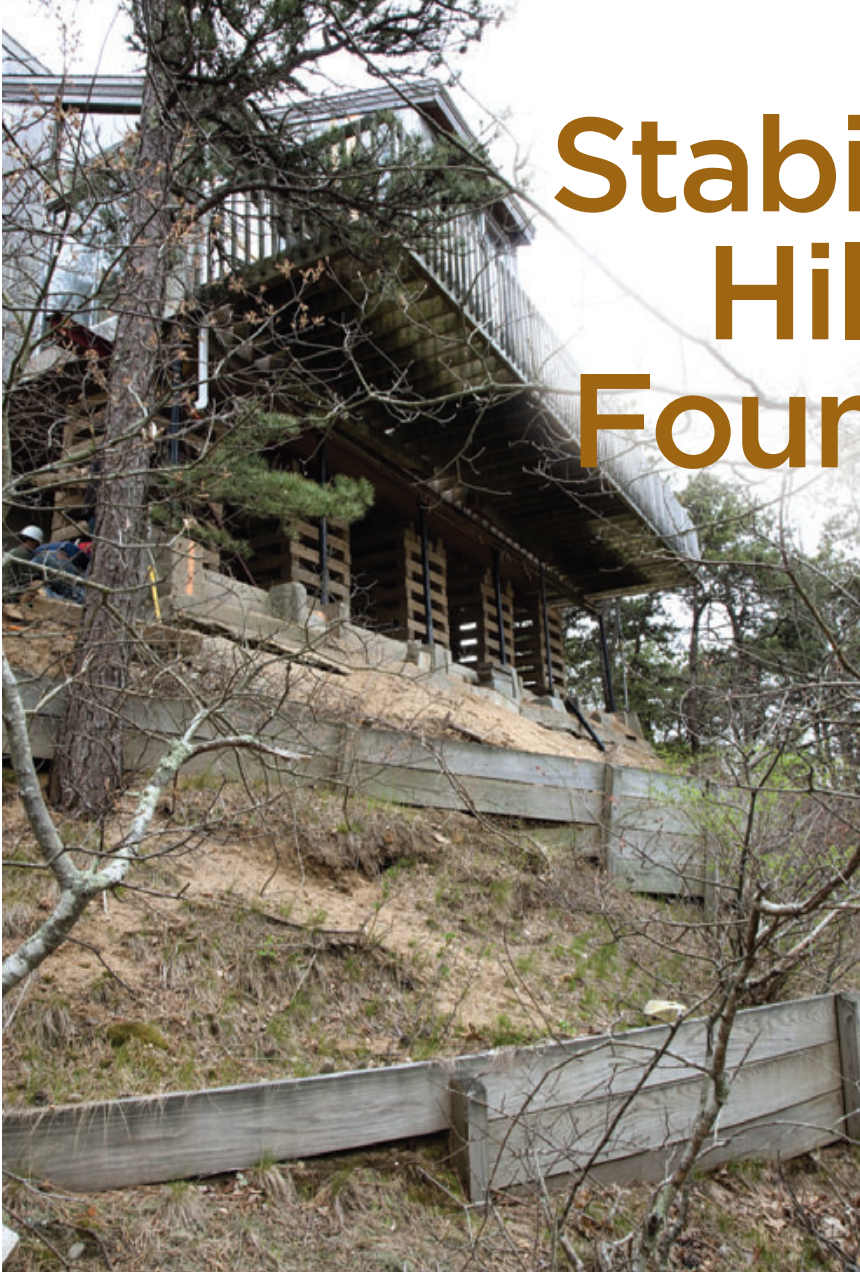
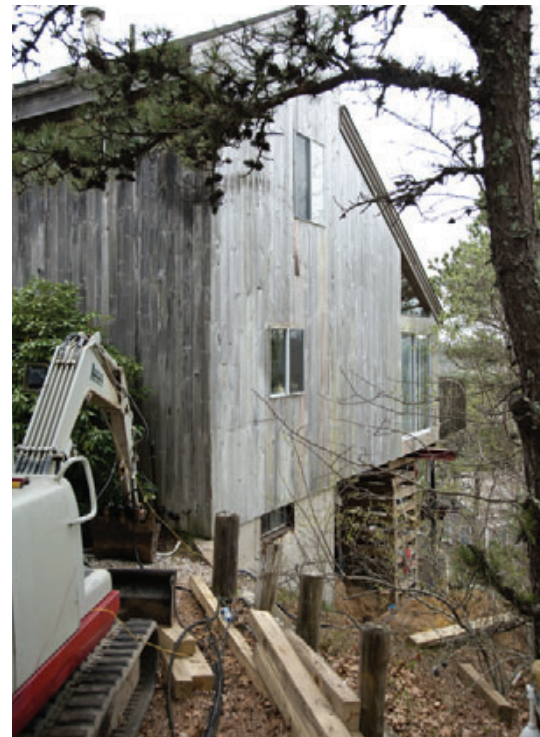
**Figure 1.** A narrow foundation cut into the hillside carried only about a third of this home's floor span. The downhill portion was built over a grade beam that was gradually moving downhill (A). A hodgepodge of crude shoring did nothing to arrest the process (B). Structural columns moved along with the grade beam, making a total structural failure imminent (C).

Had the grade beam been installed over pilings that penetrated more deeply into stable hillside — well beyond the incident angle — the installation might not have failed. Our proposal, based on our experience working with helical piers, would correct that error. The plan was to drive vertical piers deep into the hill-

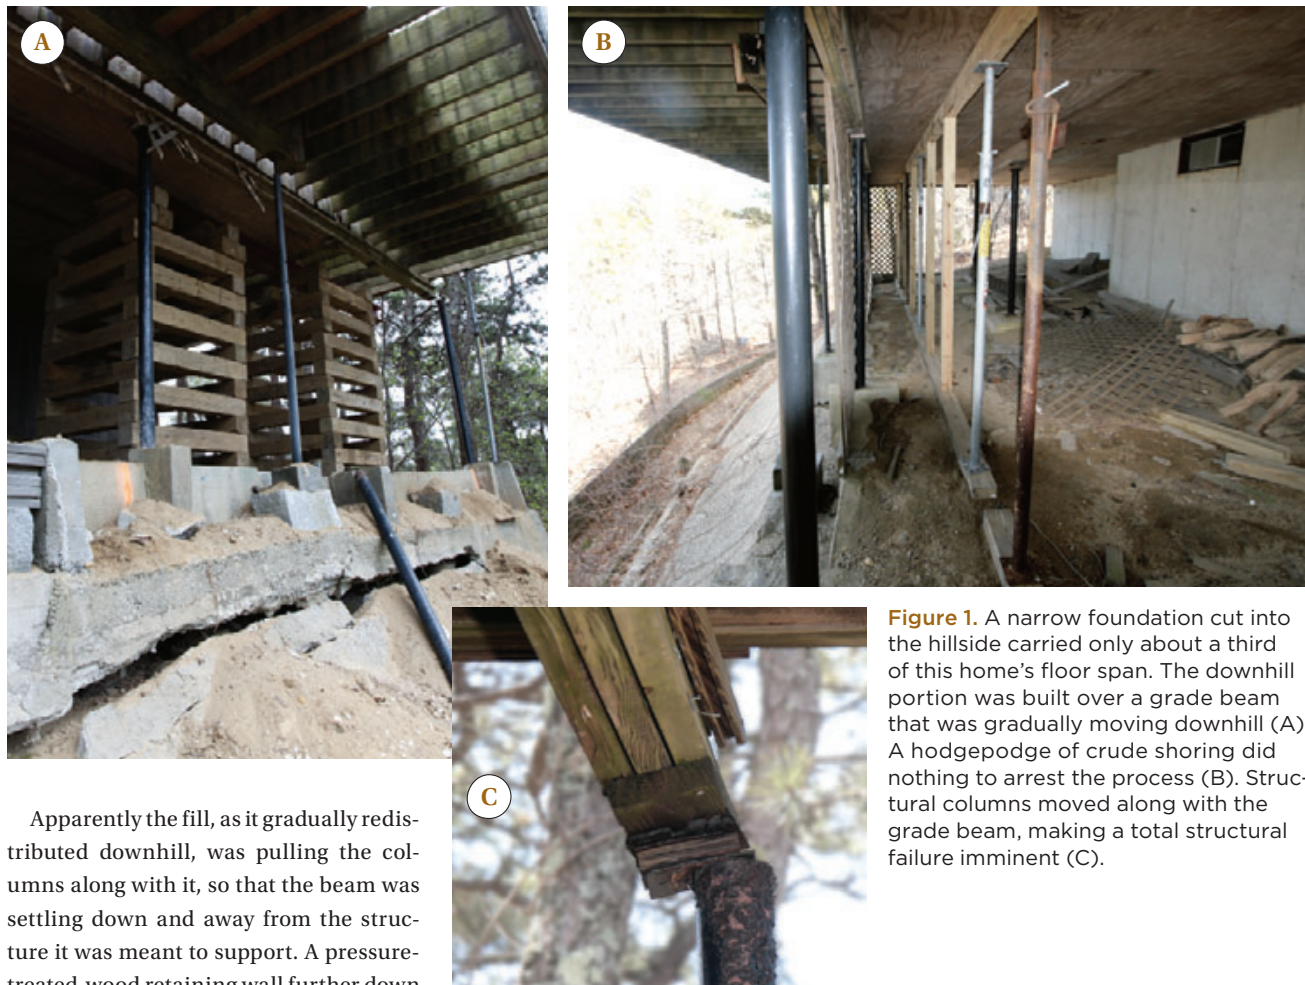
**Slip-sliding away.** Thanks to washouts that had occurred over the years beneath the grade beam, we could see the tops of tube-formed concrete columns, which had evidently been placed there to support the beam but were now tilting radically downhill. Although we didn’t do any exploratory excavation, it was clear that these columns did not extend very deeply — if at all — into the undisturbed original grade.

Apparently the fill, as it gradually redistributed downhill, was pulling the columns along with it, so that the beam was settling down and away from the structure it was meant to support. A pressure-treated-wood retaining wall further down the slope was literally bursting at the seams, doing nothing to arrest the downhill progress. When we began work, the “flying” section of this two-story house had dropped nearly 3 inches out of level. To make things even more interesting, a deck built on cantilevered 2x10 floor joists extended another 8 feet out over the abyss. It was a hair-raising place to stand.

side to support a new grade beam formed directly behind the old one (**Figure 2, page 3**). Helical tie-back anchors driven into the slope would resist the lateral forces from the uphill side of the grade beam, enabling it to do double duty as a support and a retaining wall (**see illustration, page 5**). Since removing the old grade beam would be highly impractical and expensive, we'd just leave it in place.

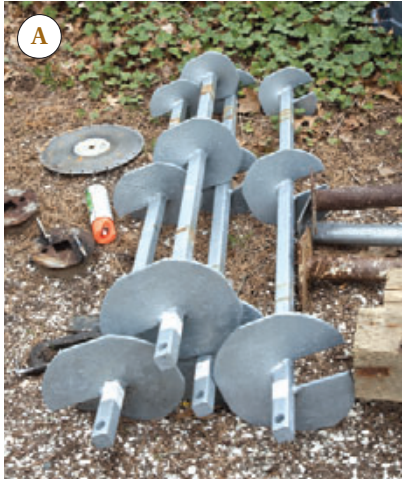
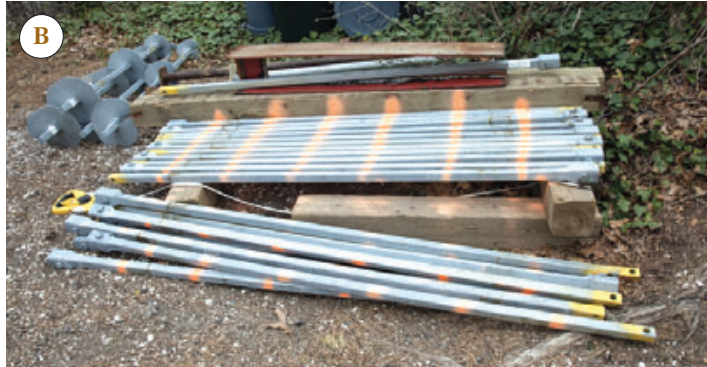
**Figure 2.** Because of the steep slope and difficult access, the helical piers (A) and extension shafts (B) were driven using a custom-made steel frame to support the auger head (C). An excavator parked at the top of the hill provided hydraulic power (D).

We hired an engineering firm to provide the design parameters and certify the actual pier insertion. To ensure predictable performance, each helical pier must be driven to both a specified depth and a particular value of resistance to insertion. The concept is simple: Cumulative soil pressure on the piers' helical plates pro-

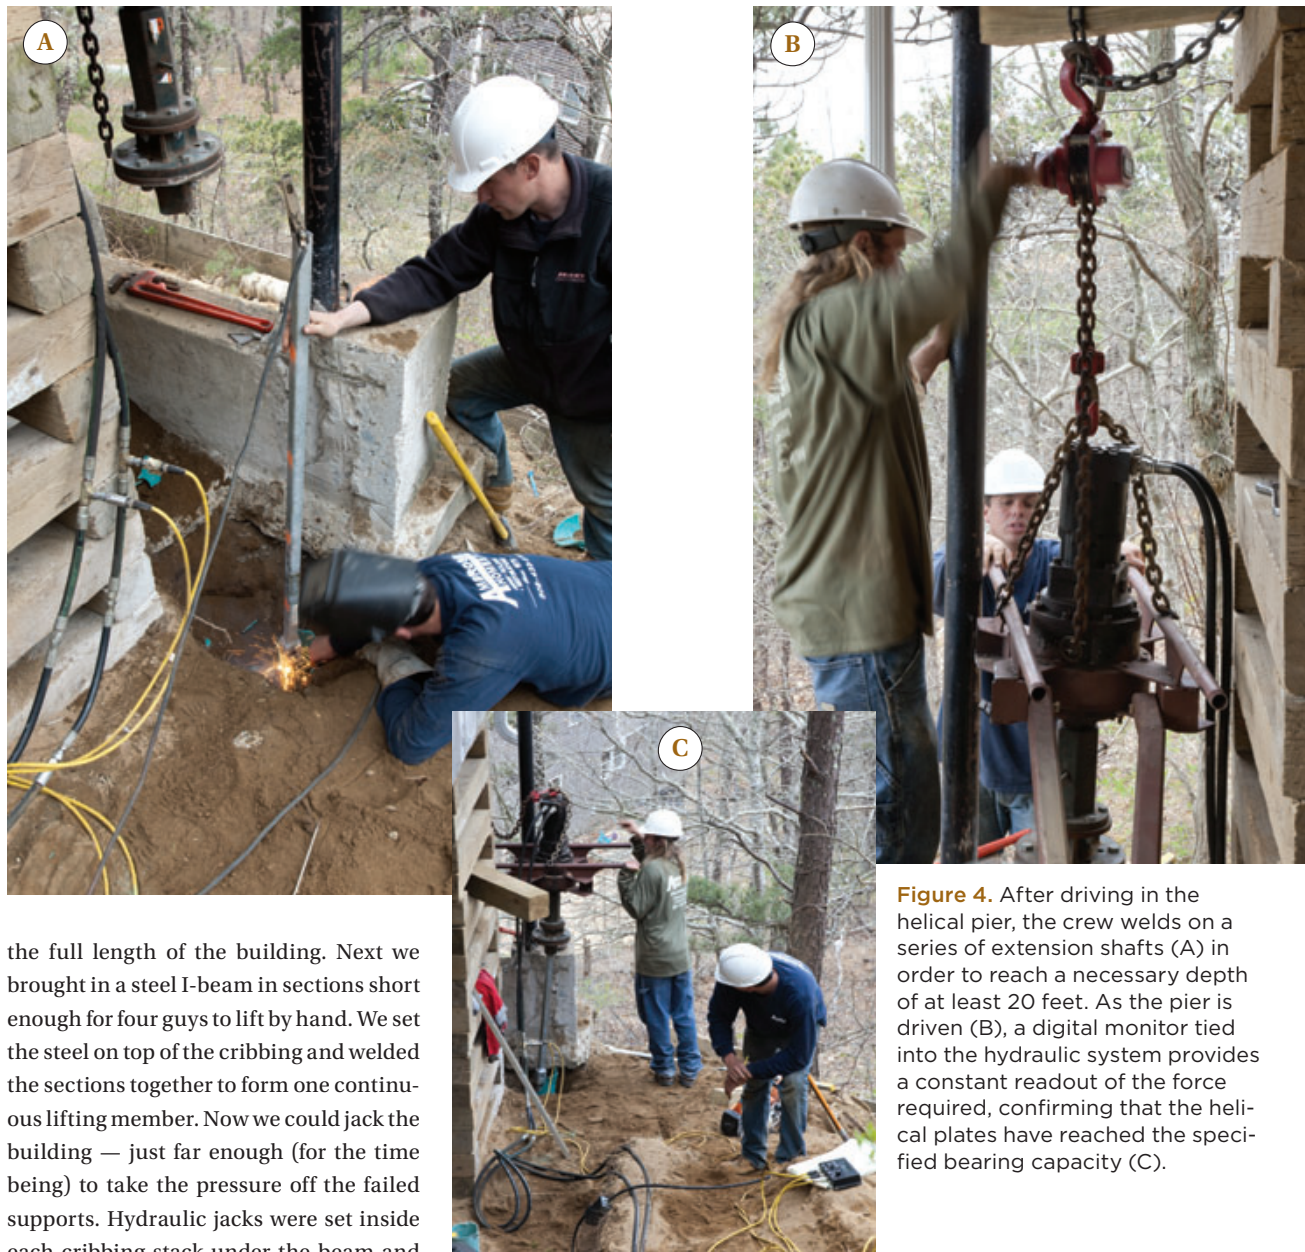
**Figure 4.** After driving in the helical pier, the crew welds on a series of extension shafts (A) in order to reach a necessary depth of at least 20 feet. As the pier is driven (B), a digital monitor tied into the hydraulic system provides a constant readout of the force required, confirming that the helical plates have reached the specified bearing capacity (C).

Helical piers are driven into the ground using a hydraulic auger head. Driving a pier to specified depth takes several thousand foot-pounds of torque. On a more-

or-less level job site, we'd mount the auger head on the mini-excavator's boom; the 8,500-pound excavator itself provides enough dead weight to resist the considerable reverse torque generated during pier insertion. However, since we couldn't place the excavator in the work zone, we fabricated a hand-portable welded steel frame to hold the head, incorporating a drag bar that we could jam against any

adjacent immovable object (**Figure 4**). We supported the head over the insertion site with an overhead chain lift suspended from a beam inserted in the cribbing. This worked well for the vertical piers. In most cases, the old grade beam provided an immovable stop for the drag bar. At one point, a nearby tree trunk came in handy. We installed all eight piers called for within two days. For certification

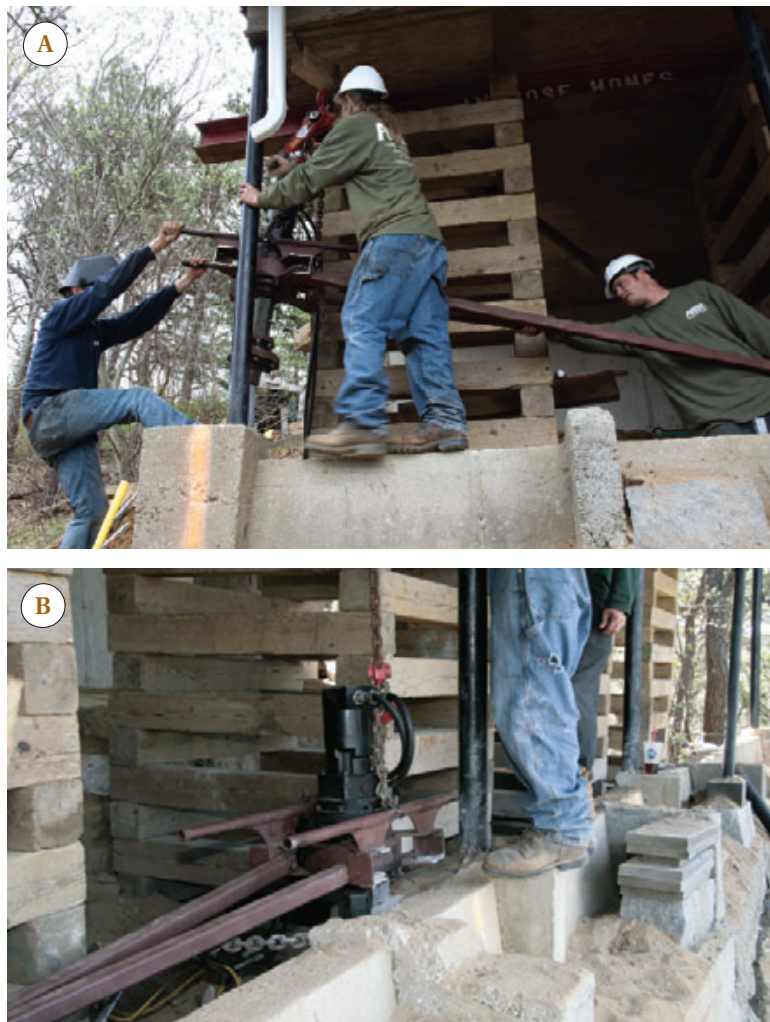
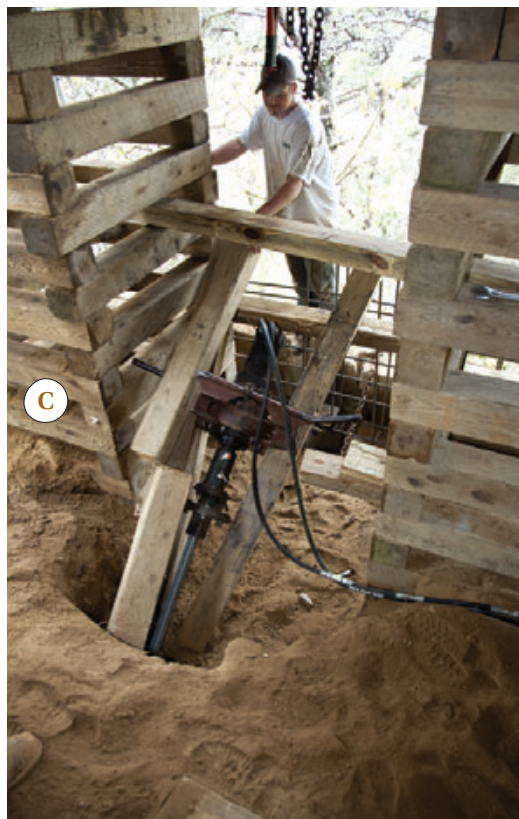
**Figure 5.** As the required driving force increased (A), a drag bar attached to the auger frame helped counter the reverse torque (B). Space between the cribbing stacks was too tight to use the drag bar; there, the crew struggled to brace the frame against the cribbing without toppling the stacks (C).

Installing the four tie-back anchors was more of a challenge (Figure 5). The tie-backs were located in the spaces between the cribbing stacks. These spaces were too tight for us to extend the drag bar, and we struggled for a while to find an alternative bracing method. The counter-rotational force tended to push individual cribbing members out of position, threatening to topple the stack. After some trial-and-error modifications, we got the cribbing to resist as an integral unit. These four anchors took another two days to install.

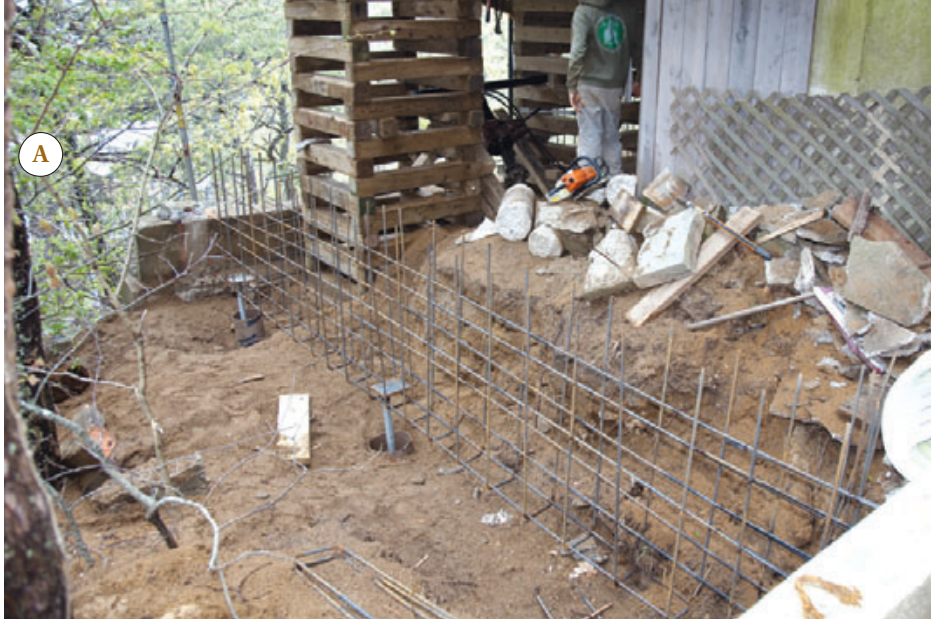
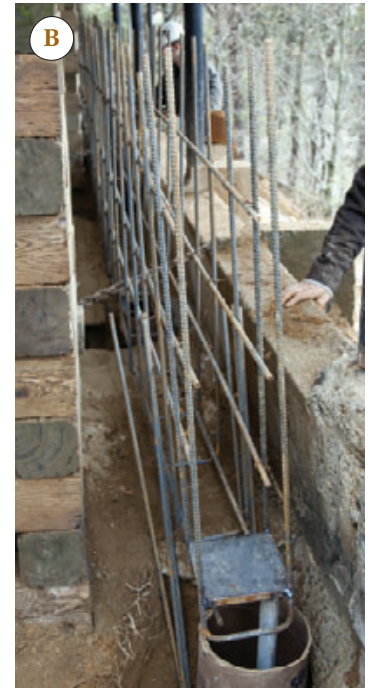
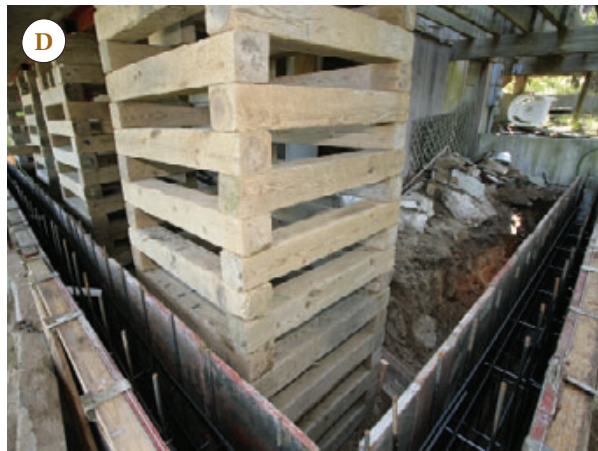
**Figure 6.** Heavy steel bearing plates welded to the tops of the piers support a beefy rebar cage, which has been spot-welded to the plates (A). Tube forms surround the upper ends of the piers, to encase them in concrete (B). After the last welds are made (C), the grade beam is ready to be poured (D).

With all the piers finally installed, we turned to fabricating the rebar cage for the 12-inch-wide grade beam (Figure 6, page 7). This called for a hefty schedule of #4 bar, 12 inches on-center vertically at both wall faces and tied to continuous horizontal bar along the top and bottom of the beam. We returned both ends of the grade beam to the basement foundation, using epoxy grout to tie the rebar in.

To tie the grade beam to the helical piers, we welded 8-inch by 8-inch by  $\frac{3}{4}$ -inch-thick galvanized steel cap plates to the end of each pier, then welded the rebar cage to the caps. At the tie-back locations, the grade beam is tied to the anchors with

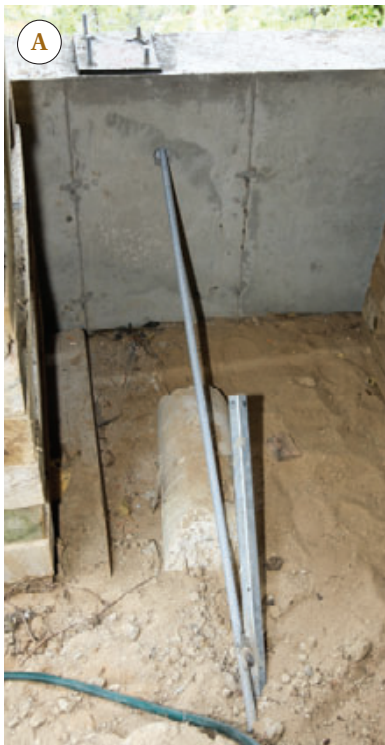
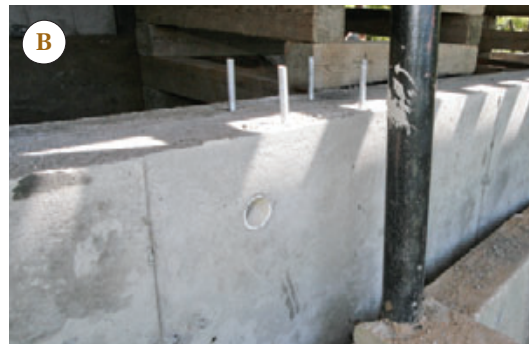
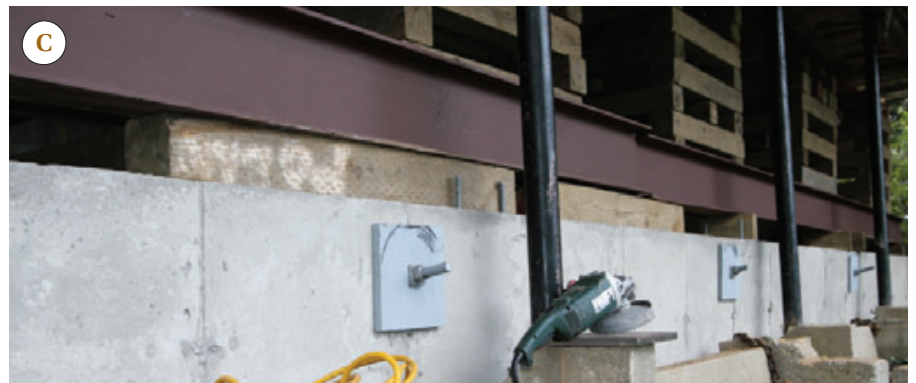
**Figure 7.** Galvanized connecting rods (A) attached to the angled tie-back piers are run through 4-inch-diameter PVC knockouts (B). Three-quarter-inch-thick steel plates on the outside of the grade beam capture the ends (C). Note the two steel I-beams sitting on top of the grade beam, ready to be welded together to form one long support.

threaded shaft extensions, which are secured with nuts and heavy steel spread plates on the beam's outer face (Figure 7, page 7). Before placing the concrete, we aligned 4-inch-diameter PVC sleeves inside the forms at the approximate anchor shaft angle; this gave us some play on the angles when connecting the extensions.

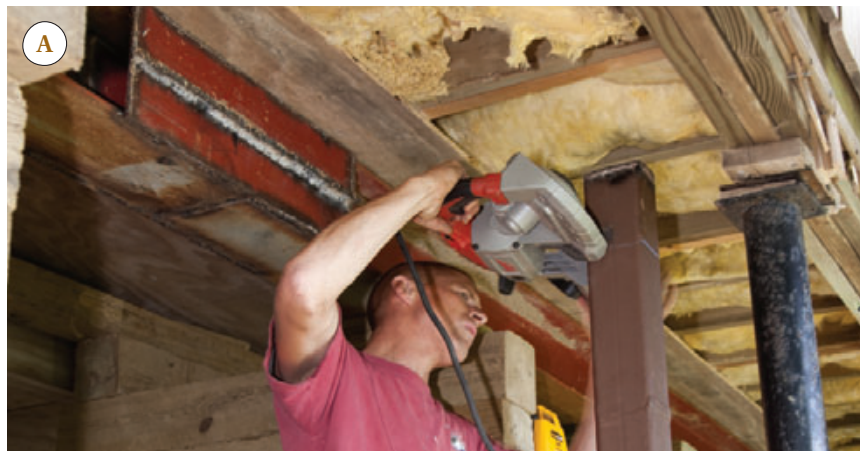
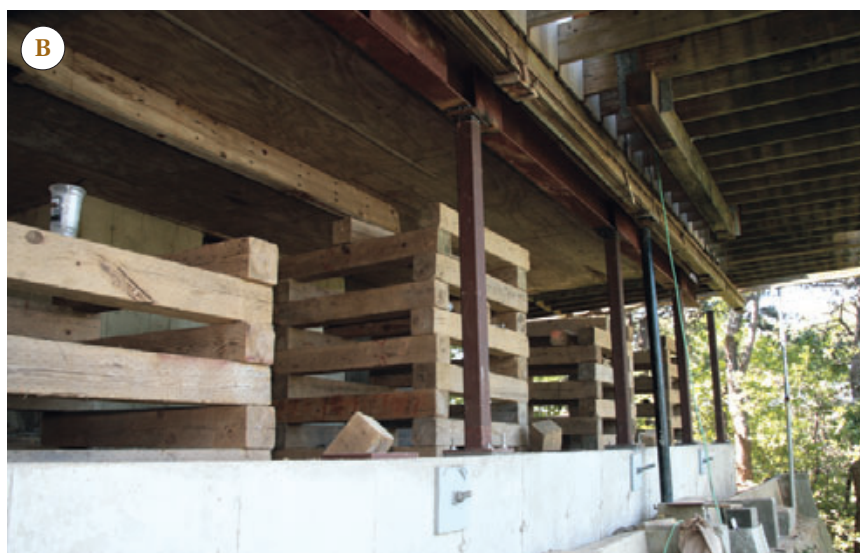
**Figure 8.** With the building jacked to its final level position, the steel columns were cut to finish height with a portable band saw (A). The steel I-beam was then jacked into place and welded to the tops of the columns (B). Diagonal 4x6 braces anchored atop the grade beam stiffen the cantilevered deck above (C).

the grade beam, trued them to a laser line, and welded them together to form one continuous beam (Figure 8).

The I-beam is supported on 4-inch-square structural steel columns. We centered their base plates along the top of the grade beam, 8 feet apart, and leveled them over fast-setting hydraulic cement. Four bolts epoxied into the top of the grade beam hold each base plate in place. We cut the posts to rough length, then plumbed them and welded them to the base plates.

Now we could make a precise allowance for the beam dimension and cut the columns to exact finish length. A hand-held band saw made short work of these cuts. We jacked the beam up, slid it over onto the columns, then welded it in place. The top flange is bolted to the floor framing, tying the structure together. We also welded stiffeners on both sides of the web at each column location to help transfer the overhead load. Finally, to take the scary bounce out of the cantilevered deck, we installed 4x6 pressure-treated diagonal braces up from the top of the grade beam.
