Expanding a Kitchen

Even a small addition can pose a lot of structural challenges

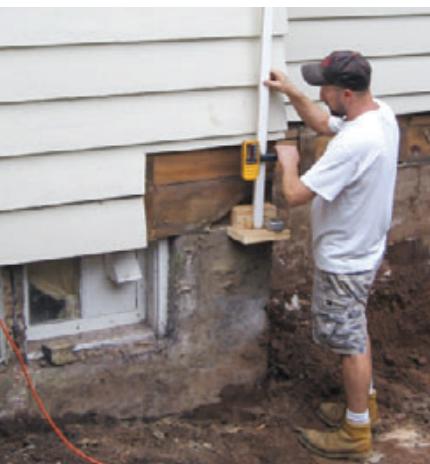
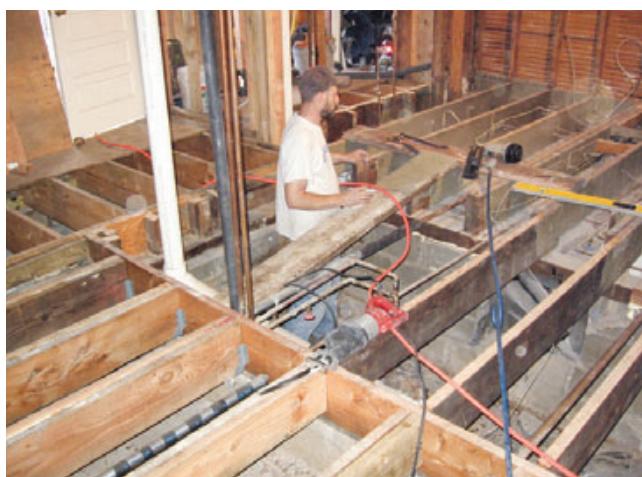
Figure 1. To establish an accurate benchmark elevation for the addition, a carpenter exposes the floor framing in the center of the proposed opening (left). The existing joists were later trimmed or shimmed — and in some cases reinforced with sistered 2x10s — to smooth out the transition into the addition and to prep the kitchen for new wood-strip flooring (below).

Though we sub out demolition, we typically block up our own foundations because it gives us more control over the schedule (see “Block Foundations for Small Additions,” 1/09). When we excavated this foundation and laid out the footing, we used the top of the floor joists at the center of the future opening between the addition and the existing house as our benchmark (see **Figure 1**).

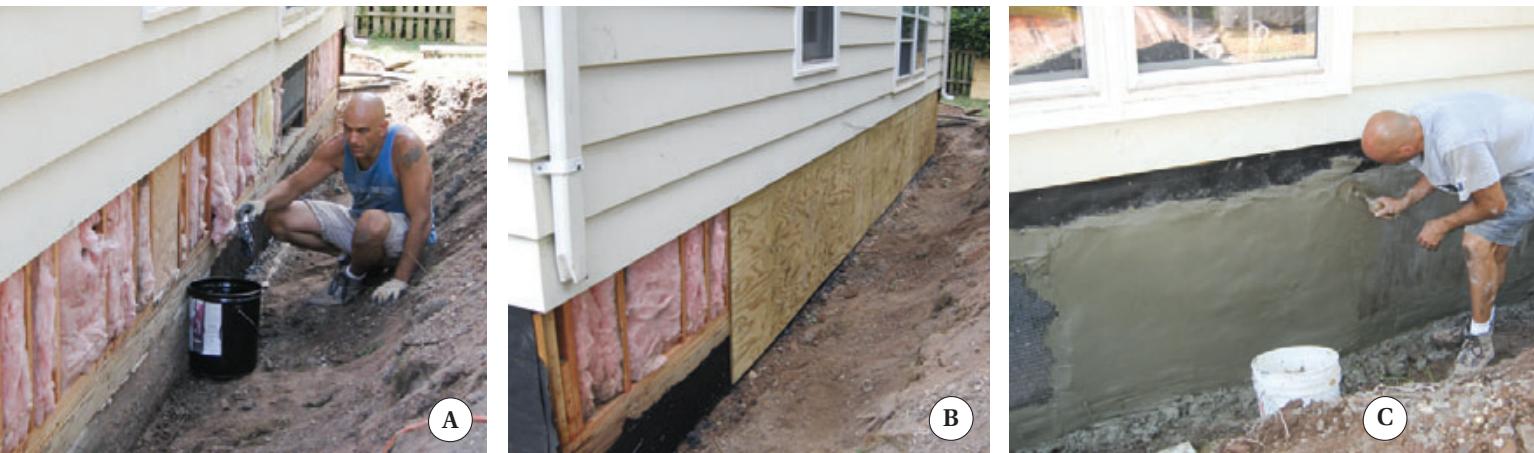
Figure 2. The architect specified a pressure-treated pony wall for resolving a grade problem along the side of the house. The crew exposed the foundation and framing, applied a coat of cold asphalt to the rim-joist area (A), then installed PT sheathing (B). Next, after preparing the wall with 30-pound asphalt felt paper and metal lath, they parged the new and existing walls (C). A second coat of cold asphalt on the below-grade portions of the parged walls (D) — along with drainpipe set in coarse stone wrapped with filter fabric — helps manage water around the foundation (E).

When the homeowners bought the property, they inherited an ugly railroad-tie retaining wall that prevented the ground from coming into contact with the home's cedar siding at one corner of the house (**Figure 2**). To eliminate it, I suggested that we regrade the backyard, but the architect explained that this option had already been rejected because of cost. Instead, he provided us with a below-grade detail that called for the removal of the retaining wall, a little excavation, and replacement of the original sheathing about 2 feet above the sill with treated plywood sheathing.

Before installing the PT plywood, we covered the exposed part of the foundation and mudsill with a generous coating of cold asphalt. We fastened the portion of the PT sheathing that fell below the sill to the foundation wall with powder-actuated fasteners. The asphalt layer helps seal the sheathing to the foundation and keeps moisture from wicking up the wall.

Next we installed 30-pound felt paper and galvanized wire lath over the plywood and parged the wall with a 1/2-inch-thick layer of mortar. Though parging isn't completely waterproof, it will block most moisture from penetrating to the sheathing and old foundation wall underneath. We parged our new block work, too, so that the entire foundation would have a uniform appearance.

Finally, we coated the below-grade portion of the parged wall with more cold asphalt before laying in filter fabric and drainpipe and backfilling the trench with coarse stone. Then we folded the filter fabric back over the stone and leveled out the grade.

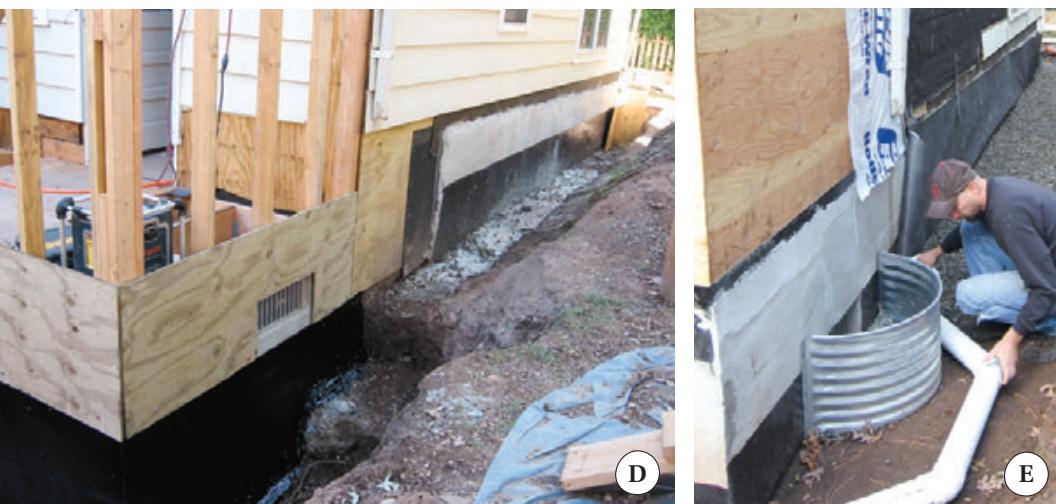
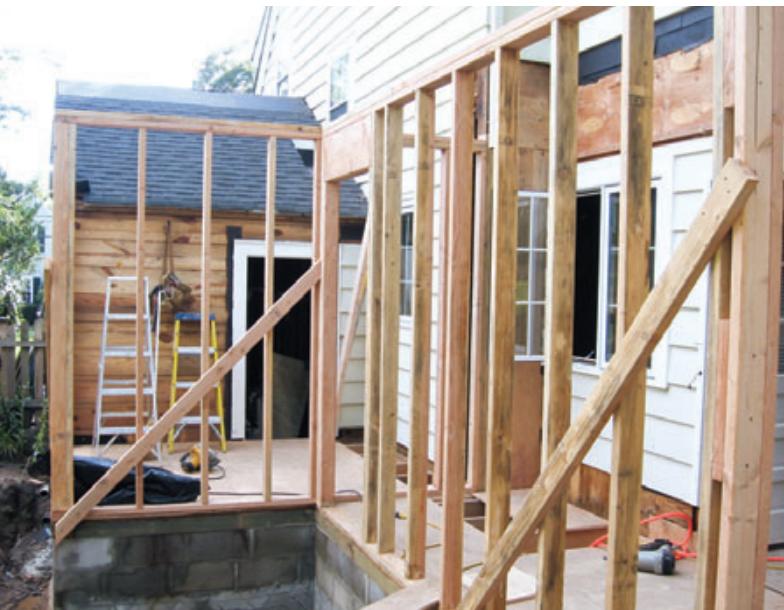
Figure 3. Instead of lowering the new mudroom floor to match the elevation of the old entry into the garage, as called for by the plans (left), the author took advantage of an extension to the garage roof (above) to create headroom above the old garage. This allowed him to raise the entryway and keep the mudroom floor at the same level.

Originally, the architect's plans called for a new mudroom and powder room adjacent to the garage to be two full steps below the kitchen floor, a design dictated by the elevation of an existing exterior garage door. However, the homeowners wanted all of the rooms to be on the same level, and we preferred to build the addition foundation so that the entire floor system would be level and as close to grade as possible. Fortunately, the roof design of the

new addition allowed us to open up the garage ceiling and create enough headroom to raise the doorway between the mudroom and garage. Instead of putting a pair of steps between the mudroom and kitchen, we were able to add them to the set of stairs in the garage (**Figure 3, page 45**).

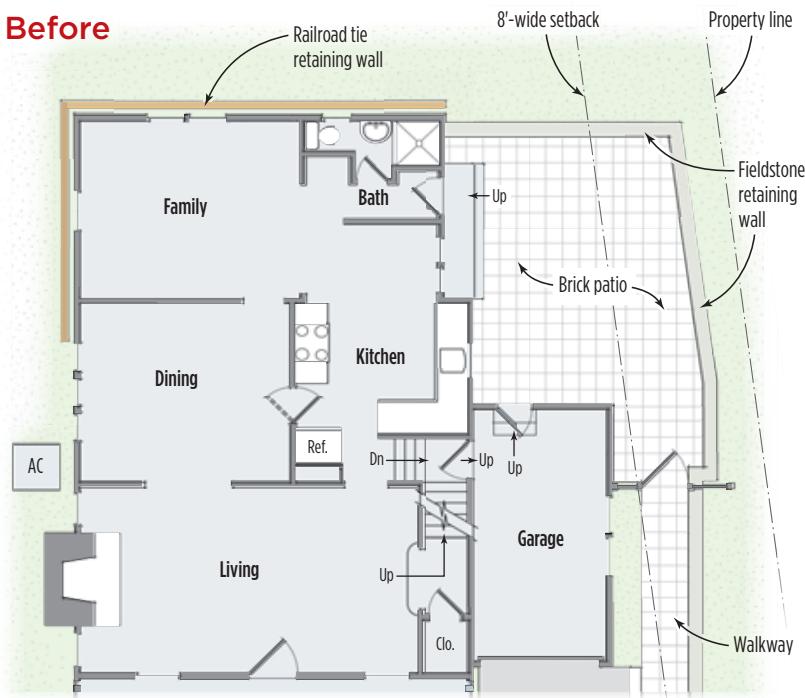
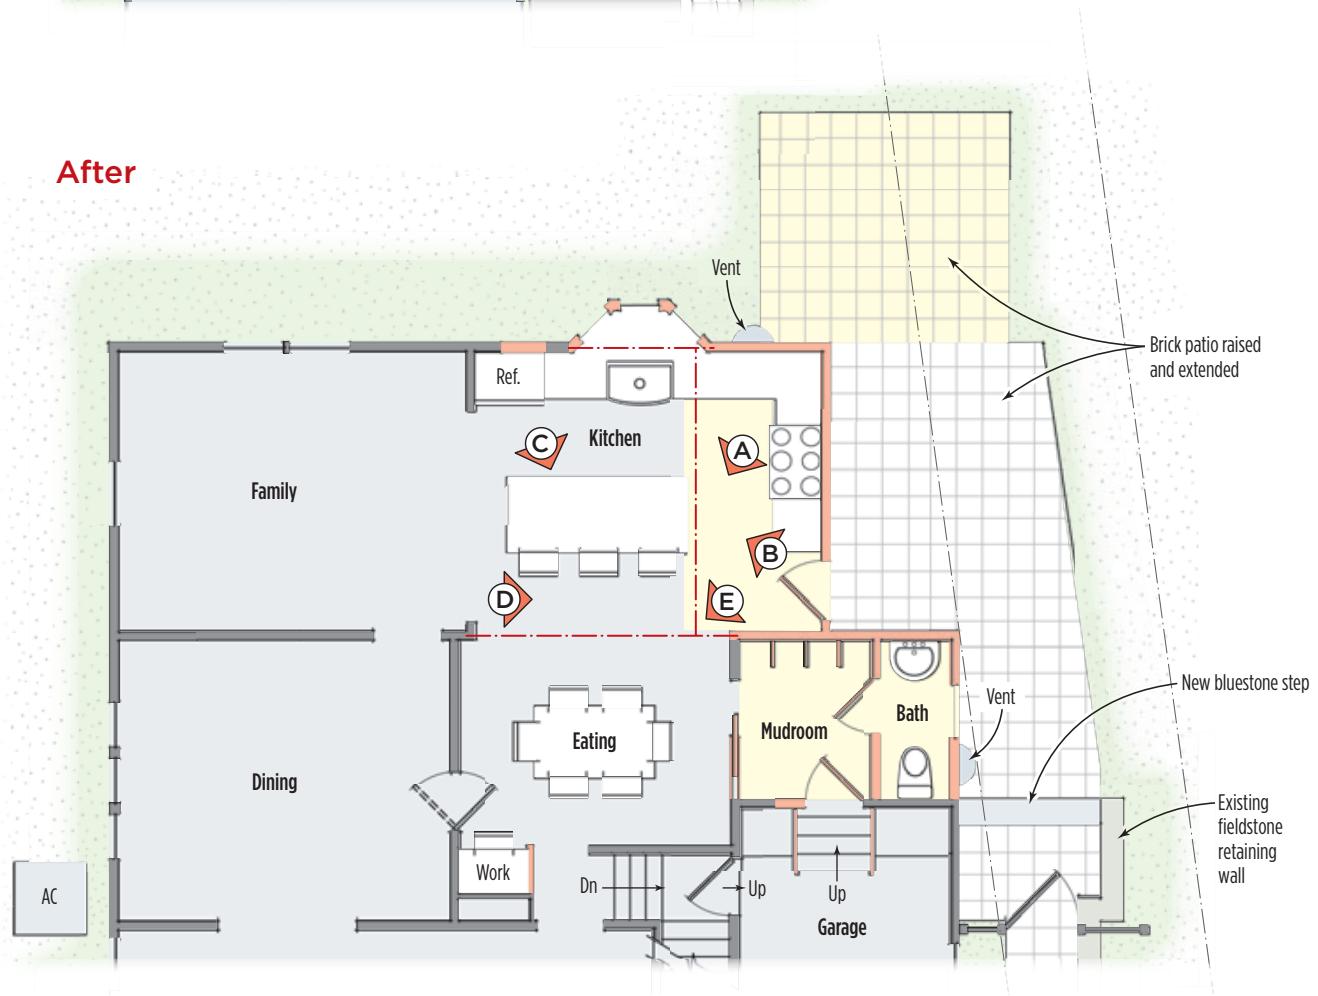
The old kitchen was crammed between a bathroom and a staircase, and had poor flow into adjacent rooms and scant natural light (left). Bumping out the rear wall and moving the bath to the new mudroom allowed the kitchen to spread into the corner, where it shares space with the family room (below). Installing flush headers, as described in the photos on the opposite page, created a smooth ceiling between the rooms and opened up the adjoining eating area.

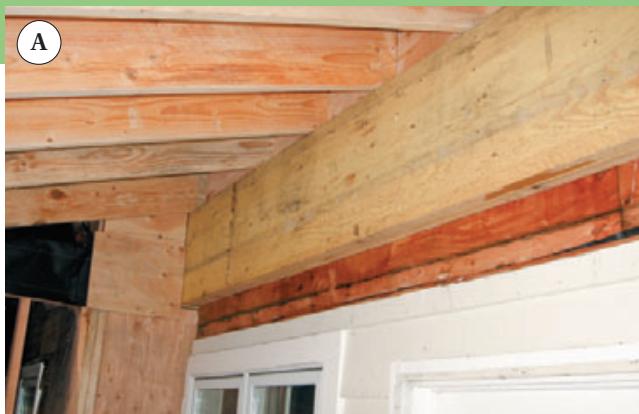
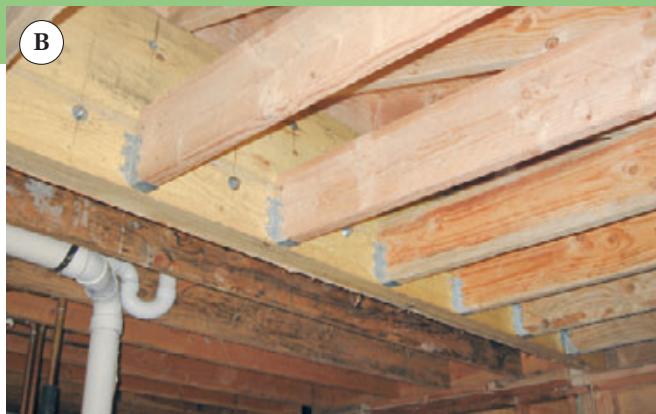
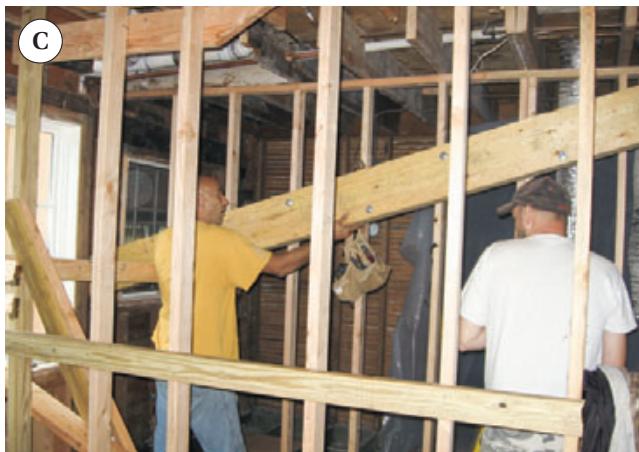
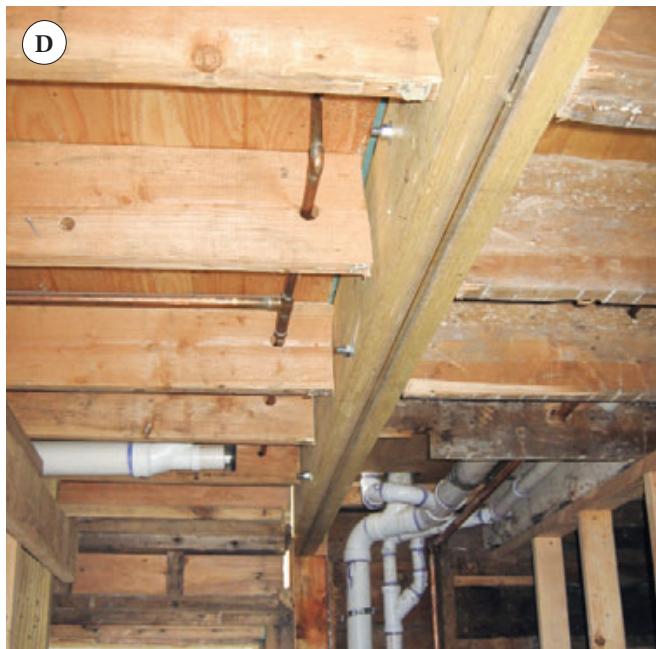
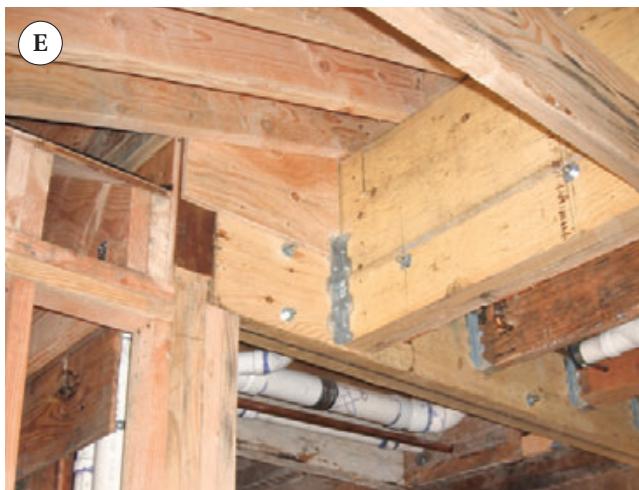
Figure 4. Before opening up the house's rear wall, the crew bolted a pair of 1 3/4-inch by 18-inch LVLs through the exterior sheathing and into the second-story floor framing to support the shed roof of the addition and the second-story framing of the main house (A). Once the house wall was removed (B), they added ceiling joists flush with the existing ones on the other side of the beam. To open up the new eating area, they also replaced an old dropped header with a new flitch beam, first cutting back the joist ends, then slipping it into place (C, D). The two new headers intersect near a support post (E), as indicated in the drawing (facing page).

Exterior header. A 12-foot section of existing exterior wall had to be removed to connect the addition to the house. Even though the second-story floor joists ran parallel to the wall (and therefore were not supported by it), this wall still carried loads from the roof above.

We bolted two 1 $\frac{3}{4}$ -inch by 18-inch LVLs through the sheathing and into the studs and the inside rim joist before demolishing the wall (**Figure 4, previous page**). At one end, this new flush header bears on another conventional LVL header that we installed for a new bay window. At the other end, it hangs from a new flush flitch-plate header.

Center wall header. During the remodel that had produced the out-of-level floor, a drop flitch-plate header had been installed to replace what had once been an exterior wall. To create a wider opening and a flush ceiling throughout the expanded kitchen, we replaced it with a longer flush flitch-plate header consisting of two 1 $\frac{3}{4}$ -inch by 9 $\frac{1}{2}$ -inch LVLs bolted around a 1/2-inch by 9-inch steel plate.

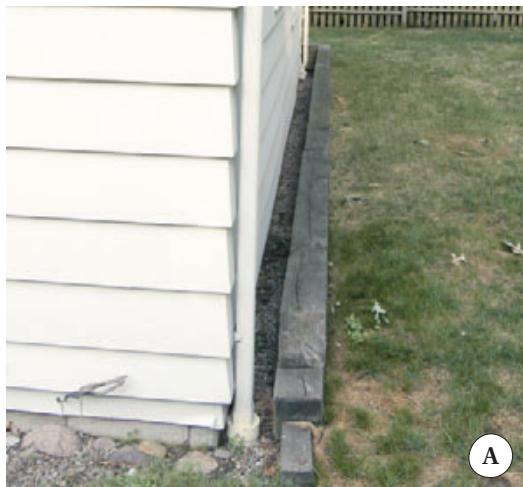
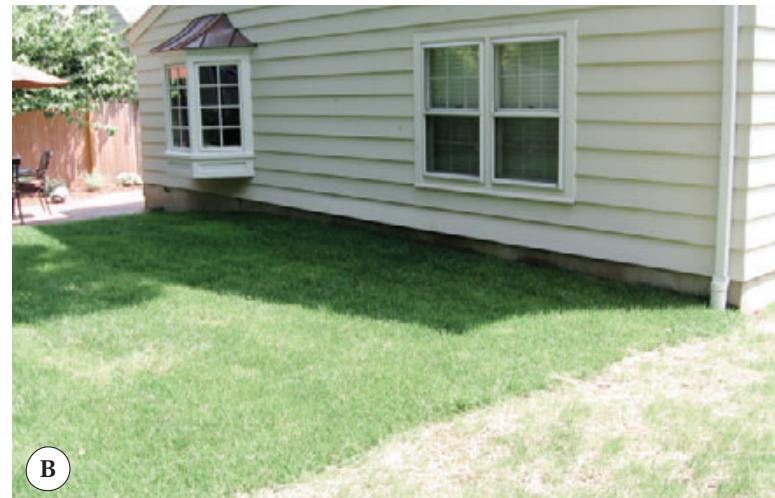
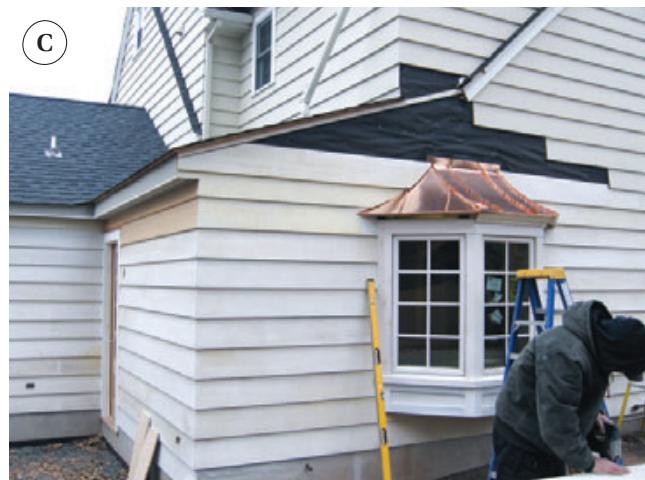
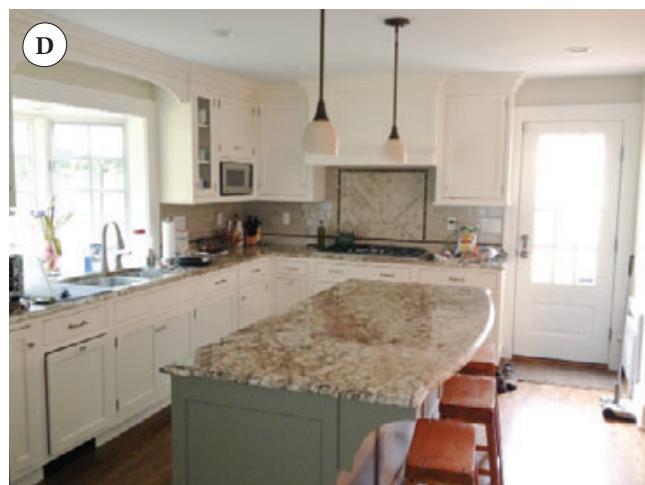
Figure 5. The original unsightly railroad-tie retaining wall (A) was replaced by a nicely graded backyard (B). Thanks to a new bay window over the sink (C) and a 12-light entry door, the reorganized and expanded kitchen gets plenty of natural light (D).

After that, the project proceeded conventionally on the interior. On the exterior, we installed horizontal furring strips above the parging, which allowed us to slightly flare the new beveled cedar siding over the stucco — a nice touch (**Figure 5**).
