Backfill

New Life for an Old Bottle

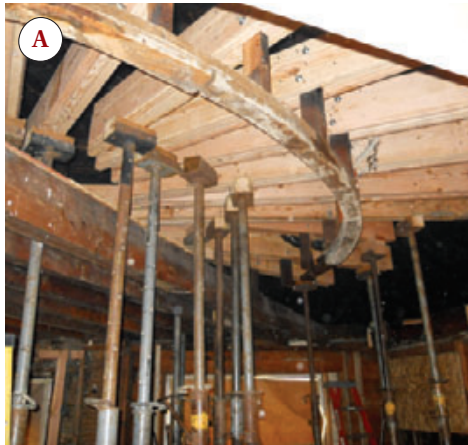
A. To temporarily bear the weight of the stuccoed bottle, a pair of 2x10s supported by pole jacks was bolted to each 16-inch on-center stud (note the curved bottom plate below the temporary 2x10s).

The project called for some creative thinking. The 38-foot-tall by 15-foot-wide bottle had a 2x4 stick frame with an overlay of lath and stucco; two-thirds of the frame's weight was supported by a steel I-beam that ran diagonally across the outer walls. The engineering report dictated that we find a way to stabilize the 33,000-pound bottle while we replaced the single existing beam with a more robust welded assembly. After much discussion we decided to do this with temporary beams and an array of pole jacks. Once the new steel was in place, the rest of the job was relatively straightforward.

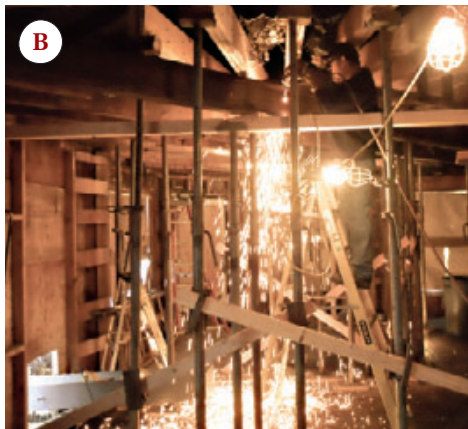
B. New steel beams were passed in through an opening in the outside wall (visible at lower left), raised into position, and welded together.

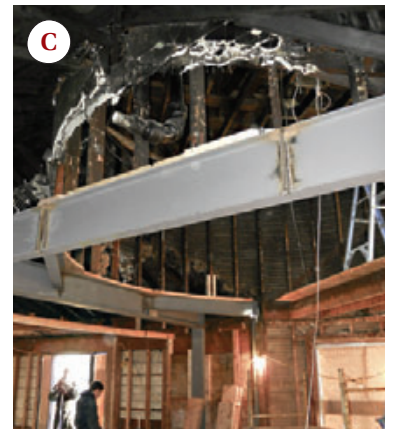
C. Clearing away the forest of temporary jacks left an open, unobstructed work space.

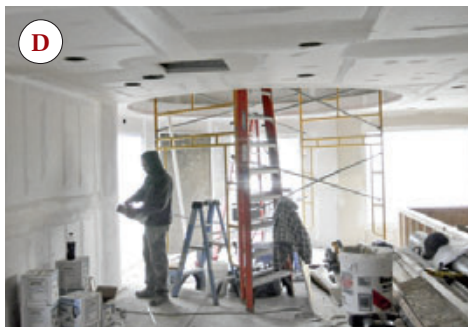
D. The restored interior was finished with drywall on steel studs. The circular opening that extends upward toward the bottle's neck is visible at rear.

The result is a big improvement over the pre-fire structure. In addition to upgrading the ventilation and other mechanicals, we restored the ceiling to its original 15-foot height and created an overhead rotunda ornamented with neon lighting and four custom milk-bottle-shaped lamps.

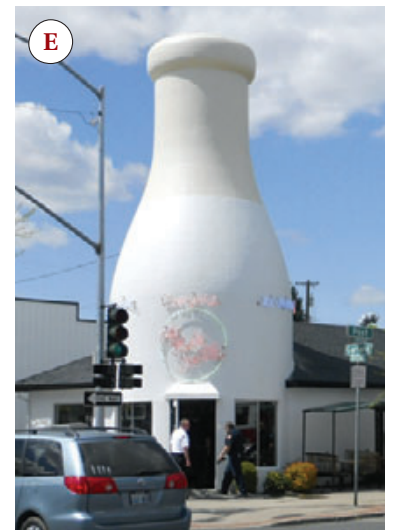
E. Structurally reinforced and freshly painted, the landmark bottle is once again open for business.
