# Remodeling in Masonry

Two projects illustrate how a methodical approach and careful details keep old walls from crumbling

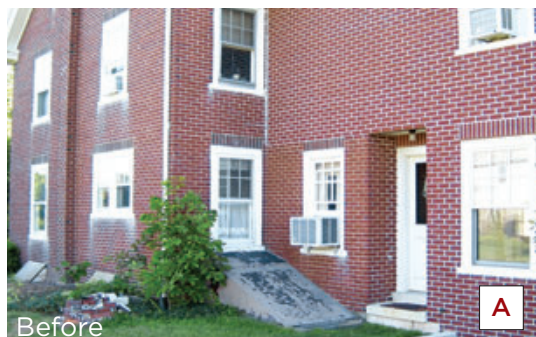
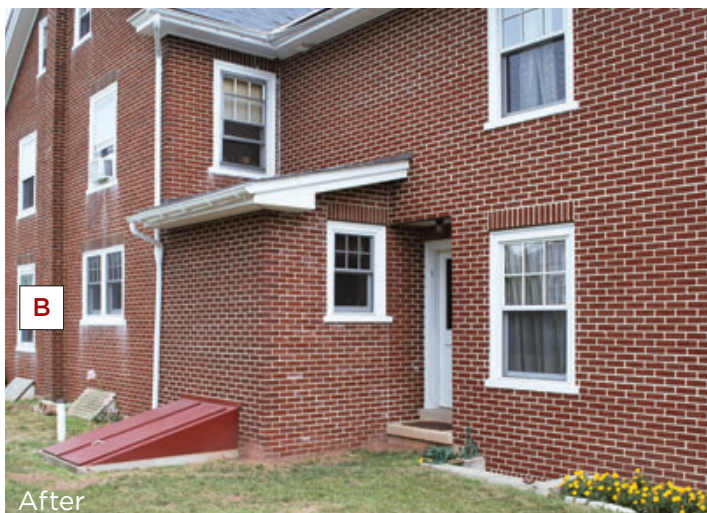
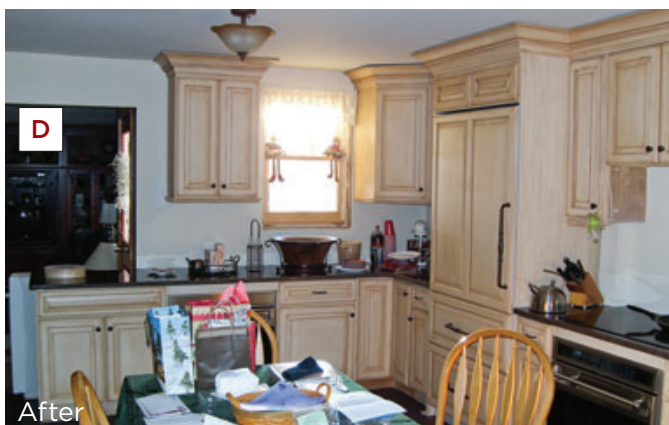
**Figure 1.** A 48-square-foot addition on the back corner of this brick home created a larger rectangular space for the kitchen. The project required removing the first-story structural brick wall in the inside corner and supporting the second story with steel beams. Note the boxed-out column at the right rear of the new refrigerator (D), which encloses a lally column positioned where the original exterior wall used to be.

The owners of a 1920s brick home called my company hoping to expand and modernize their awkward L-shaped kitchen. They wanted to build an 8-foot-by-6-foot one-story addition on an inside corner in back of the house, break through the walls, and create a larger rectangular space for the kitchen (see **Figure 1**). The biggest challenge was that we would need to remove sections of the exterior bearing walls and insert new support beams while holding up the second story.

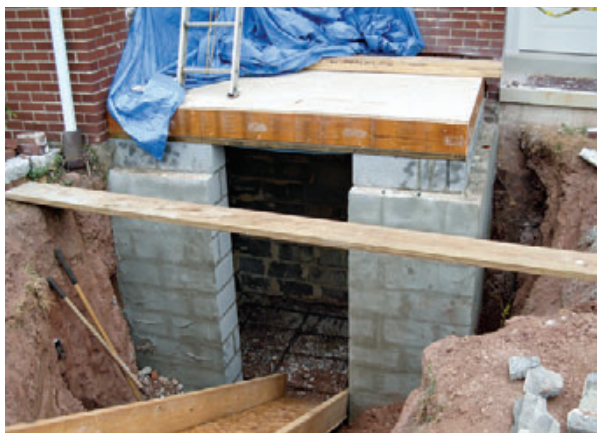
**Figure 3.** The block foundation of the small addition includes a shelf for the new brick veneer. After the deck was framed and the new masonry walls stabilized, a new precast bulkhead was craned into place.

We began work by digging the hole for the addition and laying up the foundation (Figure 3, next page). Our own crew, which is trained in masonry, laid the block. (On small jobs, we try to keep as many tasks in-house as possible; it helps

The clients wanted to retain the original bulkhead access, so we had a new precast unit installed, after first framing the deck to brace the new walls. We were ready for the steel; the subfloor gave us a convenient place for staging the exterior work.

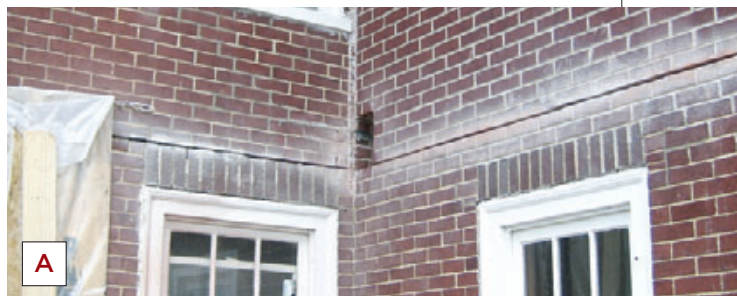
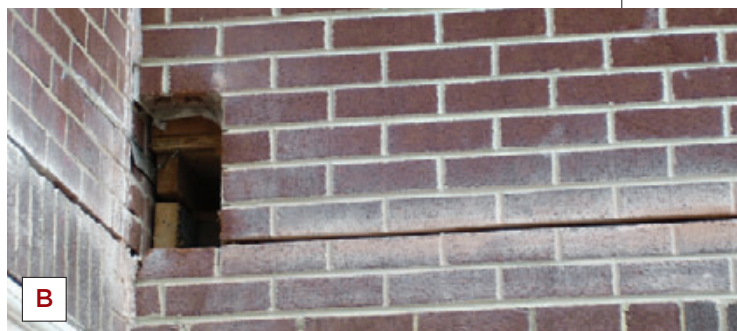
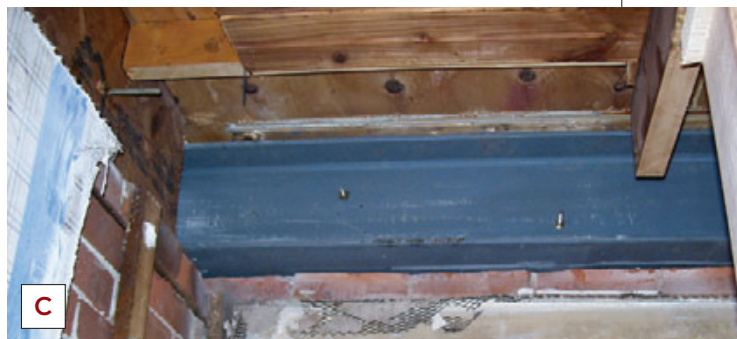
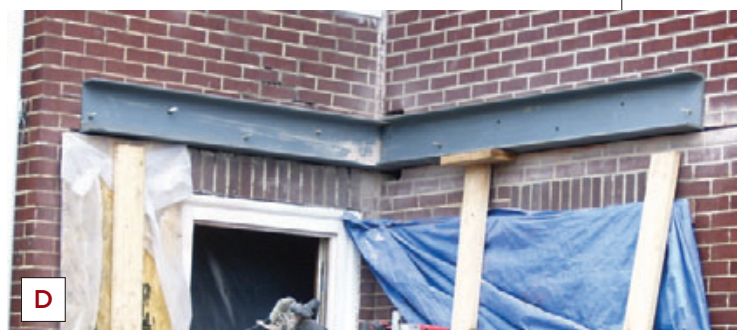
**Figure 4.** Working off the 6-foot-by-8-foot deck of the addition, the crew first kerfed the mortar joints to receive the steel angle (A) and made a hole to allow the 14-foot channel to pass inside at the second-floor level (B). The longer channel was installed first and bolted into place (C), then the shorter channel (D). The right-angle joint at the intersection of the steel channels was later welded.

We first erected temporary support walls inside — from the second-story ceiling down to the ground in the basement — to pick up as much of the floor and roof load as possible. We then used a masonry saw and grinder to cut kerfs in the mortar joints to receive the steel angles (**Figure 4**). The veneer wall required only one 8-foot-long channel on the exterior face. The double-wythe wall of the original house needed two 14-foot-long channels, one of which we had to feed through a hole we made in the veneer wall. In fact, the only bricks we had to disturb during this process were the ones removed for the pass-through and several more inside where we needed vertical channels for the support posts. Because we had transferred the house loads to the temporary supports, we didn't have any problems.

We secured the beam assemblies with a staggered pattern of  $\frac{1}{2}$ -inch through-bolts and brought in a welder to create a structural connection at the inside corner where the longer and shorter channels meet.

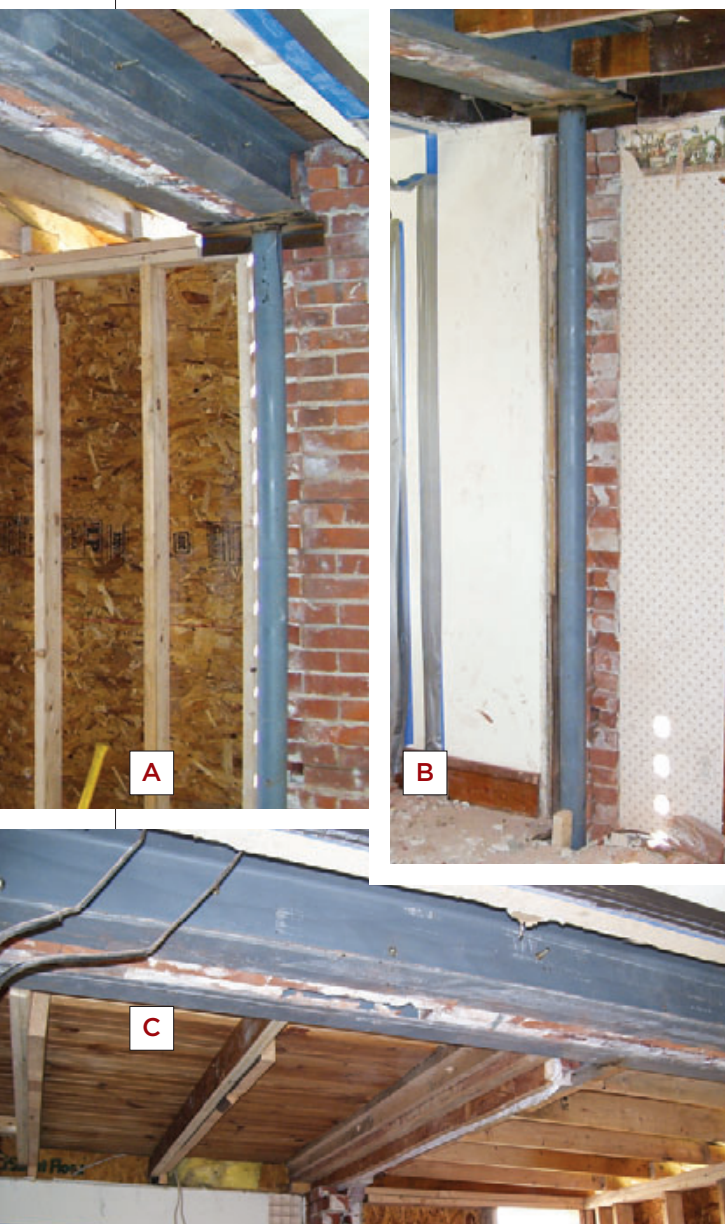
**Figure 5.** Inside, the steel beams were supported at the ends on lally columns (A, B). The existing second-floor joists, which had been cut back to allow the steel to be inserted, were sistered with new full-span LVL joists (C).

The ends of the beams are supported by 4-inch-diameter  $\frac{1}{4}$ -inch-thick steel columns with  $\frac{5}{16}$ -inch-thick steel-angle caps welded on top (**Figure 5, next page**). The column bases sit on the existing foundation wall and are grouted into place.

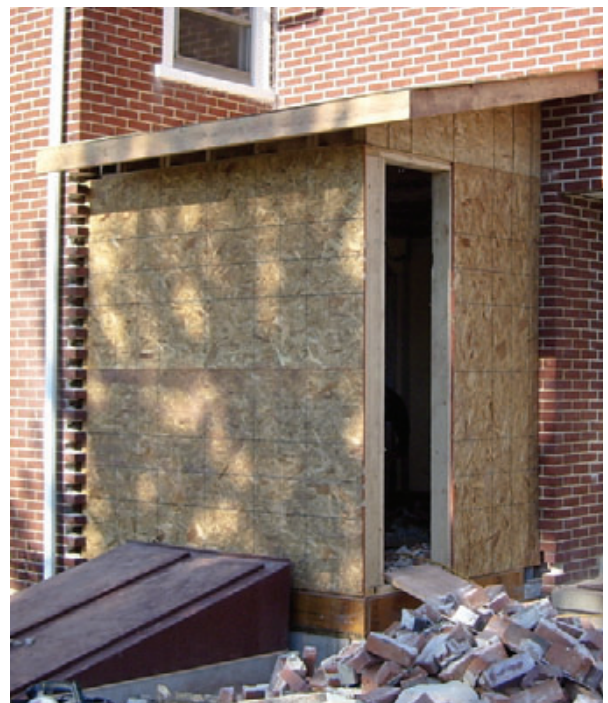
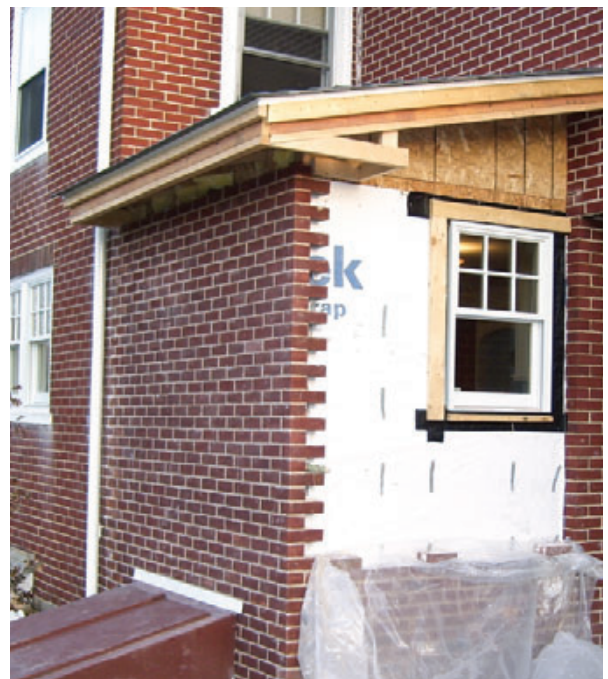
**Figure 6.** The crew left a section of sheathing off the addition so they could more easily remove the brick from inside (top). Where the addition met the original house, the new and existing bricks were toothed together beside a downspout to help hide the transition (above).

We waited until we had framed and sheathed the addition before removing any more brick (**Figure 6, previous page**). We started with a sledge, but after a few bricks were dislodged the rest popped out quite easily — reinforcing the importance of getting the steel beams in place first.

We had intended to re-use the old brick, but after trying to chip the mortar off we abandoned that idea. Fortunately, our bricklayer found a close match. The slight difference in color between the old and new brick would be most noticeable where the new addition met up with the original house. For a better blend, our bricklayer toothed the bricks together in that spot, and we also placed a downspout there. Where the addition meets the newer part of the house, the bricklayer used a simple vertical joint.

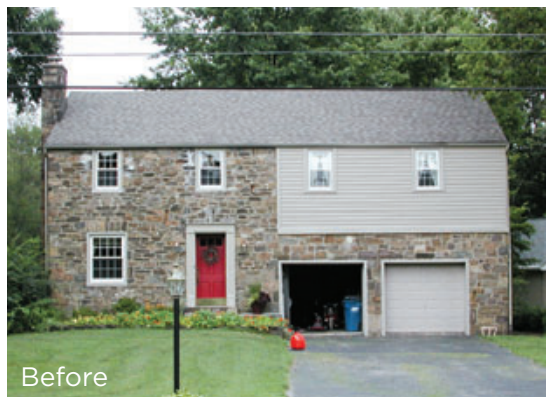
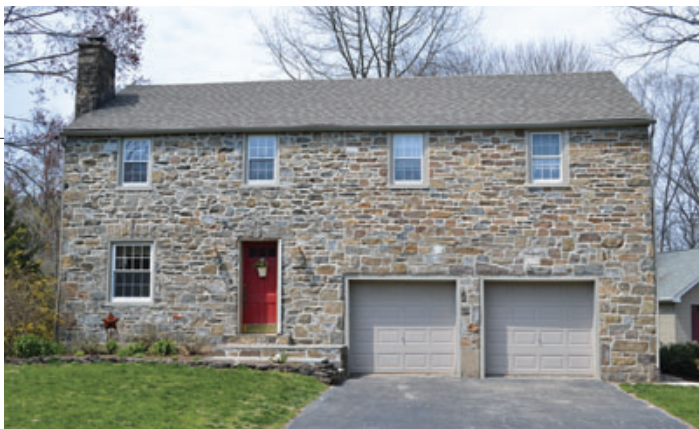
**Figure 7.** An earlier master-bedroom addition above the garage was clad with vinyl siding (left); the new owners wanted to replace the vinyl with local stone that matched the rest of the front facade (above).

This job was simpler than the brick addition, but we still had to work around structural masonry — stone, in this case. The two-story house, built in the 1940s, had structural stone walls on the front facade and stick-framed vinyl-sided walls on the sides and rear. When the previous owners added a second-story master bedroom above the single-story attached garage, they unfortunately sided the front of the addition with vinyl (**Figure 7**). Not surprisingly, the new owners wanted to replace the vinyl with stone. And rather than stone veneer, they wanted matching 12-inch-thick structural stone, so they could replicate the deep window sills across the front.

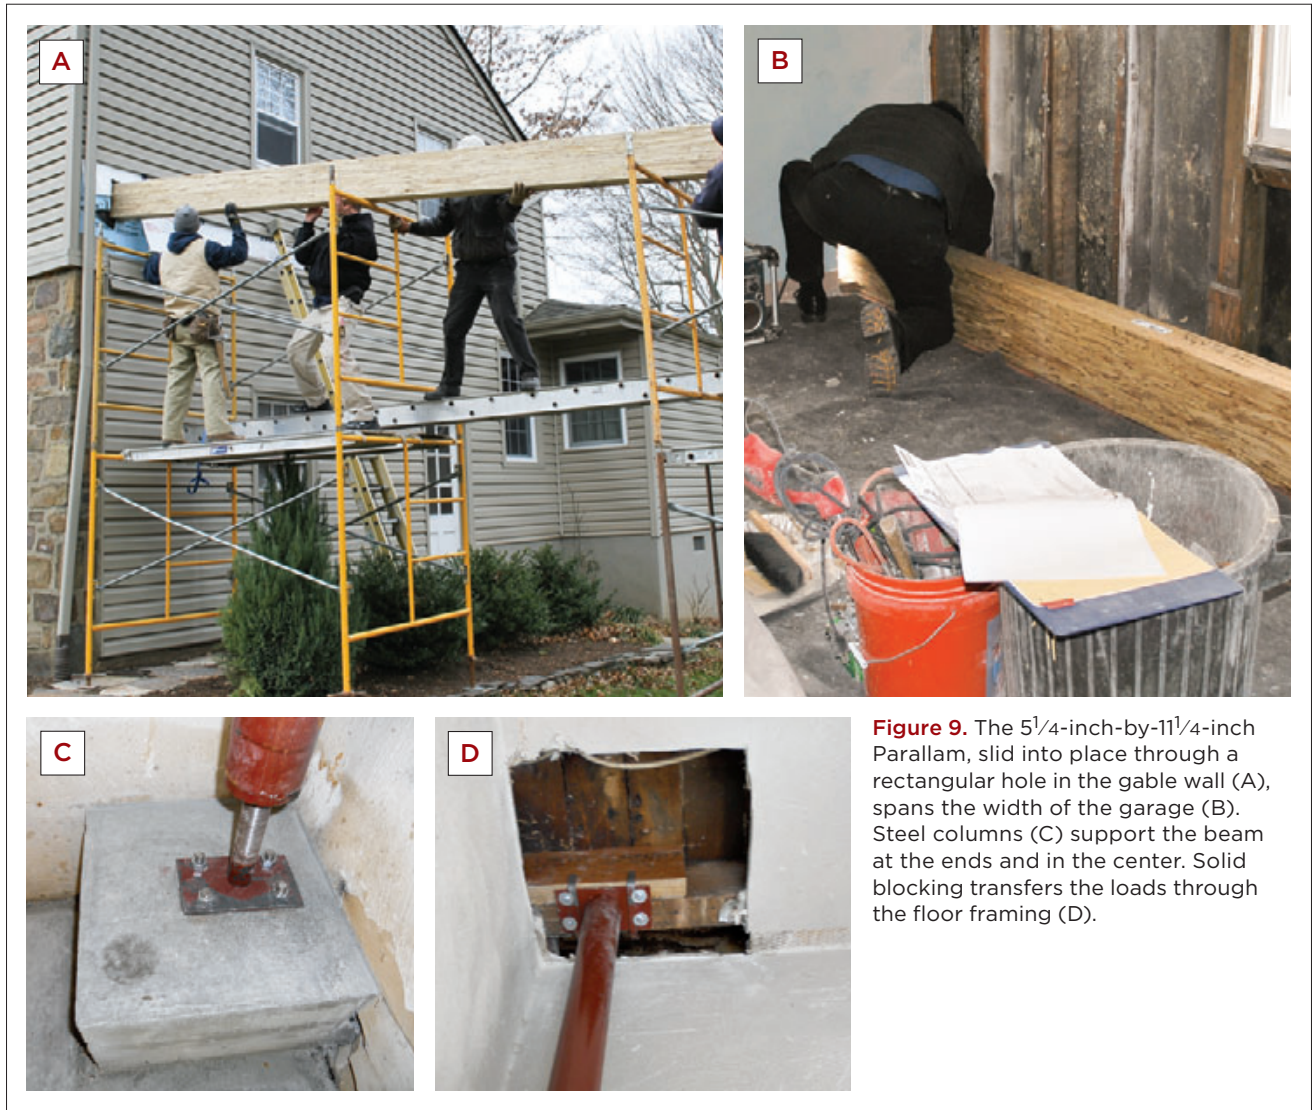
**Figure 9.** The 5 $\frac{1}{4}$ -inch-by-11 $\frac{1}{4}$ -inch Parallam, slid into place through a rectangular hole in the gable wall (A), spans the width of the garage (B). Steel columns (C) support the beam at the ends and in the center. Solid blocking transfers the loads through the floor framing (D).

The plan was to build the studwall and provide support before removing the existing vinyl-sided wall. We first removed a strip of the oak flooring, then slid the beam into place through an opening cut in the gable wall (**Figure 9**). Next, before building the new wall, we fastened the ceiling joists and rafters together with pairs of  $\frac{1}{2}$ -inch through-bolts so the roof couldn't spread when we removed the existing support. We cut birdsmouths in the rafter tails to accept the top plate of the new wall, which we then

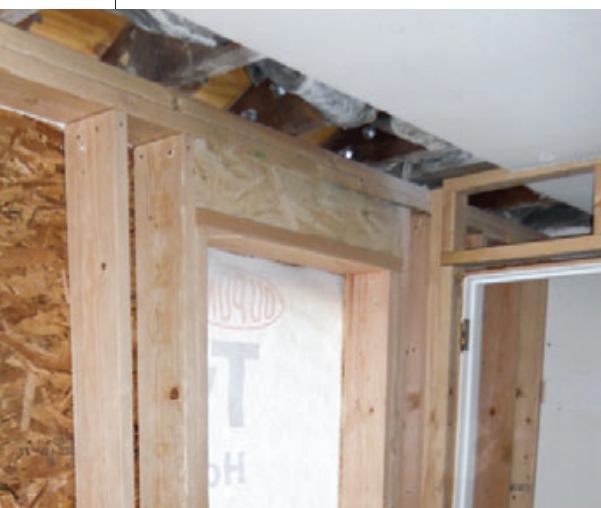
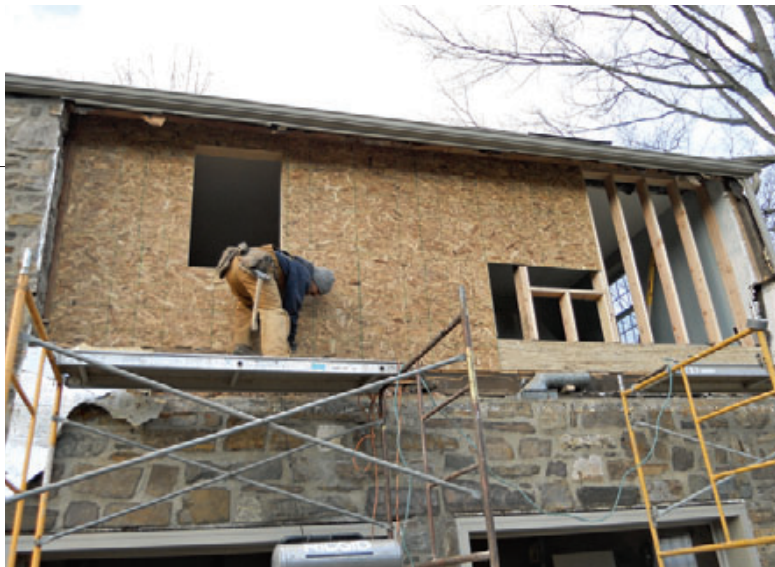
**Figure 10.** Birdsmouths were cut into the rafters to accommodate the new 2x6 wall framed on top of the Parallam (left). The face of the sheathing is 1½ inches behind the back of the stone to allow for drainage (above).

framed. With the roof now safely supported, we tore out the existing vinyl-clad wall, then sheathed the new 2x6 wall (**Figure 10**). The clients wanted to re-use the existing windows, so we re-installed them on ¾-inch plywood jamb extensions projecting out from the new wall (**Figure 11**).

Knowing this, we were comfortable relying on a layer of house-wrap, tucked behind the existing stone at the sides and the base, as a secondary watershed. In the very unlikely event that water does reach the Tyvek, it will be able to drip down to the base of the wall through the 1½-inch drainage space and into the unfinished garage.

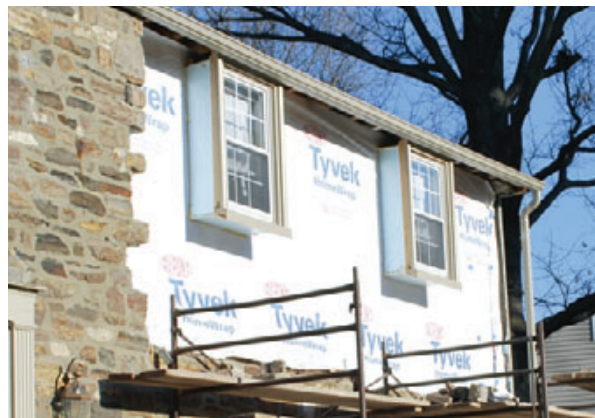
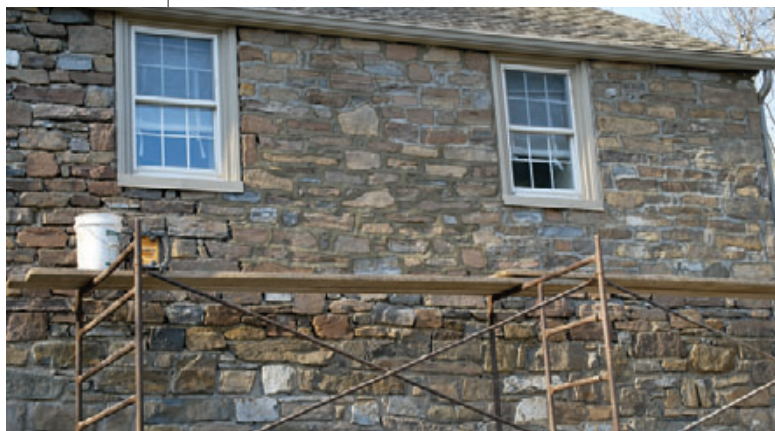
**Figure 11.** The original windows were reinstalled on plywood extension jambs set into the new frame wall (top). The new locally quarried stones should weather to more closely match the original (above).
