Straightening a Stone Wall

Good drainage and a network of steel pins and helical tiebacks give this wall a new lease on life

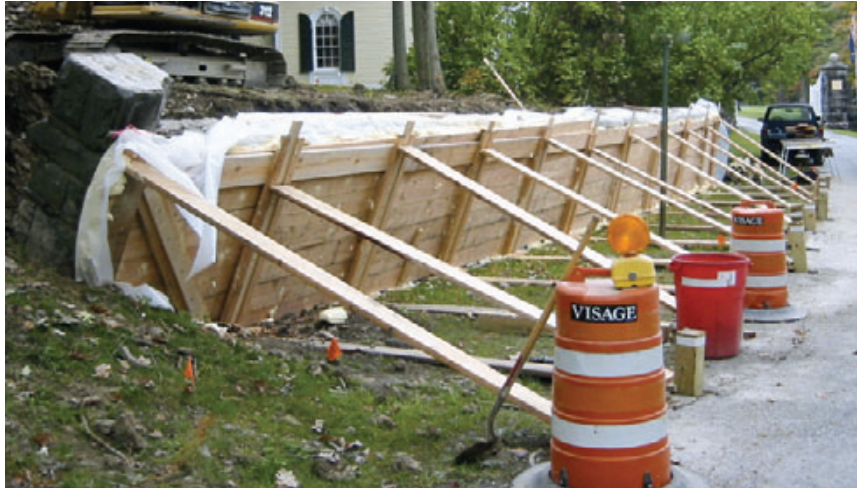
Figure 1. A system of horizontal kickers and diagonal braces bearing against 6x6 posts driven deep into the soil — one of which is visible just to the right of the traffic beacon — held the wall in position during excavation of the poorly drained original backfill.

The first step in assembling the shoring was to use a jackhammer attachment on an excavator and a steel plate to drive a series of pointed 6x6 posts about 5 feet into the soil, spaced 6 feet apart along a line 10 feet or so in front of the wall. We then ran a horizontal 2x12 kicker from each post toward the base of the wall, where it butted against an upright 2x12 with two attached 2x4 trimmers. We used Timberlok screws to fasten 2x12 diagonal braces to the kickers and uprights (see Figure 1).

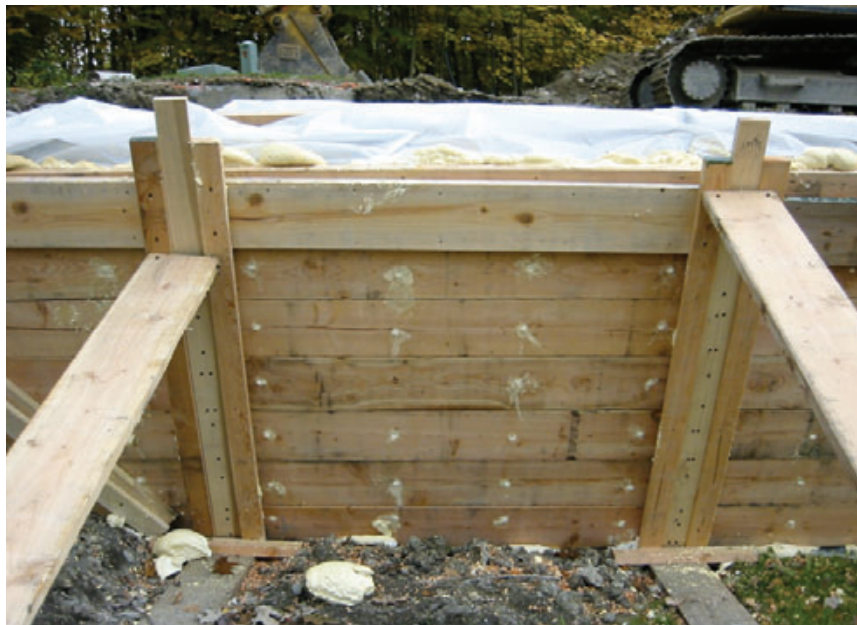
Figure 2. Closed-cell foam injected between the uneven stone wall and the shoring planks ensured consistent contact, eliminating areas of localized stress that could have caused the wall to fracture when straightened. A 4-mil poly slip sheet kept the foam from bonding to the stone.

Once the system of posts, kickers, uprights, and diagonal braces was in position, we draped a sheet of 4-mil poly between the uprights and the wall and screwed horizontal 2x12s to the uprights. The result was a solidly braced wall that stood parallel to the face of the stone, with several inches of space between the two. Next, to ensure uniform bearing along the entire face of the wall, we had a spray-foam contractor inject 2-pound polyurethane foam into the void through 1½-inch holes bored through the horizontal shoring planks (Figure 2). The expanding foam — which was prevented from sticking to the stone by the poly slip sheet — created a perfect “dental impression” of the wall, minimizing any chance that the stones would shift position when we moved the wall.

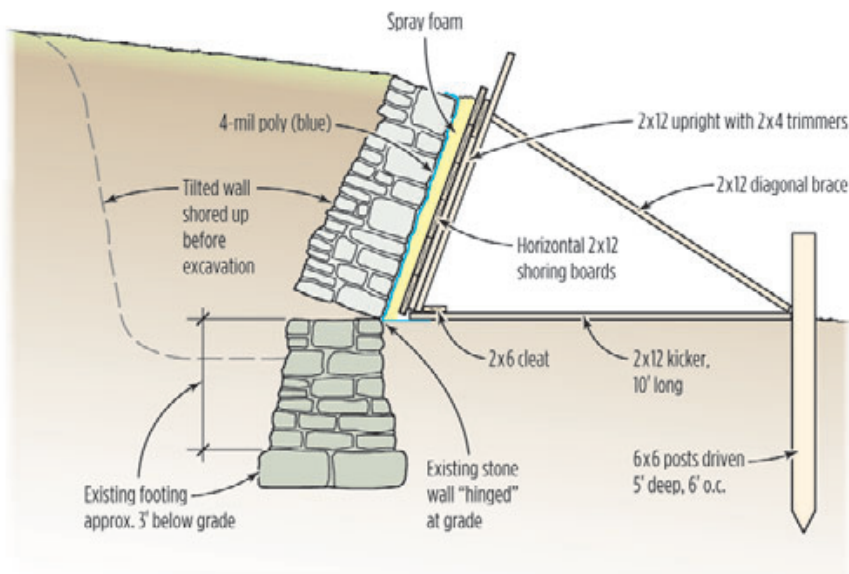
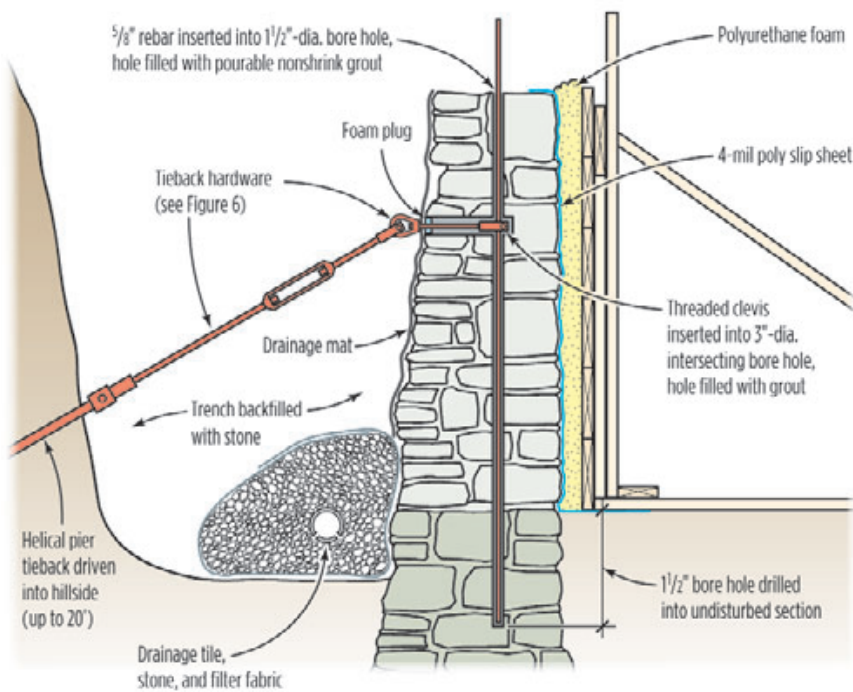
Two-Stage Rescue

Before any digging could proceed, the wall was stabilized against 2x12 shoring planks padded with spray foam (top). After careful excavation, the wall was gently tilted back into upright position, and an array of helical tiebacks and grouted reinforcement was installed (above).

Our plan for saving the wall had two stages (see illustration, facing page). First,

we'd stabilize it in its current position with a bombproof system of posts, plank shoring, and diagonal braces. The shoring would prevent the wall from toppling while we excavated behind it, and later serve to distribute the pressure that we'd

Then — if we succeeded in getting that far — we'd pin the straightened section of the wall together with rebar and add a system of tiebacks and soil anchors to hold it in position permanently.

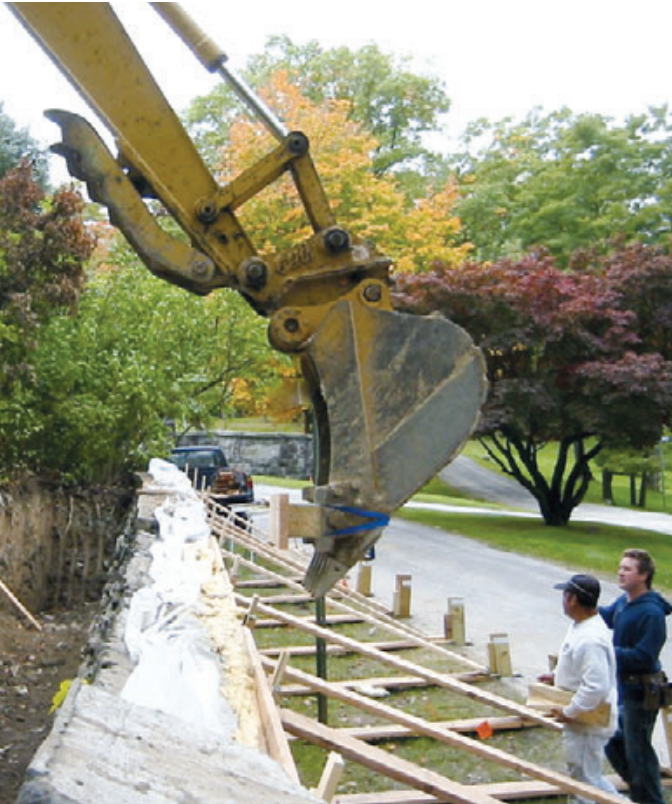
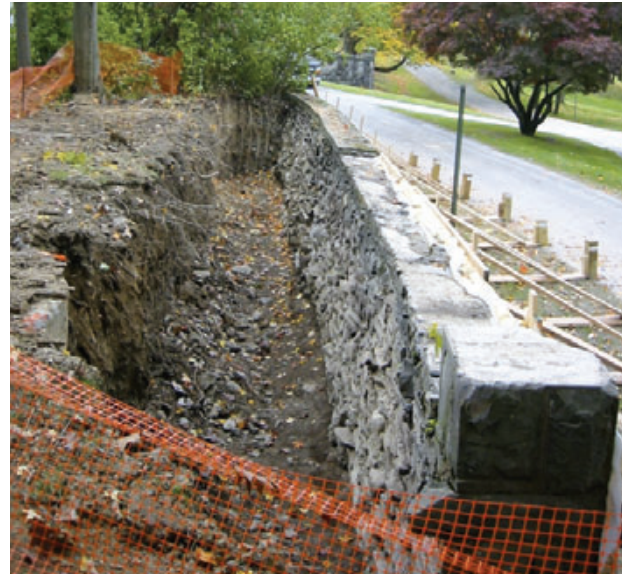
Figure 3. A heavy wood block strapped to the excavator's bucket (left) distributed the pressure across a 4-foot section of shoring as the wall was eased upward. Though relatively little lifting force was needed, only a large machine could supply the necessary reach across the excavation. The wall's battered configuration — wider at bottom than top — increased its stability in the fully upright position (above).

Easy does it. We'd originally thought of using jacks to stand the wall upright, but we soon realized — given the amount of movement needed at the pilaster end of the wall — that this would make for extremely slow going. Instead, we decided to use the boom of the excavator to grab onto the wall from behind and ease it back into position.

Fortunately, there was enough open space on the bank behind the wall for the operator to position the excavator as needed. Starting just beyond the pilaster, he eased the bucket against the top edge of the shoring as we removed the screws at the outboard end of the diagonal brace, then gently used the hydraulics to pull the wall an inch or two further upright (Figure 3, page 4). We then repositioned the diagonal brace and screwed it back against the kicker — with a 4x4 block just behind it to further distribute the load — before moving the machine 6 feet down the wall and repeating the process.

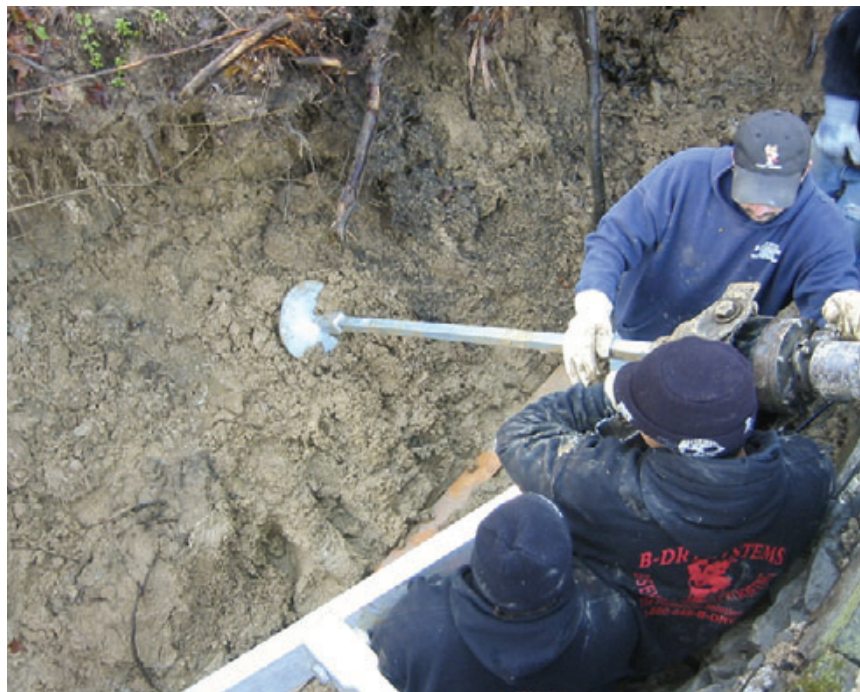
Figure 4. Helical soil anchors furnished tieback points for fixing the reinforced wall to the hillside. The anchor sub was familiar with retaining-wall design and recommended an appropriate depth and spacing for the anchors.

Once the wall was standing upright, we began preparing the system of internal pins and external tiebacks that would lock it in position. The first step was to have a helical-pier contractor drive a series of soil anchors into the slope behind the wall, at about the same spacing as the diagonal braces for the shoring. Some of the anchors had to be driven to depths of nearly 20 feet

to achieve the required 15,000-pound withdrawal force (**Figure 4**).

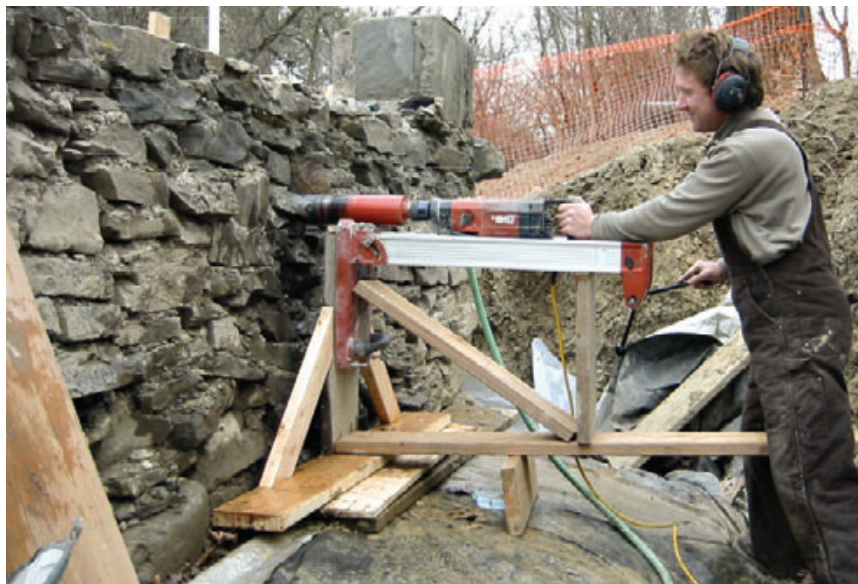
Figure 5. An improvised stand supports the coring drill used to bore 3-inch-diameter holes for the wall tiebacks. To provide an aiming point, a length of white closet rod — visible at top left — was inserted in the previously drilled vertical holes extending from top to bottom of the wall.

The next step was to drill holes for the rebar. We began by marking a point on the top of the wall directly in front of each soil anchor; then we used a 1½-inch cruciform bit in a Makita rotary hammer drill to bore from there into the undisturbed section below grade. Progress was slow, mostly because the bit had to be pulled out frequently to clear the dust from the holes. Once we'd finished the vertical holes, we used a regular Hilti core drill rig to bore a series of intersecting 3-inch horizontal holes about 2 feet below the top of the wall. These larger holes would accept the connecting hardware that would link the internal rebar to the soil anchors (**Figure 5**, page 5).

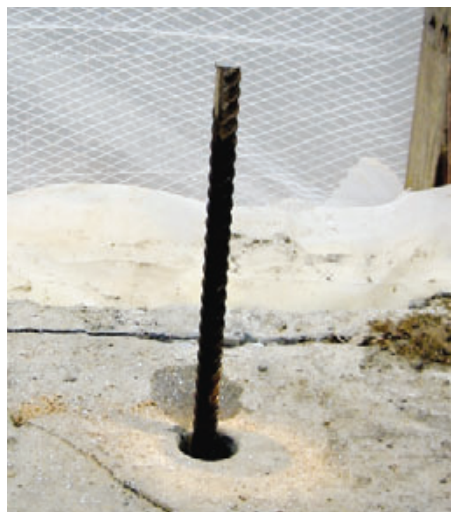
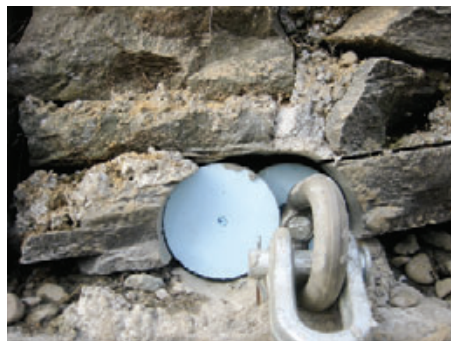
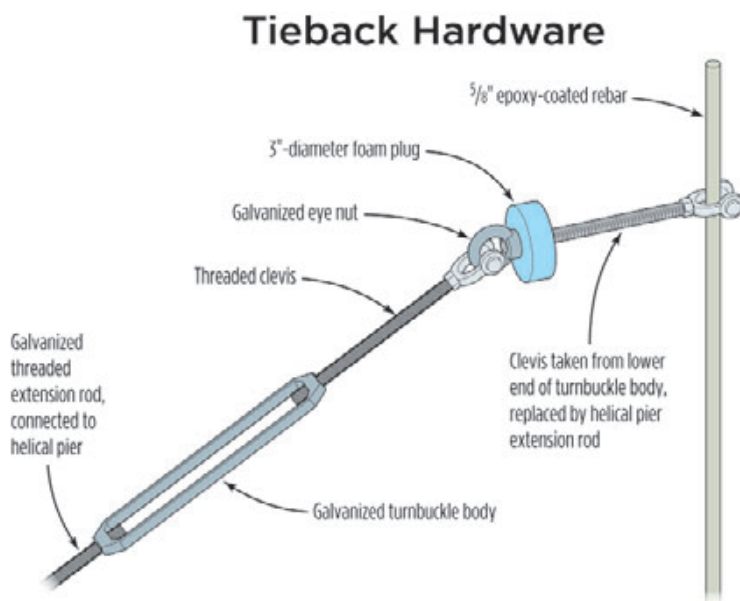
Figure 6. Strands of epoxy-coated rebar pin the repositioned upper wall to the undisturbed portion below grade (above left). The protruding ends visible here were later cut off flush with the top of the wall. The clevis removed from the bottom of the turnbuckle forms a strong mechanical connection with the rebar (above). A foam plug prevented grout from leaking out of the 3-inch-diameter horizontal holes (left).

We assembled those connectors from heavy-duty eye nuts and galvanized turnbuckles purchased from a distributor of marine hardware (**Figure 6**, page 5). As we inserted a threaded clevis in each

horizontal bore hole, we dropped a $\frac{5}{8}$ -inch strand of epoxy-coated rebar into the intersecting vertical hole so it passed through the eye. After repeating this process at each set of holes, we poured non-shrinking machinist's grout into the hole in the top of the wall, embedding both the rebar and the attached clevis. Once the grout had set, we screwed the ends of the turnbuckle assemblies to the threaded extensions supplied by the soil-anchor manufacturer (Figure 7, page 6).

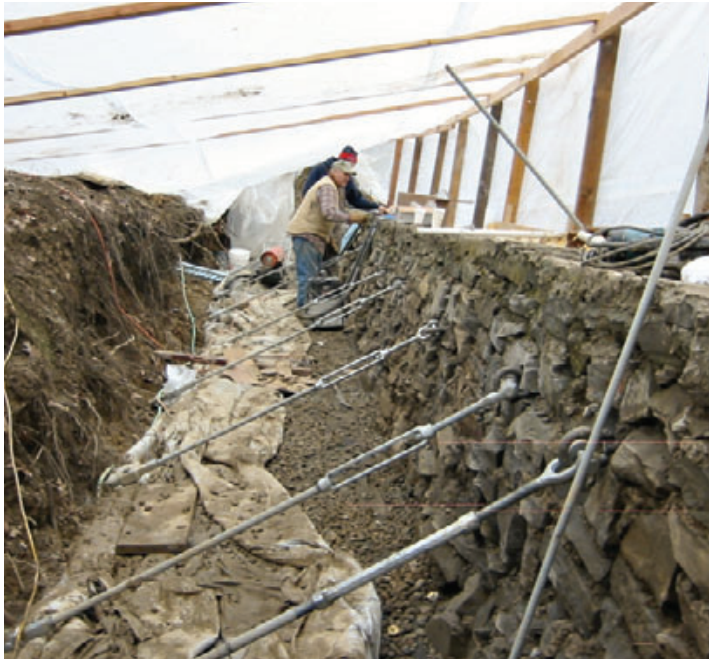
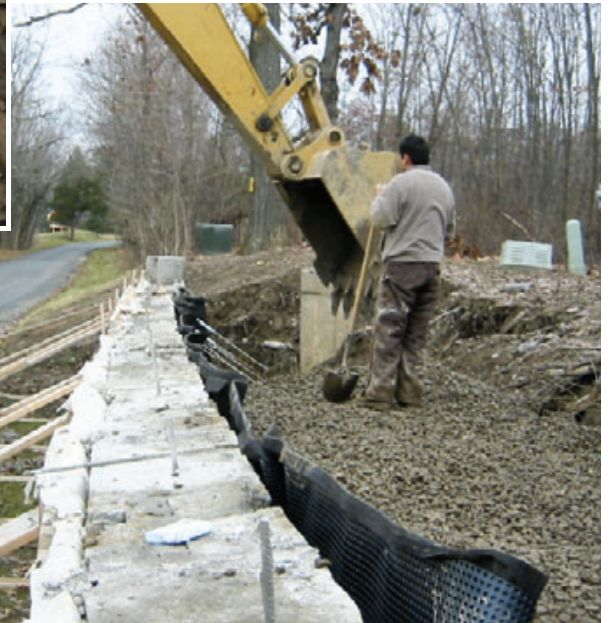
Figure 7. Once the grouted wall pins and hardware had been mechanically fastened to the exposed ends of the helical soil anchors (left), the inner face of the wall was covered with a dimpled drainage mat and the excavation was filled with stone (below).

After snugging up the turnbuckles, we waited several days before backfilling to make sure that there were no signs of shifting or settling. When we were satisfied on that score, we hung a dimpled drainage mat against the inner face of the restored wall — slitting it in places to pass around the tieback anchors — and backfilled with

clean stone. (We'd already run drainage tile at the base of the wall to keep our feet dry while we worked.) We then cut off the protruding rebar and bedded the original coping stones in fresh mortar, sealing the joints where the stones butted together with a polyurethane sealant.

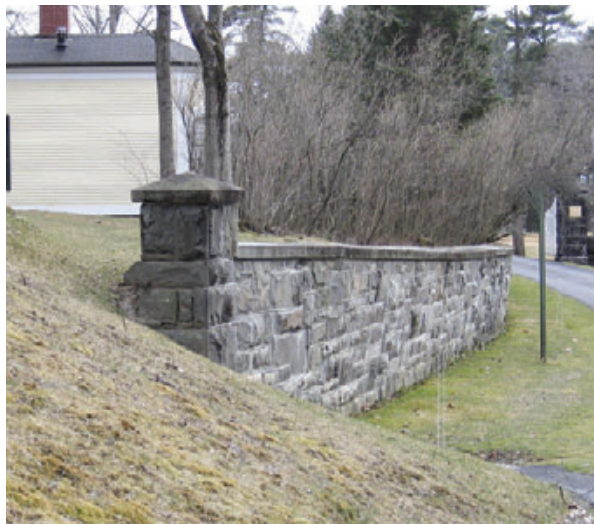
Figure 8. The restored section of the wall stands perfectly straight. To save the mature plantings visible at rear, repairs were limited to the most severely affected section; parts of the original wall remain several inches out of plumb.

But compared to the cost of building an entirely new wall, the repair project was a bargain: Estimates for reconstruction ran upward of \$90,000. Moreover, our approach retained the wall's original materials and historic character (**Figure 8**), making it a win-win situation by any standard.
