# Strengthening an Old Roof

New LVL framing straightens and stiffens an underbuilt timber frame

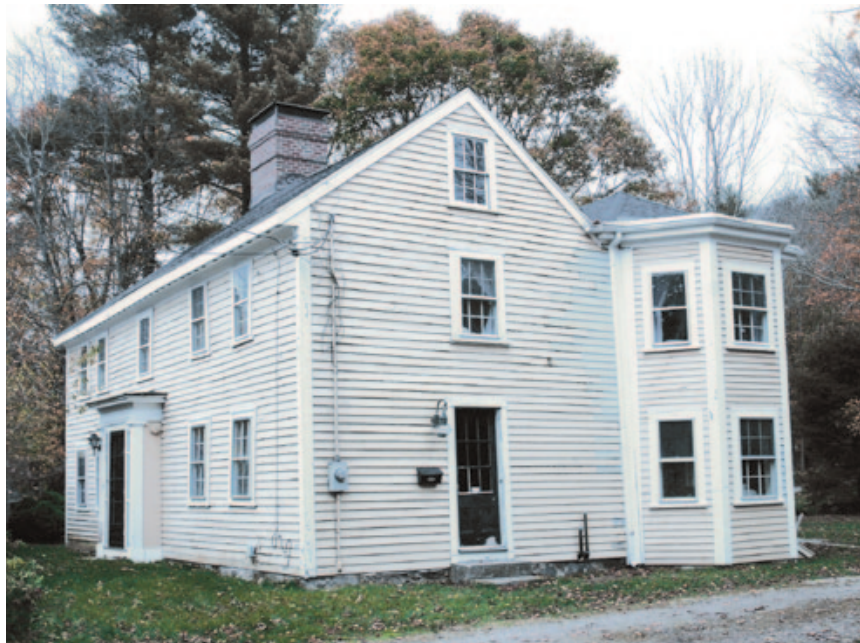
**Figure 1.** Though still intact after nearly 300 years, the framing of the gable roof needed reinforcement to eliminate a long-term sag of the roof deck between the widely spaced rafters.

As a remodeler on Boston's North Shore, I work on my share of older homes. But few are as old as one of my recent projects, which involved extensive structural repairs to a farmhouse originally built in 1723, with a "new" wing off the back dating to the early 1800s (see Figure 1, next page).

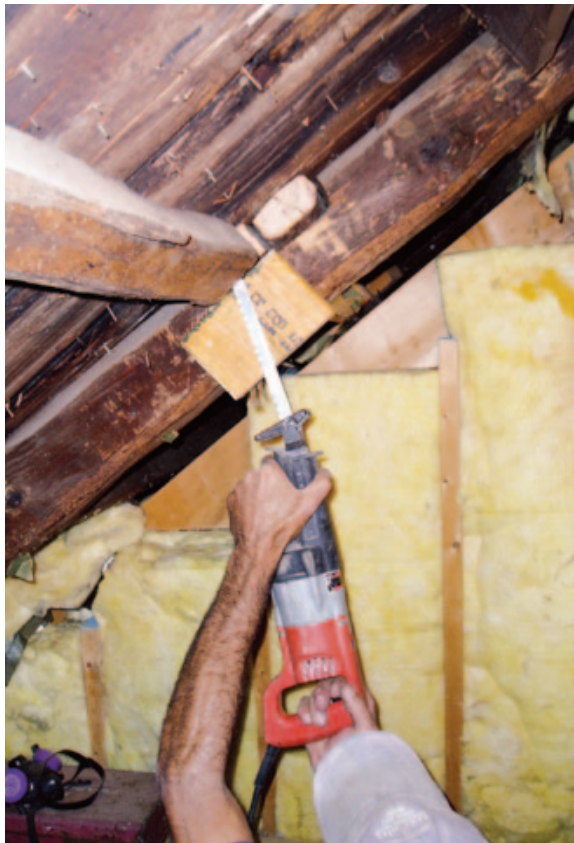
**Figure 2.** The original undersized purlins were small-dimensioned pieces of timber hewn flat on two sides, with some of the bark left on. Their ends were carefully cut free of the rafters, creating space to insert LVL sisters.

hangers. Fitting the sisters was fairly slow going, because we had to cut both ends of each of the original purlins free of the rafters, using a short LVL offcut as a Sawzall blade guide (**Figure 2**).

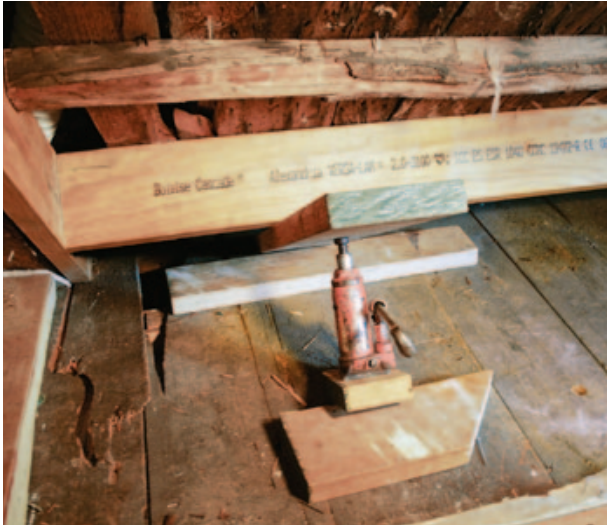
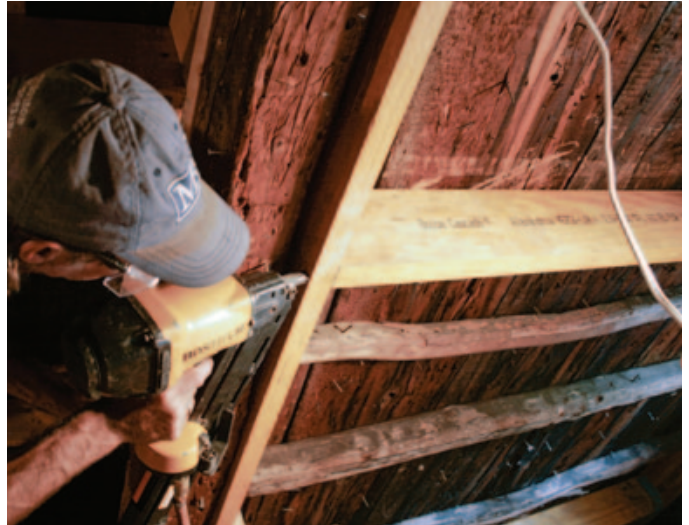
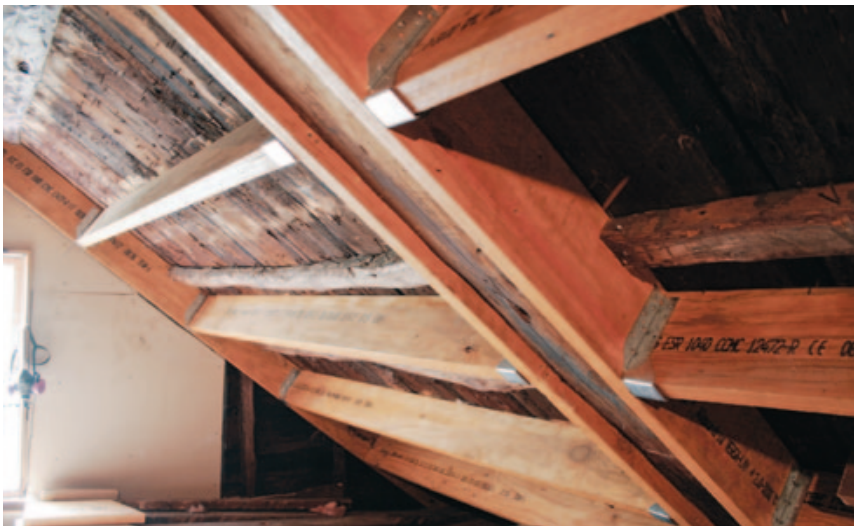
**Figure 3.** Bottle jacks and scraps of blocking were used to press the new LVL purlins against the roof boards (above left). A level cut at the base of each LVL sister sits flat against the existing timber plate. Working down the roof one rafter bay at a time, the crew temporarily secured each new purlin with a single nail at each end (above) before fastening the assembly permanently with joist hangers (left).

After sistering each side-by-side rafter pair, we fitted new LVL purlins between them on approximately 2-foot centers, adjusting the placement as needed to avoid the original purlins. Space in the blazing hot attic was tight, making this an awkward task. Once each new purlin was in place, we used a pair of bottle jacks to drive it home just tightly enough to overcome the sag in the original boards (**Figure 3**). We tacked the purlins in position with a couple of nails before fastening them permanently with joist hangers. (Although conventional framing lumber would likely have been strong enough and would certainly have saved some money, at this point I was glad I'd chosen to play it safe with LVLs: Their uniform size and absence of crown made it much easier to judge when things were flat and straight.)

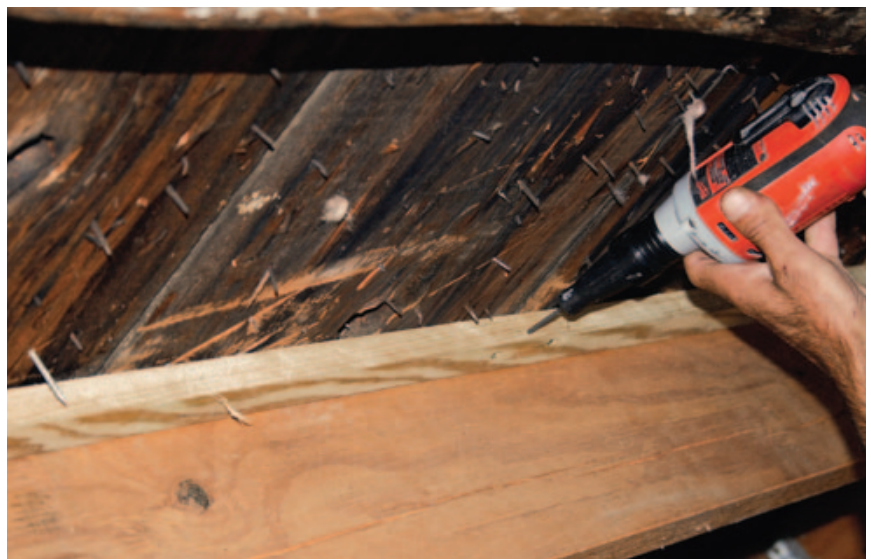
**Figure 4.** A 1½-inch by 1½-inch nailer fastened alternately to the purlins and the roof boards stiffens the assembly against racking without penetrating the existing roof shingles.

Since there was no way to gain access to the roof deck from above without tearing off the existing roof, we couldn't drive fasteners down through the roof boards and into the new purlins. I knew future snow loads would tend to push the boards more tightly against the framing, so I considered going without any fasteners at all in this area. In the end, though, caution won out. I came up with an indirect fastening method that involved screwing 1½-inch by 1½-inch lumber strips to the side of each LVL, with additional screws — sized to stop short of the roofing underlayment when driven home — passing through them from below and into the roof boards (Figure 4).
