# Rehabbing a Rotted

# Porch Stair

## A template helps to fit the bottom tread neatly around the posts

by Emanuel Silva

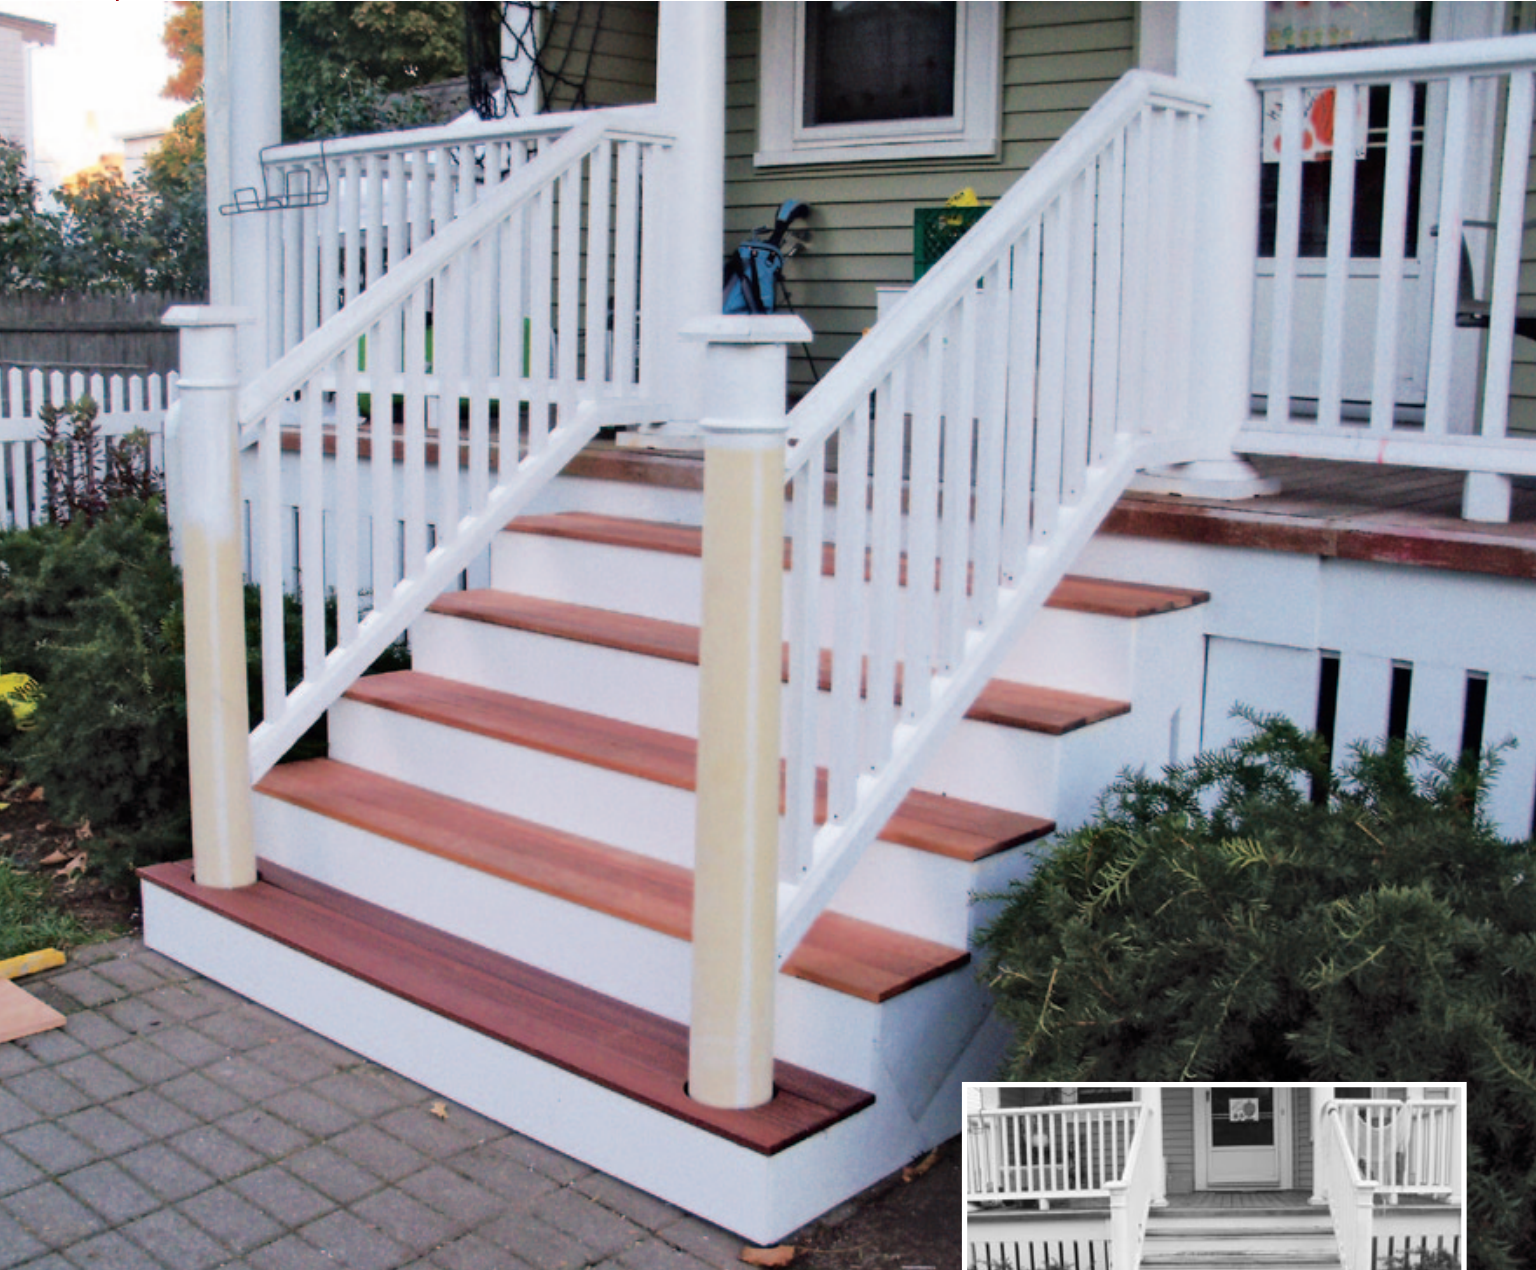
When I dismantled the newel posts, they fell apart as if I were peeling back a banana. The bottoms were totally gone. Though not made of treated material, the posts were short columns meant for use on porches and some care had been taken initially to prevent them from failing. Each had been installed on a pressure-treated block to keep it away from ground contact, and the middle of each block had a hole drilled in it to provide drainage.

But even with these details, the posts took on moisture. The supports around the posts were soaked with water, too, and one of the stringers had minor rot damage. A huge contributing factor was that dirt had collected between the tread and the posts, trapping the moisture.

**Figure 1.** Poor drainage and a lack of maintenance caused the original newels to rot.

After removing all the supports for the posts and cutting out the rot damage to the stringer, I could start to rebuild (**Figure 1**). I cut a piece of pressure-treated stock and fastened it to the side of the damaged stringer, which stiffened it up and gave support for the new post (**Figure 2**). All the fresh cuts got a coat of wood preservative to help prevent rot. I repeated the original block detail beneath the

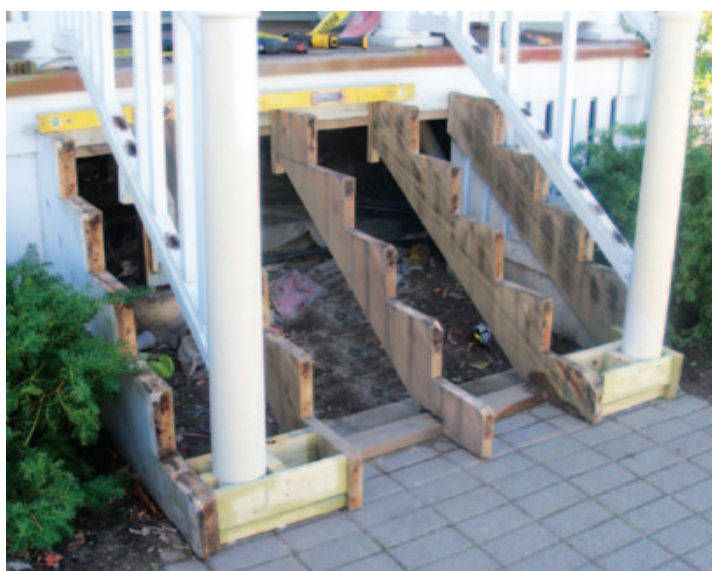
**Figure 2.** A pressure-treated frame was built to support the new posts and bottom tread.

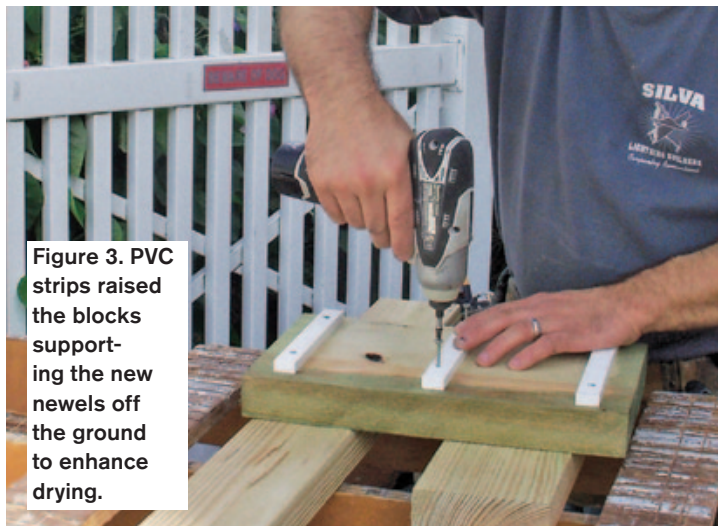
**Figure 3.** PVC strips raised the blocks supporting the new newels off the ground to enhance drying.

posts, but to improve drainage, I added PVC spacers to the bottom of each block and drilled multiple, larger holes (**Figure 3**).

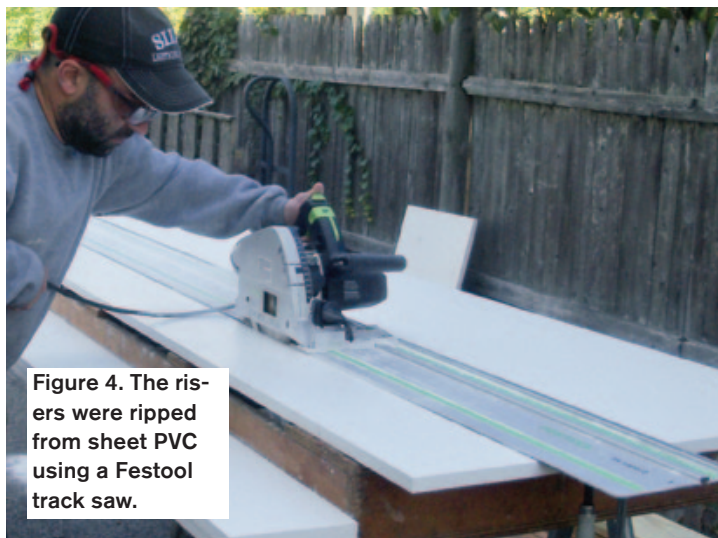
**Figure 4.** The risers were ripped from sheet PVC using a Festool track saw.

At my workstation, I have a table where I cut all my stock to size (**Figure 4**). A Festool track saw (Tooltechnic Systems; 888/337-8600, festoolusa.com) made cutting the risers quick and accurate. Before installing the new risers, I applied a coat of primer to the cuts on the existing skirt boards, which were in good shape. The risers were fastened to the stringers with Cortex fasteners (FastenMaster; 800/518-3569, fastenmaster.com). These made quick work of securing the screws and hiding the screw holes (**Figure 5**). Shims installed as needed to keep the risers flat and straight also helped keep the space between the treads and risers consistent.

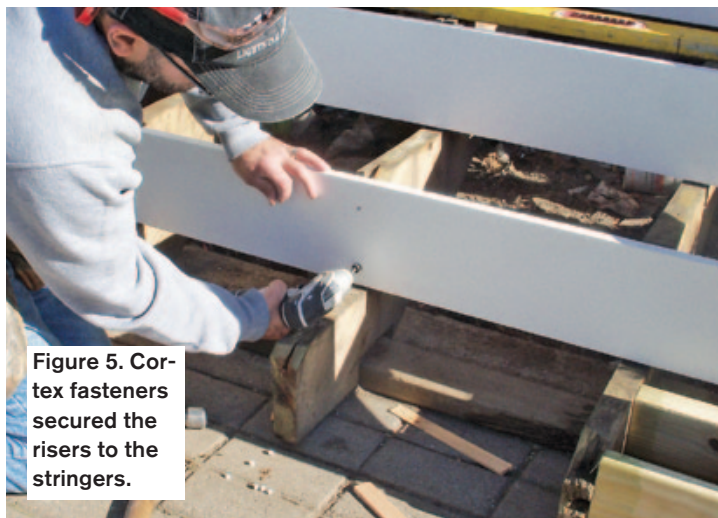
**Figure 5.** Cortex fasteners secured the risers to the stringers.

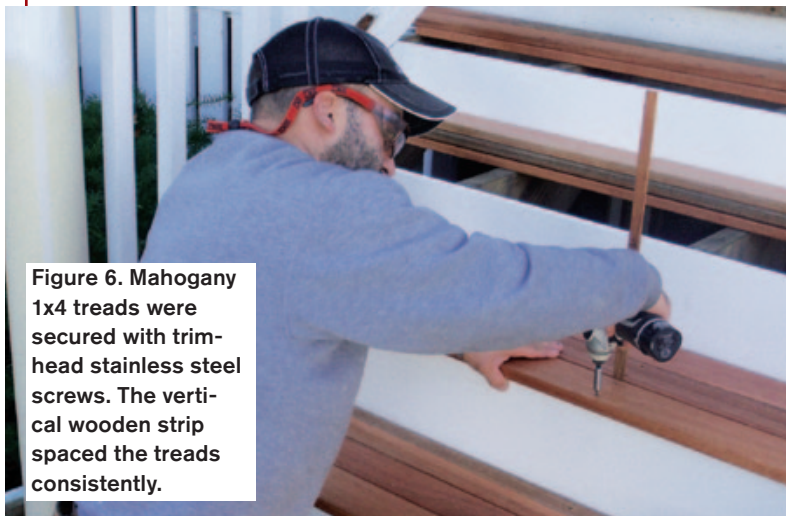
**Figure 6.** Mahogany 1x4 treads were secured with trim-head stainless steel screws. The vertical wooden strip spaced the treads consistently.

I used three mahogany 1x4s for each tread, with one board ripped to 2½ inches to yield a tread depth of 10⅜ inches, including the tread overhang (**Figure 6**). That won't meet code in a lot of jurisdictions, but many northeastern states, including Massachusetts where I work, allow a minimum tread depth of 10 inches.

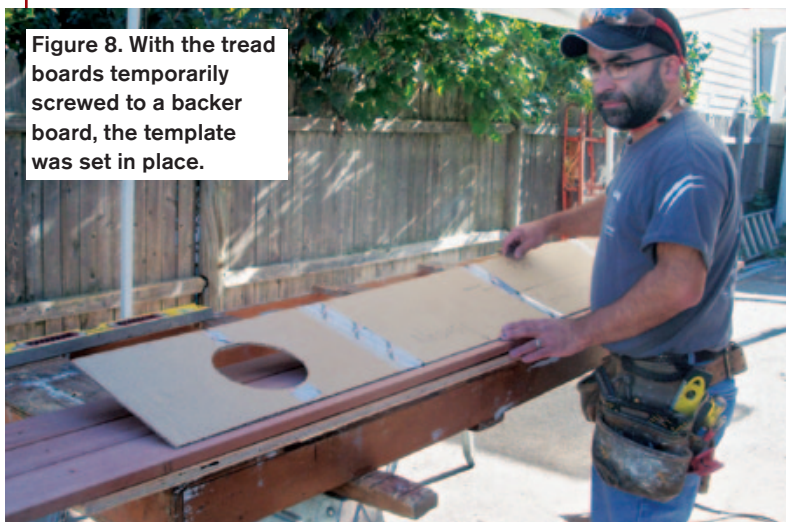
**Figure 8.** With the tread boards temporarily screwed to a backer board, the template was set in place.

I secured the three tread boards to a plywood backer, leaving the boards a few inches longer than the finished treads would be. I screwed the boards to the backer through their ends (which would get trimmed off). Securing the template to the boards with tape kept everything in line (**Figure 8**).

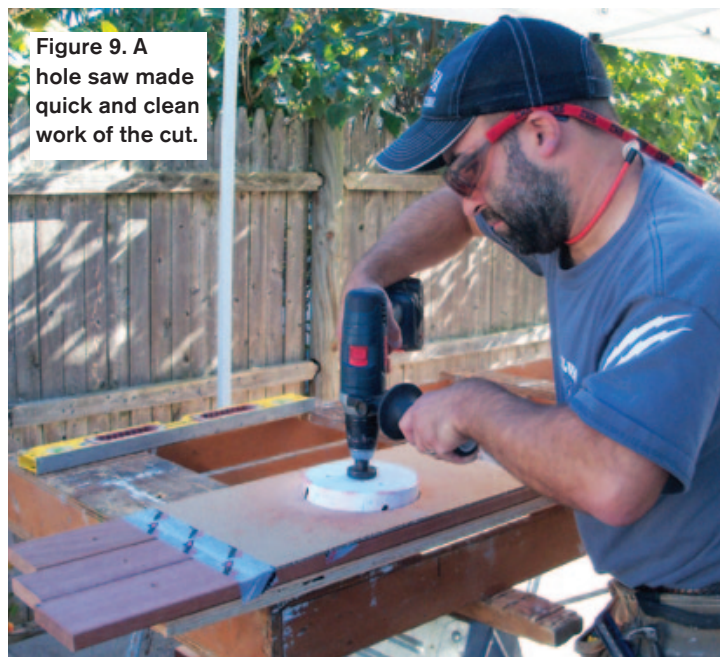
Figure 9. A hole saw made quick and clean work of the cut.

Drilling with a hole saw can be tricky. The pieces that were to be cut out could move around, causing damage, so I screwed them to the backer to keep them in place as I drilled. I set my drill on low speed and drilled through the mahogany with no problems (**Figure 9**). Then I laid a guide across the boards and cut them to length. I eased the ends of the boards and applied a coat of Penofin.

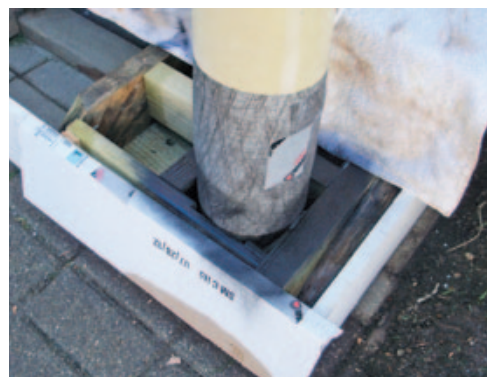
Figure 10. Black spray paint made the frame and lower part of the newel practically invisible once the tread boards were installed.

Before installing the treads, I spray-painted the bottoms of the columns and supports with black paint to make them less visible through the gap between the tread boards and the post (**Figure 10**). Lining up all the boards correctly to install the bottom tread took a little patience (**Figure 11**).

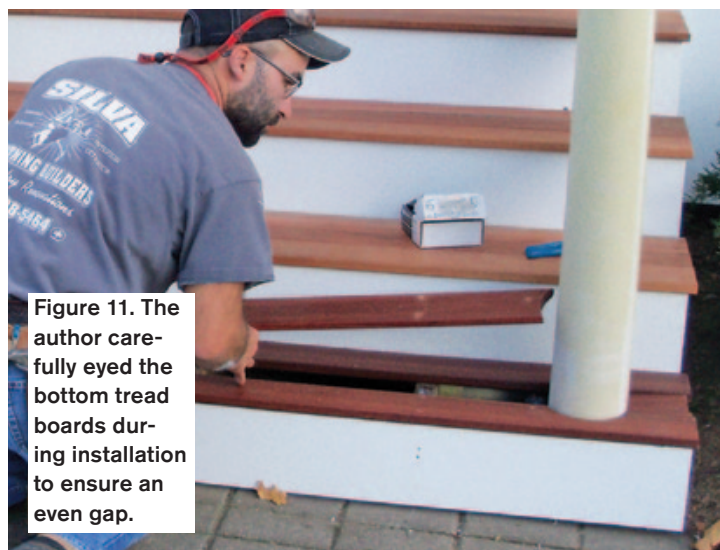
Figure 11. The author carefully eyed the bottom tread boards during installation to ensure an even gap.

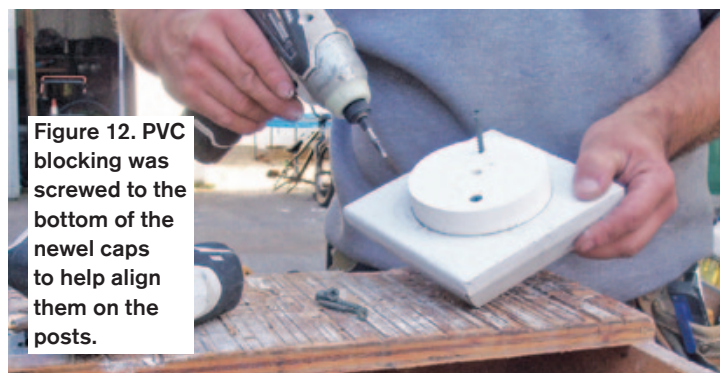
Figure 12. PVC blocking was screwed to the bottom of the newel caps to help align them on the posts.

I reused the existing post caps but replaced the inner supports for the caps with PVC (**Figure 12**). These I cut using a 4-inch hole saw, and then I screwed them to the bottom of the caps. No screws were needed to fasten the caps to the posts, just sealant applied around the support.
