Installing Windows in a Deep Wall

Repairing Cracked Granite at Sink Cutouts

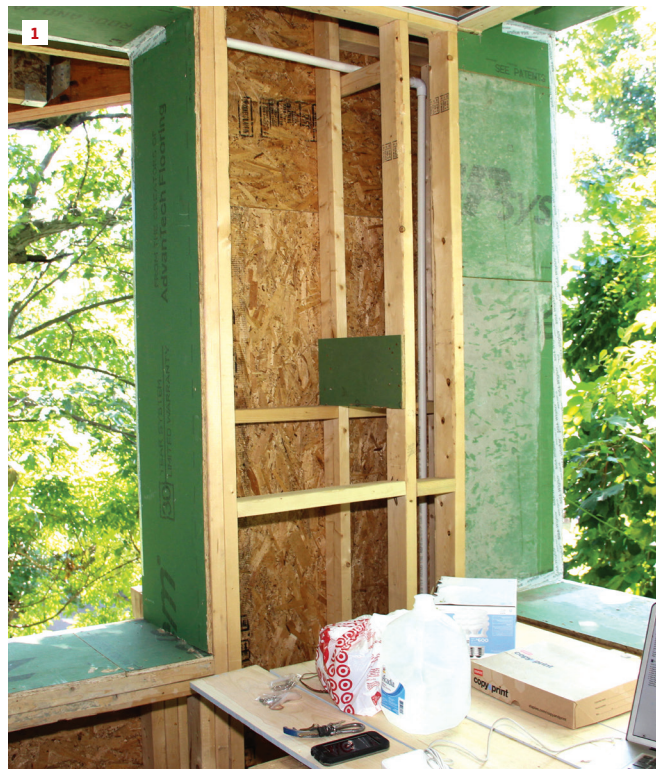
The project shown here is a two-family townhouse in the Fort Hill neighborhood of Roxbury. Placetaylor's deep wall system is simple: a 16-inch-thick double stud wall framed with 2x4 studs, connected with gussets at mid-stud height (1). With dense-blown cellulose insulation, the wall is calculated at R58. The window openings are boxed out with bucks made from Zip System panels, and the wall sheathing, taped at the seams, forms the building's air control layer. The builders expect to hit the Passive House air-tightness standard of 0.6 ACH50.

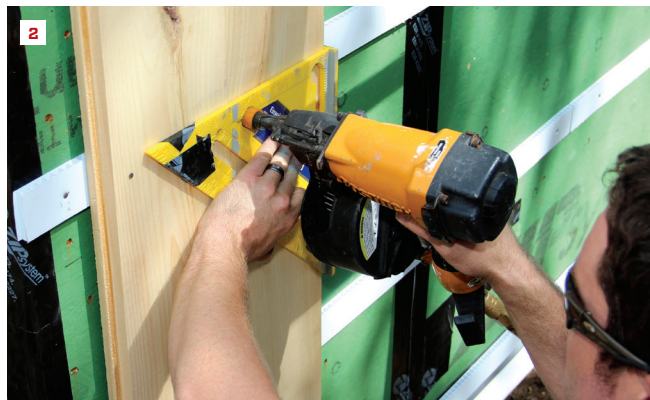
The home's rainscreen siding detail is also simple but robust. The Zip System sheathing and joint tape form the weather-resistive barrier. To hold the vertical ship-lap board siding off the wall and create a space for drainage and air-drying, Placetaylor uses strapping made from corrugated plastic signboard, bought for a few

dollars a sheet at an office supply store and ripped into strips (2).

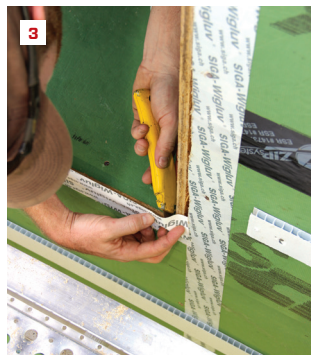
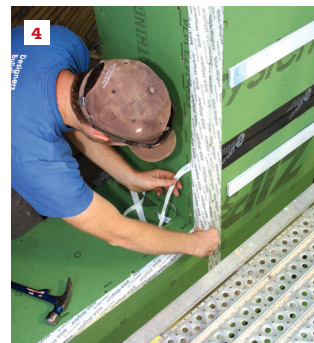
Because the air control layer of the building is at the exterior skin, including the windows, all of the seams in the window buck and window opening are taped using Siga Wigluv tape. The outboard window faces are taped to the OSB—tape is applied first to the sill (3), then to side jamb joints (4) and the head jamb (5). Strips of tape are also applied in the window buck at joints and in corners (6). Finally, a small patch of tape is applied over the complicated corner intersections of the sill with the jambs and the wall sheathing (7). Everything inboard of the window plane, including the inner part of the window bucks, is left untaped so that the wall can dry to the inside.

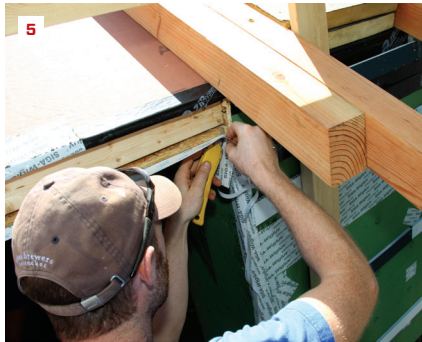
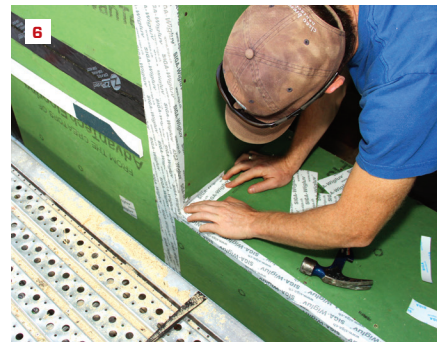
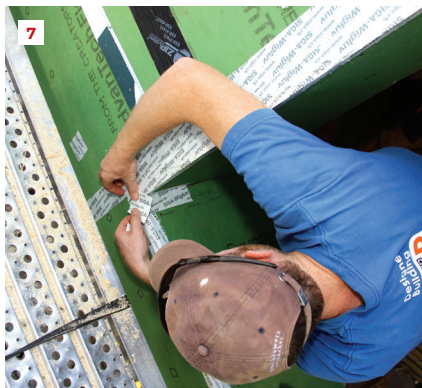
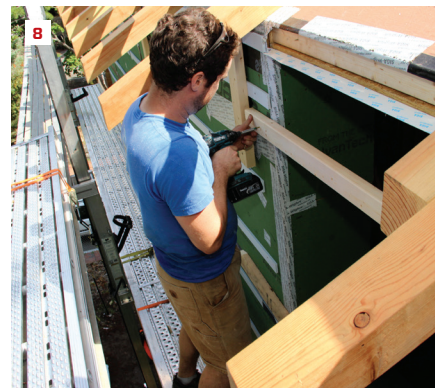
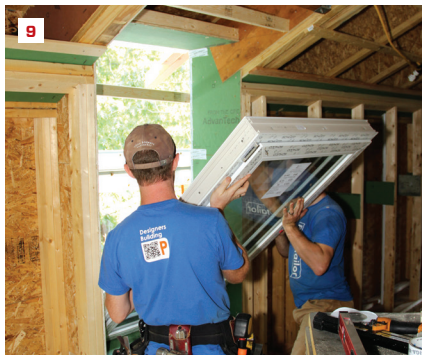
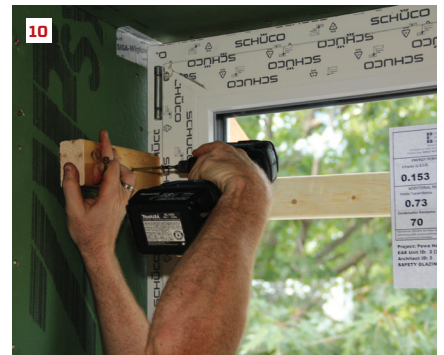
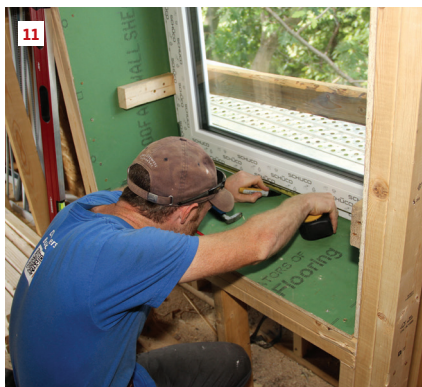
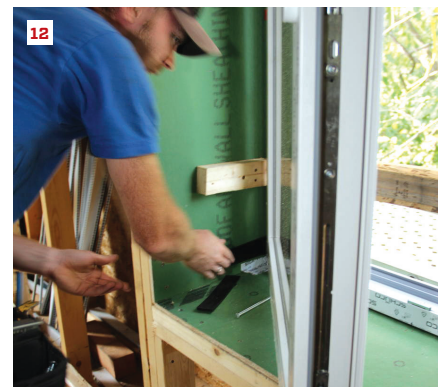
Before the windows are set (Placetaylor is using European-made, triple-glazed Schuco tilt-and-turns), temporary 2x3 rails are fastened across the window opening to serve as positive stops that hold the window flush with the wall sheathing (8). Inside the house, each window is lifted into the opening (9) and positioned tightly against the 2x3 rails, where it is secured with two temporary blocks screwed top and bottom to the window buck side jambs (10).

The temporary 2x3 rails and blocks hold the window in plane while the crew fine-tunes the window's placement. First, the window is roughly centered at the head jamb with shims, then it's precisely centered at the sill by measuring off the window buck (11). The crew fine-tunes the hinge jamb using pry-bars and shims (12) and makes a final check for plumb (13). They repeat the process at the sill, first checking for level (14), then fine-tuning with shims (15).

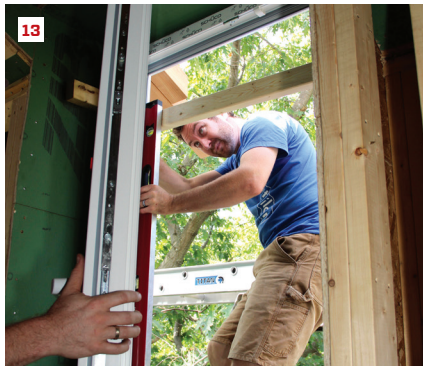
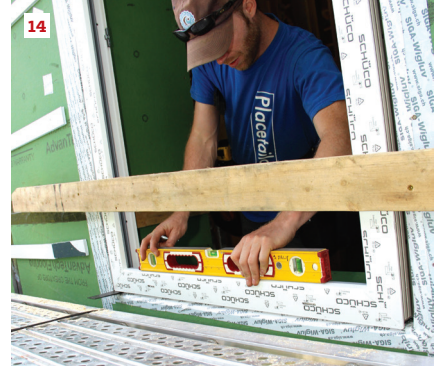
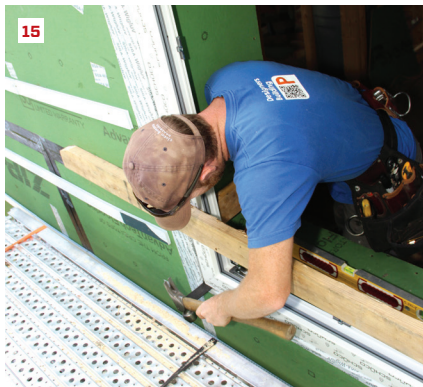
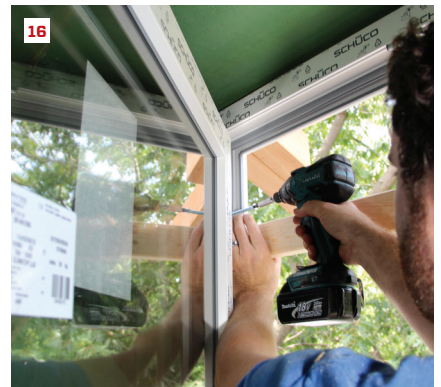
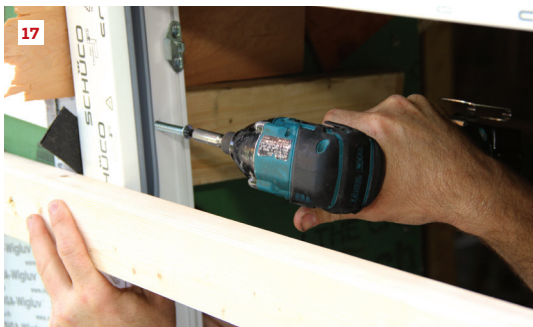
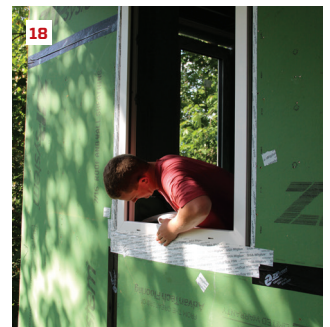
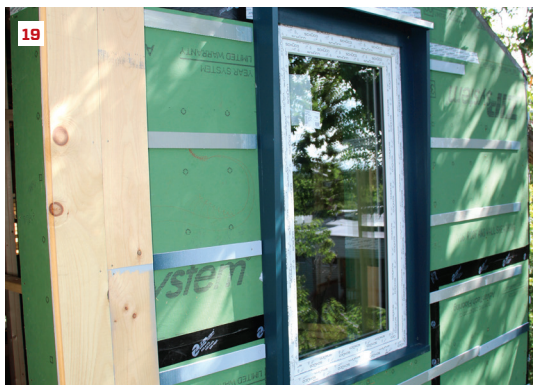
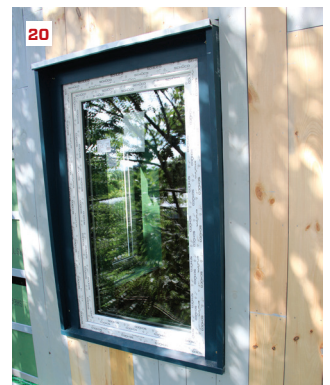
Schuco windows are held in place by self-tapping lag screws supplied with the units and driven through holes predrilled in the frame. This window gets eight screws: three through each side jamb (16, 17), and two through the top rail.

Setting the windows flush to the exterior sheathing makes it simple to integrate them into the weather-resistive barrier and drainage plane by taping the exterior face of the window frame to the Zip sheathing with Siga Wigluv tape (18). Placetaylor trims the window out with a simple custom trim package (19). Where the vertical ship-lap board siding butts against the trim (20), the joints are left uncaulked to promote drying.

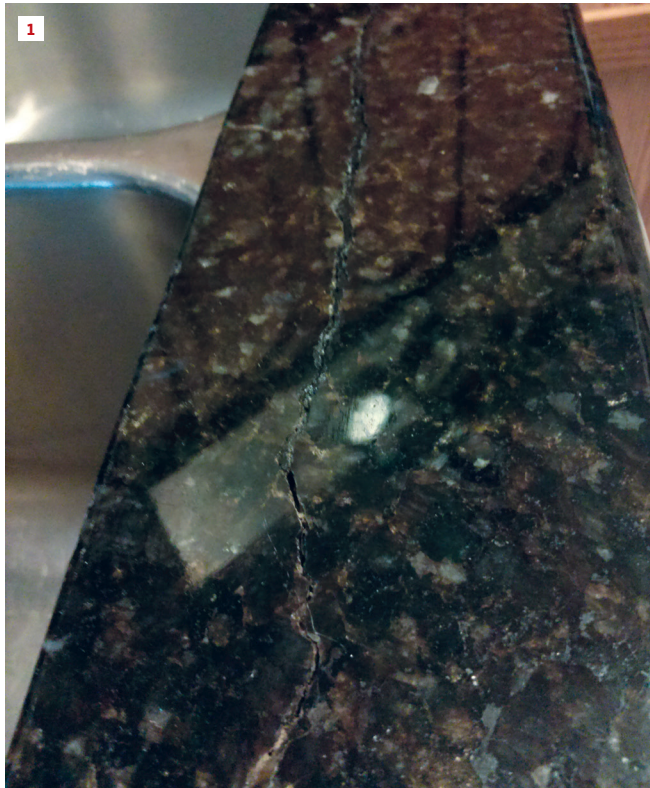
I recently repaired two granite countertops that had failed reinforcing rods at the kitchen sink cutout. One was an Uba Tuba top (1), and the other was a Bordeaux top (2). In each case, the cause was a compounding of failures rather than just a single problem: Latex caulk was used instead of silicone between the undermount stainless steel sink flange and the underside of the granite; particle-board scraps glued with polyester adhesive were used to support the flange of the undermount sinks instead of a Hercules Universal Sink Harness (3) from Braxton-Bragg (braxton-bragg.com); and plain steel rods, instead of stainless or fiberglass ones, were embedded in the granite with polyester adhesive instead of epoxy, the material recommended by the Marble Institute of America.

Water from activity in and around the sink had leaked past the failed caulk and ponded on the sink flange until the granite absorbed it. It passed through the polyester adhesive to the steel reinforcing rod, causing the rod to rust and expand, which cracked the granite.

In the case of the Uba Tuba top, the homeowner had attempted to repair the crack—or to at least disguise it—by filling it with black caulk, but the only solution for a problem like this (short of replacing the top) is to remove the rusting rod and reset the sink using the proper supports, adhesives, and sealants.

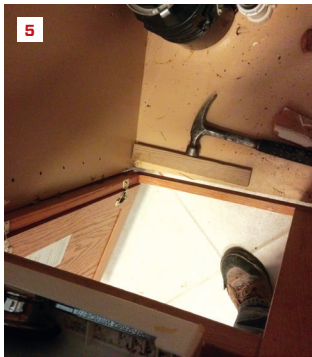
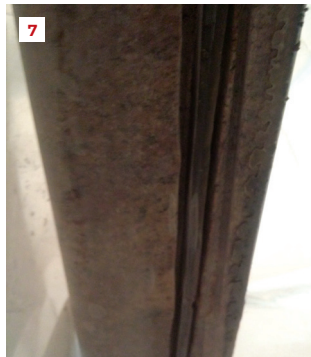
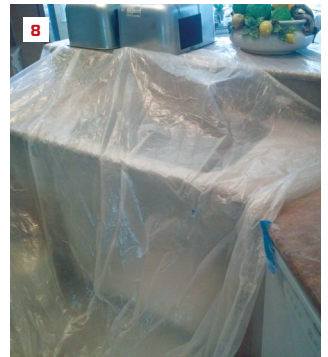
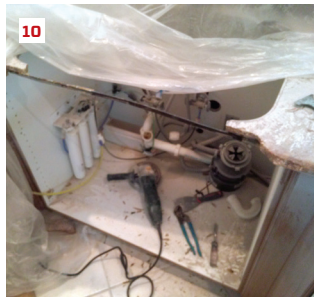
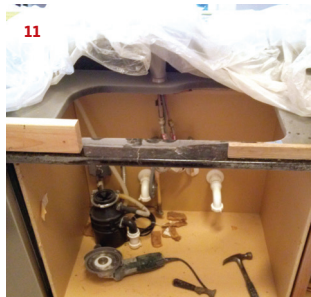
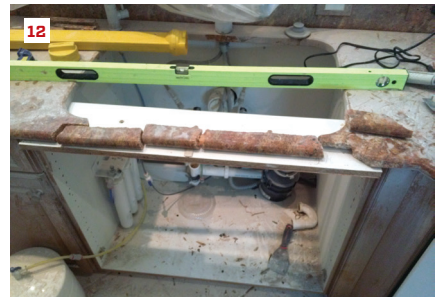
To do that, you need access to the rod as well as room to grind the granite from underneath, so I began by removing the face of the cabinet. With frameless cabinets, sawing through the metal dowels holding the cabinet front to the sides of the box does the job (4). The false drawer front also may need to be removed—because the sink behind it restricts access to its screws, I pry it off by wedging two scraper blades between it and the cabinet rail, then driving a chisel between the scrapers. If you don't have scrapers in the truck, you can use two drywall knives—the goal is to provide hard surfaces for the chisel to push against

With framed cabinets, I first remove any screws holding adjacent cabinets together. Then I use a hammer and wood block to separate the face frame from the box in a single piece (5); it typically pops off easily, with no damage. You can remove the cabinet door first, but I find that to be unnecessary.

Once the cabinet front is removed, it's easy to see how a leaking sink flange delivers water to the bottom of the rod (6). Tapping a scraper between the sink flange and the underside of the stone will remove the sink without damage to either.

To remove the rod, I grind away the adhesive on both sides wherever the rod is rusted (7). One deep cut into the stone on one side, then a gentle tap with a chisel between the rod and stone on the uncut side will usually free the rod.

To keep the dust down, I cover the sink cabinet and surrounding area in poly (8), but containing the dust is an uphill battle.
