BY DOUG HORGAN

## Masonry Through-Wall Flashing at Windows

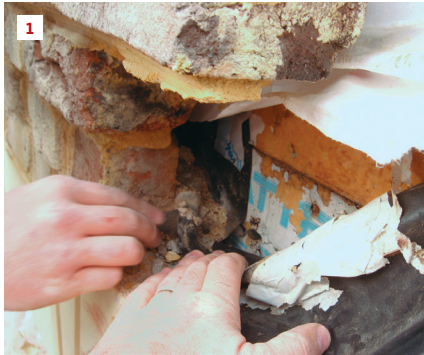
When we finally opened up the wall, we discovered that the through-wall flashing had been pieced in, with

the seams simply lapped, not sealed. Water was draining off the housewrap and onto the head flashing, but it was leaking through the seams. Plus, there were no end dams, so water was spilling off each end of the flashing and finding its way past the housewrap, past a layer of foil-faced polyiso insulation, and into the wall (1).

To repair the problem, we opened up four courses in the wall—enough so that we could pull up the existing housewrap and install a one-piece, 18-inch-wide through-wall flashing. We typically try to use purpose-made rubberized asphalt “thru-wall” flashing materials. These are similar to the self-adhered flashings made for roofs or windows but have a stronger polyethylene face layer. The thicker material stands up to abrasion from masonry and tends to come in wider widths, so we can get a good lap behind the housewrap and still bring

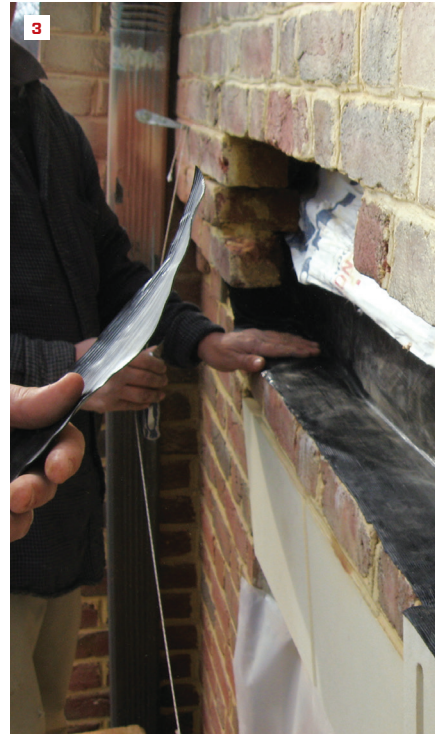
This last point is important because it prevents water from soaking back into the masonry below the flashing and finding its way into the framing. There are purpose-made flashing materials with metal drip edges, but they are expensive, difficult to work with, and aren’t stocked in our area. On some jobs, we have fabricated stainless steel drips along the outer visible edge (2). Most of the time, however, we just have the masons bring the flexible through-wall flashing all the way out to the face of the brick (3).

If you try to be clever and hide the edge of the material, know that holding it back any more than a tiny bit will allow water into the veneer. On existing work, we often find through-wall flashing cut back to the middle of the brick, which dumps water directly into the core of the brick and into the open back half of the head joints. Pulling the flashing all the way out to the face is a good

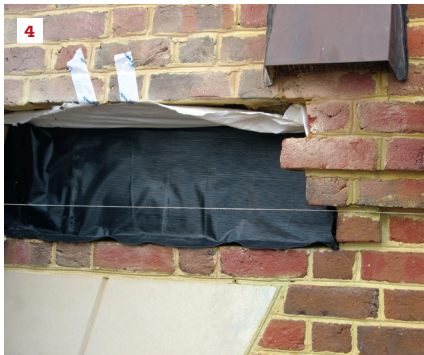
The other critical detail on any through-wall flashing is the end dam, which is simply a fold at each end of the flashing that brings the material up into a vertical head joint (4). This detail allows the flashing to function more like a collection channel, or spout, than a flat membrane. Creating an end dam is also more reliable than trying to seal overlapping pieces of flashing: Whenever we need a mid-span joint in flashing for a long run, we create end dams, turning the ends of each piece up into a head joint.

Through-wall flashing needs to run longer than the jamb flashing on each side of the window, so water won’t find its way back into the opening. To ensure that water can escape, weep holes should be placed at each end dam and at every third brick to provide ample drainage (see photo, page 33). Weeps are commonly created by open head joints, or by fitting head joints with cotton rope

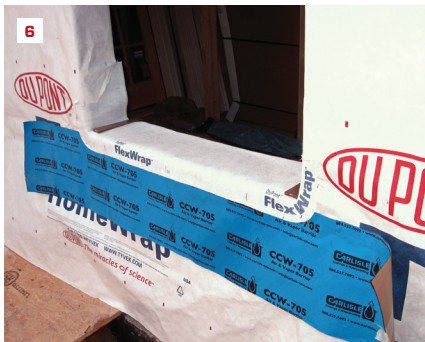
We are careful to flash around windows, using high-quality butyl-rubber flashing and properly integrating it with the house-wrap and window flashing (5). (For examples of details using a variety of different flashing materials, see “Flashing a Flanged Window,” Nov/12, and “Flashing and Trimming a Window,” Aug/12.)

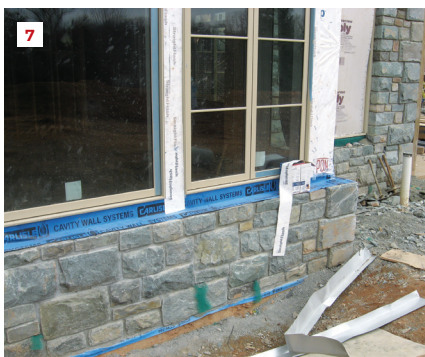
masons, if left to their own devices, will let the sill pan drain into the air space behind the brick, leaving the through-wall flashing at the base of the wall to do all the work. However, we feel that best-practice should include a through-wall flashing right below each window that is integrated with the sill pan (6). Any water leaking from any window needs a clear path out of the wall as quickly as possible.

It's important to run the through-wall flashing long enough so that the jamb flashing, as well as the sill pan, lap over it. This includes the jamb flashing between windows (7). (Make sure to lap correctly; reverse shingling is the bane of every flashing job.) And as with every through-wall flashing, each end must be turned up to create an end dam so that water is channeled out of the wall. Otherwise, it is likely to dribble back into the masonry and find its way inside.
