BY STEPHEN KLUG

Fixing Faulty Roof Framing

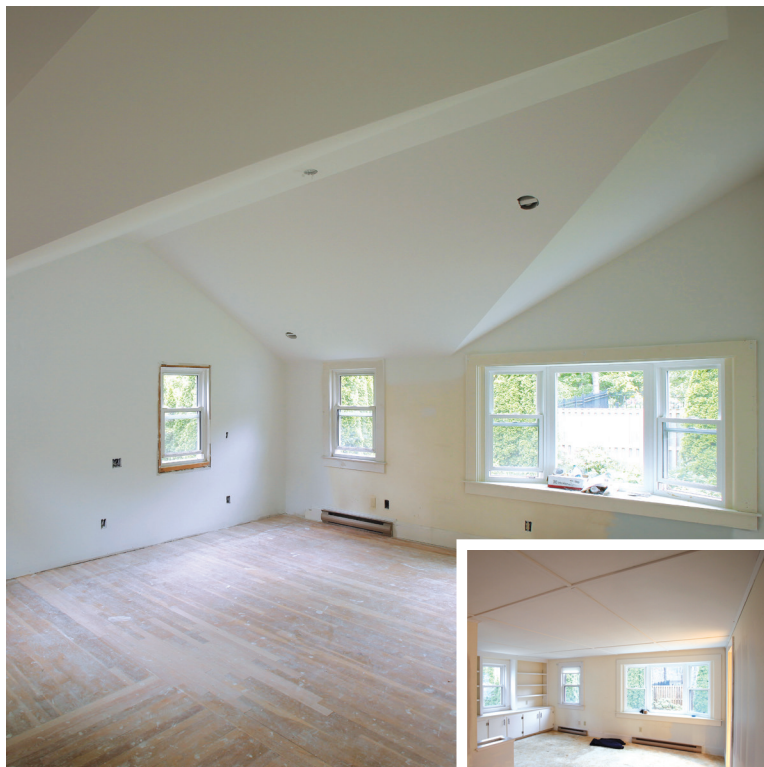
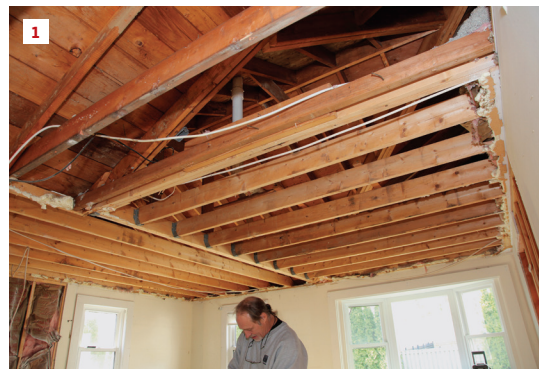
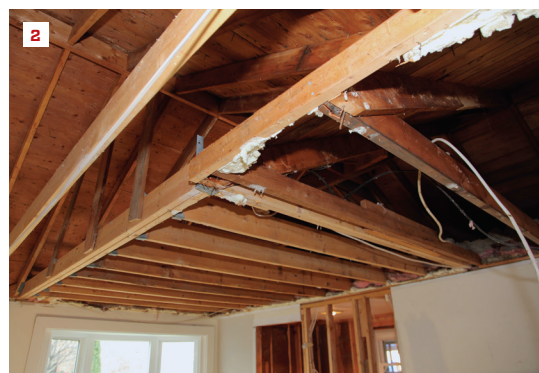
evaluated the roof framing. As the insulation fell away and the existing framing was exposed, the trouble mentioned earlier found us. When the addition had been built, a structural valley had been added to just one side. The valley framing on the other side was a hybrid, with a structural valley meeting a doubled rafter, and a "California valley"—with one roof resting on the other—continuing the rest of the way (1). The builder had then suspended the ceiling-joint support beam from the rafters above using vertical 1x6s (2). The problem was compounded by the fact that both ridges were non-structural. These techniques were right out of the Rube Goldberg school of home building.

In my predecessor's defense, the doubled rafters carrying the point load of the roof on that side landed on a built-up corner of the bedroom closet, which served as a post. But removal of that closet was part of the remodel, so we needed to add a new structural valley on that side.

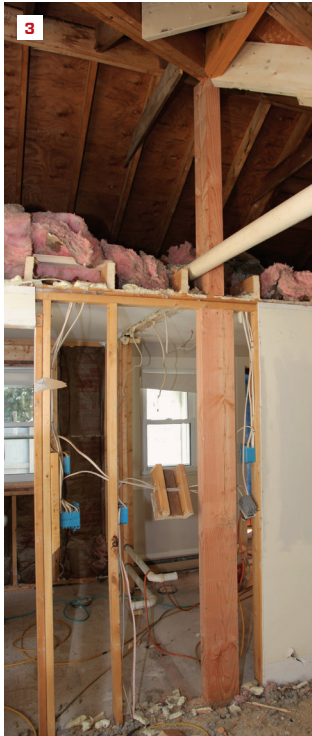
The framers inserted a post to support the existing triple 2x8 valley as well as the new structural ridge. They continued the post down through the wall framing below (3), and down into the crawlspace, where we poured a footing to pick up the point load. The framers also removed the section of original roof framing that continued under the roof of the addition; this exposed the entire length of the valley from below.

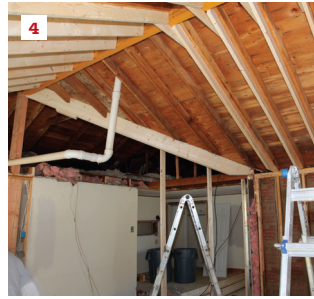
With the roof supported, all the original ceiling joists were taken out and the old roof at the valley supported temporarily with vertical 2x4s until a new double 2x10 valley was in place between the ridge and the inside corner of the ell (4).

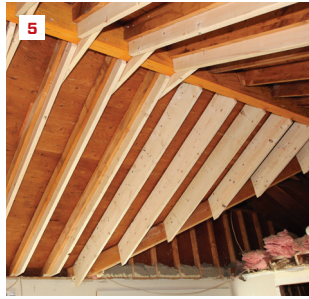
My goal was to keep the original unvented roof intact, so for insulation, we decided to use 10 inches of spray foam to give us the required ceiling R-value without venting. To get enough depth, 2x10 rafters were sistered onto each of the original 2x6 rafters, using framing nails and Timberloks (5). Jack rafters were either sistered or added as needed

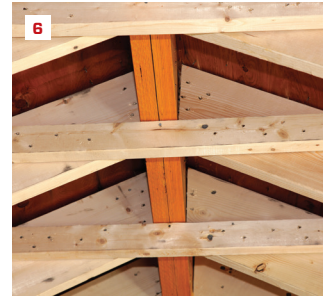
along both valleys. To deal with uplift issues without opening up the roof, 2x4 collar ties were used to join each pair of rafters (6). The ties gave the ceiling a flat section at the top, but the clients were fine with that compromise, and it gave the electricians a level place to mount the ceiling fan.

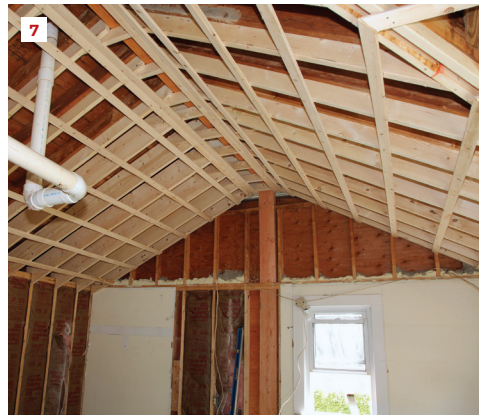
With all the new rafters in place and both ends of the ridge supported on posts, the crew ran furring strips over the whole ceiling (7) and filled in the framing above the bathroom walls and over the flat ceiling. Insulation (8) and drywall followed closely after the plumbing and electrical work, and I came in with my crew afterward to finish off the project.
