# Troubleshooting

## **Preventing Shower Curb Problems**

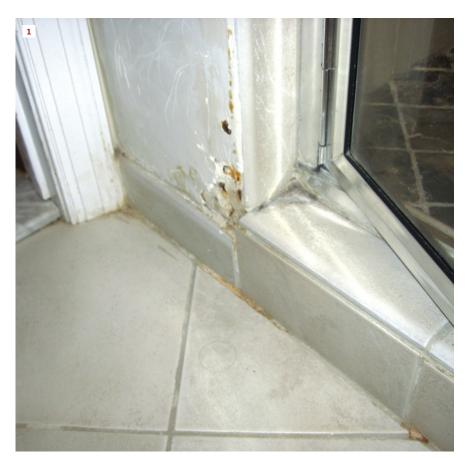
The damage shown in the photo above (1) is typical of the problems we see on existing showers. Cracks in tile and stone grout lines allow water through the finishes, even when those finishes aren't submerged. Curbs are especially problematic because they are commonly framed in wood—typically double or triple 2x4s (2) which shrinks and expands with seasonal changes in

humidity. Those dimensional changes mean that cracks in the grout are inevitable. A shower is one of the "rainiest" environments we build in-even small cracks or slightly porous stone can let a lot of water through.

Simply running the liner to the outside edge of the curb isn't enough to prevent water damage. Any water that seeps through cracked grout lines will easily wick under the liner edge and soak the framing, which is what had been happening in this shower for years (3). We've seen similar damage on numerous other existing showers.
