BY DOUG HORGAN

## Steep-Slope to Low-Slope Transitions

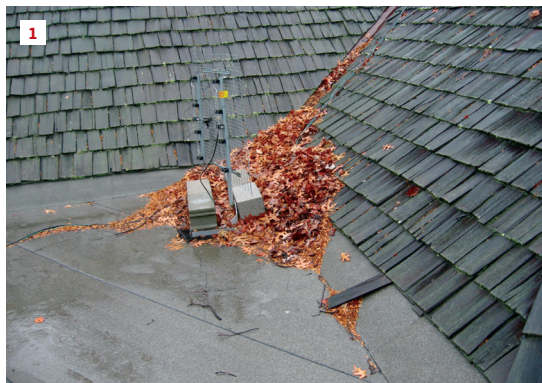
This is a small but vulnerable spot, and we often see it detailed incorrectly on existing work. Valleys are prone to collecting leaves, particularly if someone sets up an antenna at the base of the valley (1). The lower roof unavoidably slows down water drainage, and when the valley is clogged, a significant amount of water coming down that valley will tend to spread out and back up under the shingles. Wind can intensify the problem, pushing the water upward. Snow tends to pile up here as well, and ice damming is likely. Compared with some other regions in the U.S., the D.C. area may not see that much snow. But we’ve had enough big storms during the last 24 years to make it imperative to detail roofs to manage melt-water and the potential for ice dams (2).

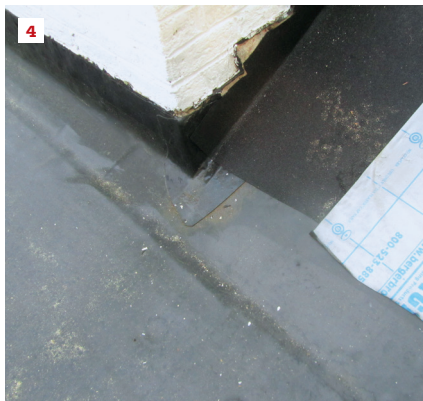
At the roof transition shown in photo (4), roofers had installed peel-and-stick over the EPDM lap. They had the right idea, but the peel-and-stick they used was rubberized asphalt, which reacts with EPDM. They also didn't overlap the two membranes enough, so it wouldn't have been long before a significant leak developed along the entire length of the overlap.

EPDM, TPO, flexible PVC, and uncured Neoprene—any of the common roofing membranes for low-slope roofs—are not compatible with asphalt-based roofing, including most peel-and-stick underlayments. We solve this by installing an aluminum counterflashing, as shown in the illustration. If we do need to shingle over the lap, we may add a peel-and-stick membrane, which has a better chance of self-sealing around any fasteners that

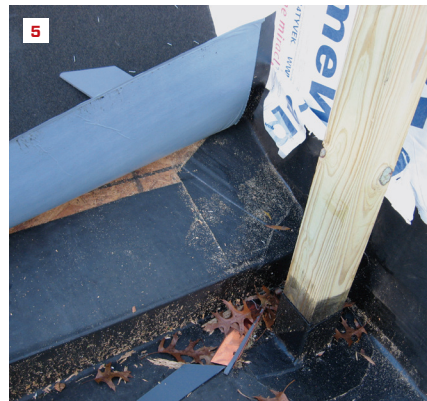
In the instance shown in photo (5), the installer left the release paper on to provide isolation. The problem with this detail is that I'm not sure what the life of that release paper is—certainly not as long as aluminum's—so this is a middle-road detail, maybe not best practice. But at least there won't be an immediate failure due to the incompatibility of the two membranes.

Photo 5 also shows a sad detail we often

see on roof-top decks—a through-roof railing post. It would have been far better to attach the railing to the sidewall. When we come across a through-roof post and can't persuade the owner to change it, we'll make the best of it. But getting this detail right is a subject for a different article.
