Old House, New Foundation Lifting and resupporting an early-1800s home on a tight site

BY FRED AND EZRA AMBROSE

In September we undertook the restoration and remodel of a two-story early-1800s residence in the historic village center of Wellfleet, Mass. We began by lifting the house off its failing foundation and setting it back down on a full poured-concrete basement. This article will look at that process. As of this writing, we've moved on to a gut-remodel of the building.

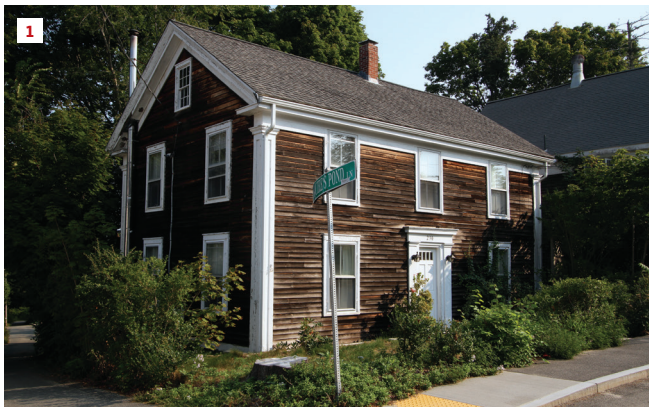
The house was built on a lot that sloped immediately down from street level, which set the front door sill about 9 inches lower than the sidewalk (1). Because no attempt had been made to adjust the grade to deflect runoff, water ponded against the foundation, eventually rotting the front sill beam. Also, the oldest part of the foundation consisted of a single thickness of mortared brick (common in the area's sandy soils) set barely below grade without any footings. Consequently, the building had settled unevenly, stressing its timber frame to near failure. When we started work, the building department had already ordered the house vacated.

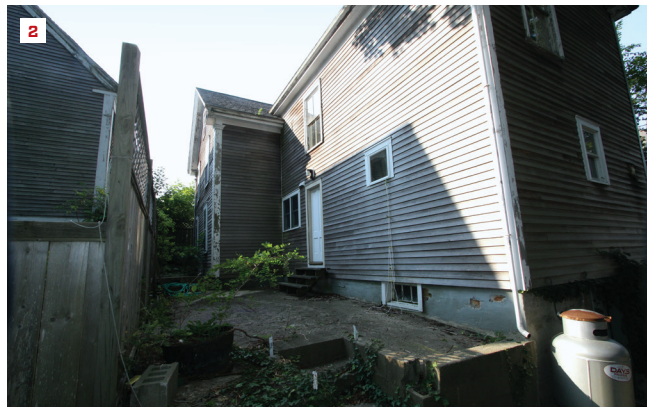
At the back of the original building was an extension that had been built in the 1920s on a full foundation of hand-mixed concrete interlaced with bricks and rubble (2). This part of the foundation was accessible through a door in the rear and allowed about 6 feet of headroom. Under the original structure, the builders had expanded the basement area by excavating to within a few feet of the older brick foundation, shoring it with small-diameter logs driven vertically, stockade-style (3). This innovative approach may have destabilized the grade, and a small forest of teleposts suggested a history of nerve-racking creaks and pops as the building settled.

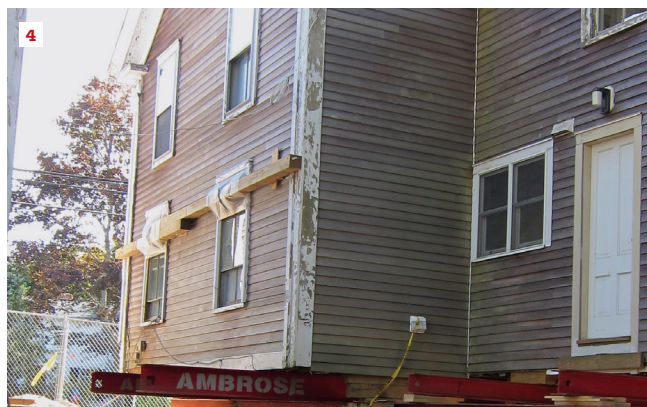
The shifting foundation had caused some of the tenons in the timber balloon frame to pull away—as much as 1½ inches in places—from their mortises. Before we jacked anything up or worked on the sills, we stabilized these joints by running a heavy chain from a central interior timber through the tops of the first-floor gable-end windows to a pair of 6x6s running the full width of the building (4). We used a come-along to keep tension on the chain,

which prevented the frame from spreading further during the foundation work. (Later, after the building had been set down on its new foundation, we would pull the joints tight and reinforce the connections.)

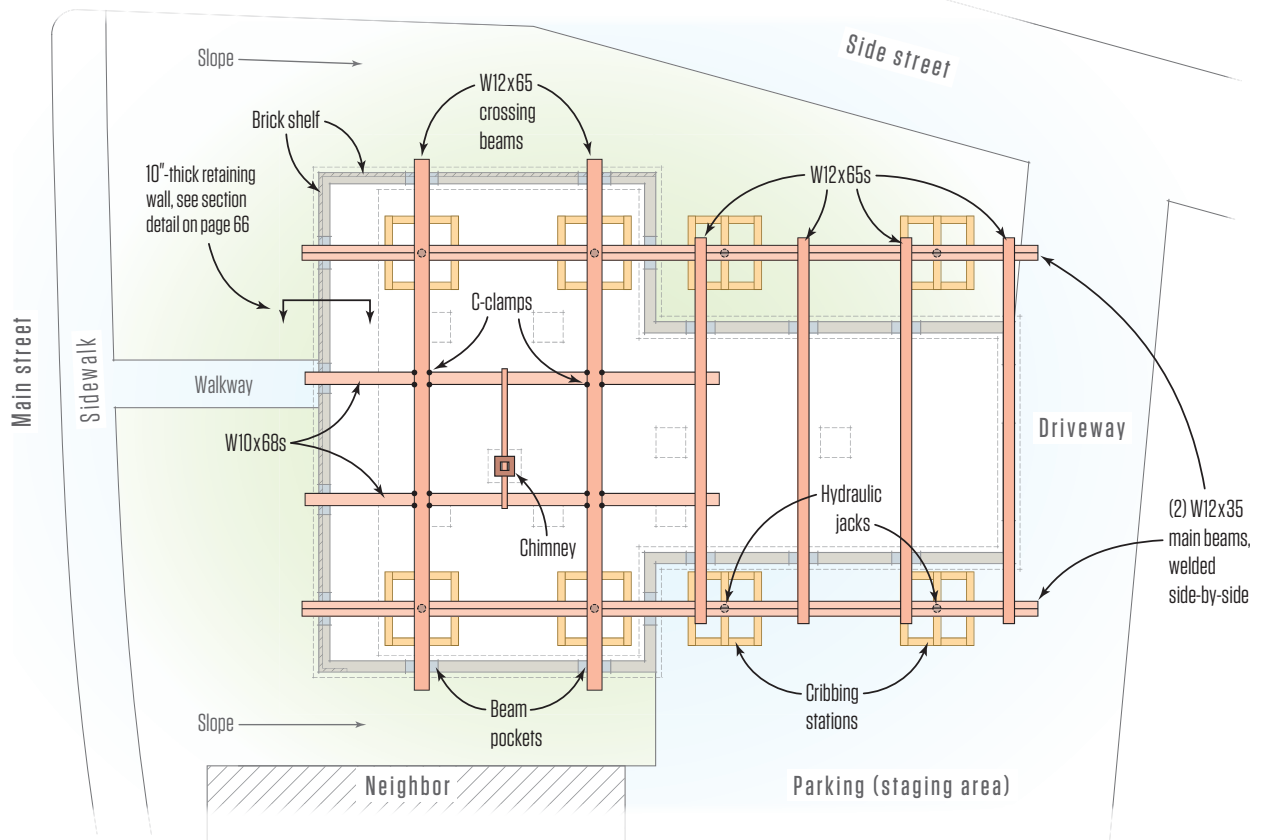
Beam Layout/Foundation Plan

With the front sill replaced, we turned our attention to placing the steel I-beams needed for the lift. Since the building itself occupies most of this street-corner lot, access for inserting the beams was limited to the back, where we had a small staging area, and one side of the building at the front (top left in “Beam Layout/Foundation Plan,” above). Given the close quarters, we delivered mainly 16-foot lengths of steel, which we welded on site to create the lengths we needed.

One of the design principles for lifting a beam is that its flange should be at least as wide as the web is high—nominally, a square section profile that prevents the beam from rolling over under load. This was a particularly important consideration for the two main beams, which would provide the direct jacking points for lifting. These two beams would need to be 50 feet long and would run outside the walls of the building’s narrower rear extension and under the original structure at front. We built them up from front to back using W12x35 I-beams welded side-by-side with their ends offset in a staggered pattern. Each 16-foot section weighed about 560 pounds, so we used our mini-excavator to wrestle them individually onto cribbing before welding.

We wanted to set the beams as near to their final elevation as possible so we wouldn’t have to lift them very much later. Fortunately, the halfway point on these beams fell outside the foundation, so we were able to move them nearly into final position without having to reset the support straps that suspended them from the excavator. We set them level, at a height that left enough room for the shorter crossing members to fit between them and the underside of the floor framing. This sounds more straightforward than it

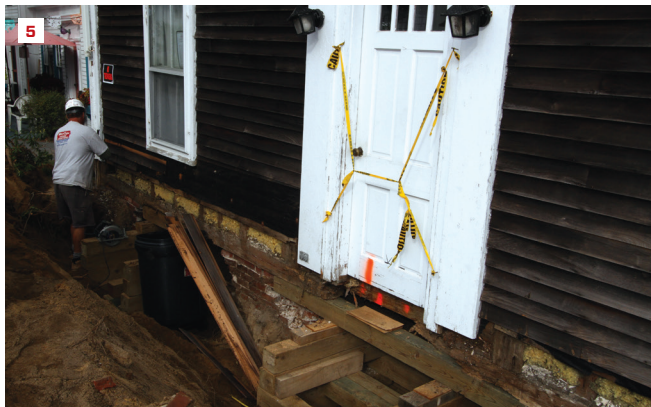
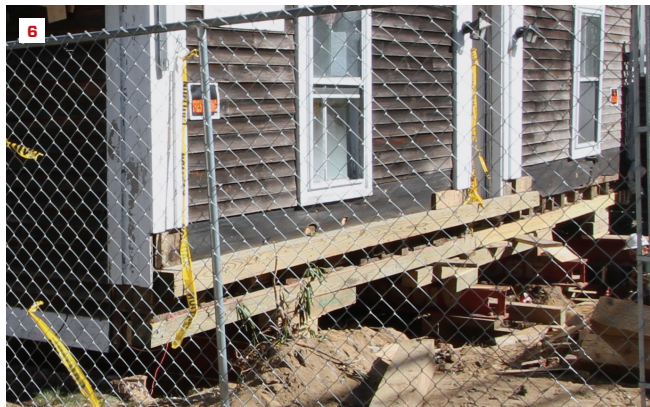
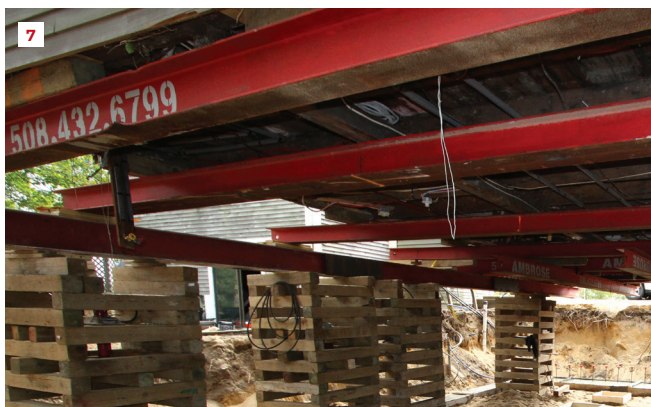
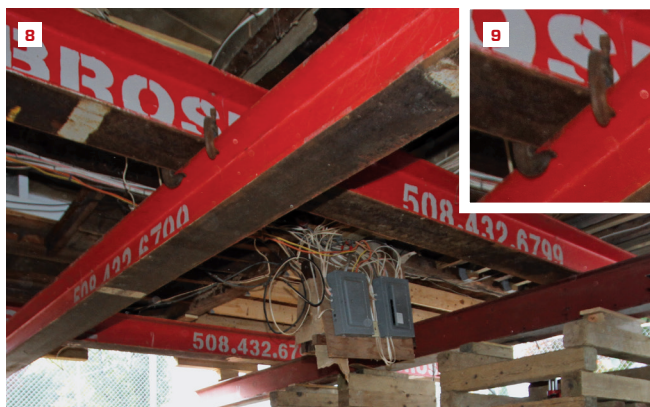
Next, we inserted the “needles,” or crossing beams, from which we would ultimately block up to support crucial locations under the building. In the addition, the joists ran across the width of the building and were mortised into a central carrying beam. We placed four needles parallel to the joists, shimming as needed to pick up the central timber and to make sure that all three sills in the addition were fully supported (7).

In the front of the house, the joists ran the full width of the building, supported by two intermediate carrying beams that divided the floor system into three sections. To support this part of the house, we inserted two crossing beams, which would eventually rest on top of the two main 50-footers (8). Because of the tight conditions on the site and the need to work around a brick chimney in the center of the basement, moving these beams into position re-

We then hung two additional beams at a right angles to the crossing beams, aligned directly under the two floor timbers. To hang these beams, we used special heavy-duty Wilton C-clamps capable of supporting 15,000 pounds each (9). We snugged blocking between their flanges and the underside of the floor timbers to make a solid connection.

To pick up the chimney load, we punched a hole through the brick and flue tile and slid a scrap of tube steel through it (10). The standard alternating brick courses transferred the stresses and effectively held the chimney intact with no further reinforcement.

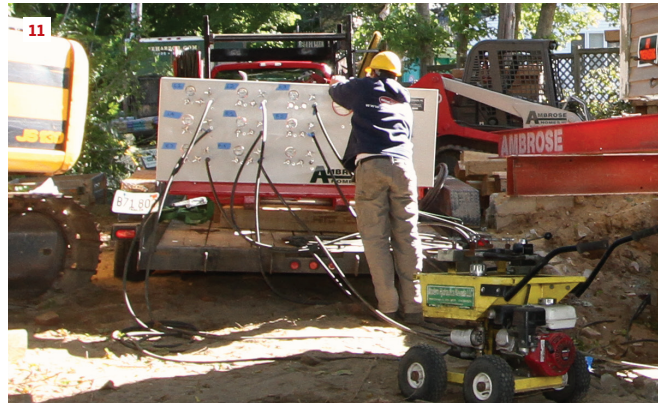
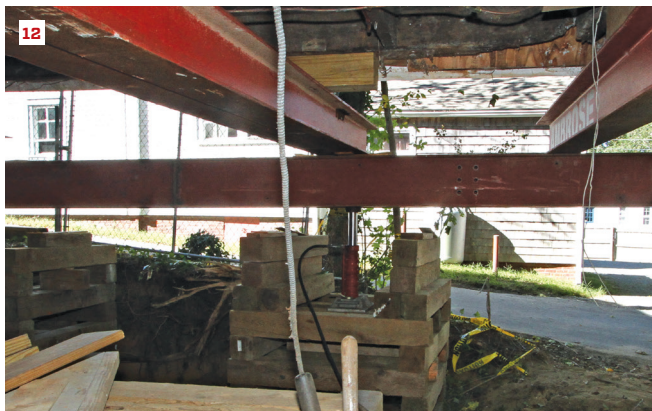
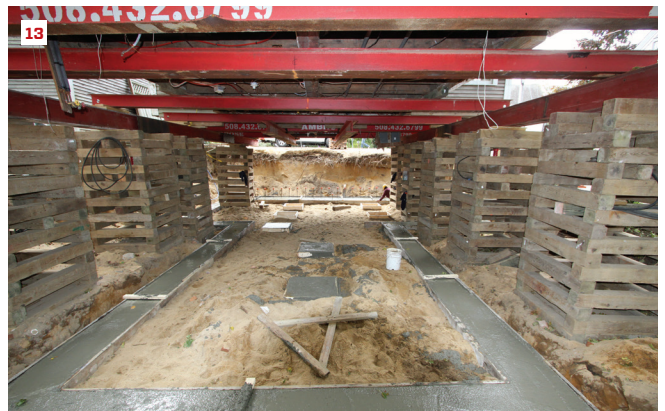
With all the needles placed, we brought in the nine-point hydraulic jacking system, which we had recently purchased used and had completely refurbished. A central manifold (11) controls all nine jacks, which are driven by a single main piston. We set eight

of these jacks under the main beams and lifted them just enough to transfer the building load off the foundation. Once we were sure that the entire structure was safely supported, we jacked it another 3 feet or so—high enough to get our skid steer underneath to complete the excavation. The maximum throw of the jacks is about 14 inches, so we had to reset them three or four times. Each reset involved blocking solid between the cribbing and the steel beams, resetting the jack, lifting, then blocking again **(12)**.

To locate the footings, we used a vertical laser to pinpoint the building corners, then offset the forms by 4 inches. We added 8-inch-thick pads for intermediate Lally columns and for the chimney. For all but the front wall, we poured standard 8-inch walls on 16- by 8-inch footings **(13)**. With the grade falling steadily away front to back, this provided sufficient support for the structure.

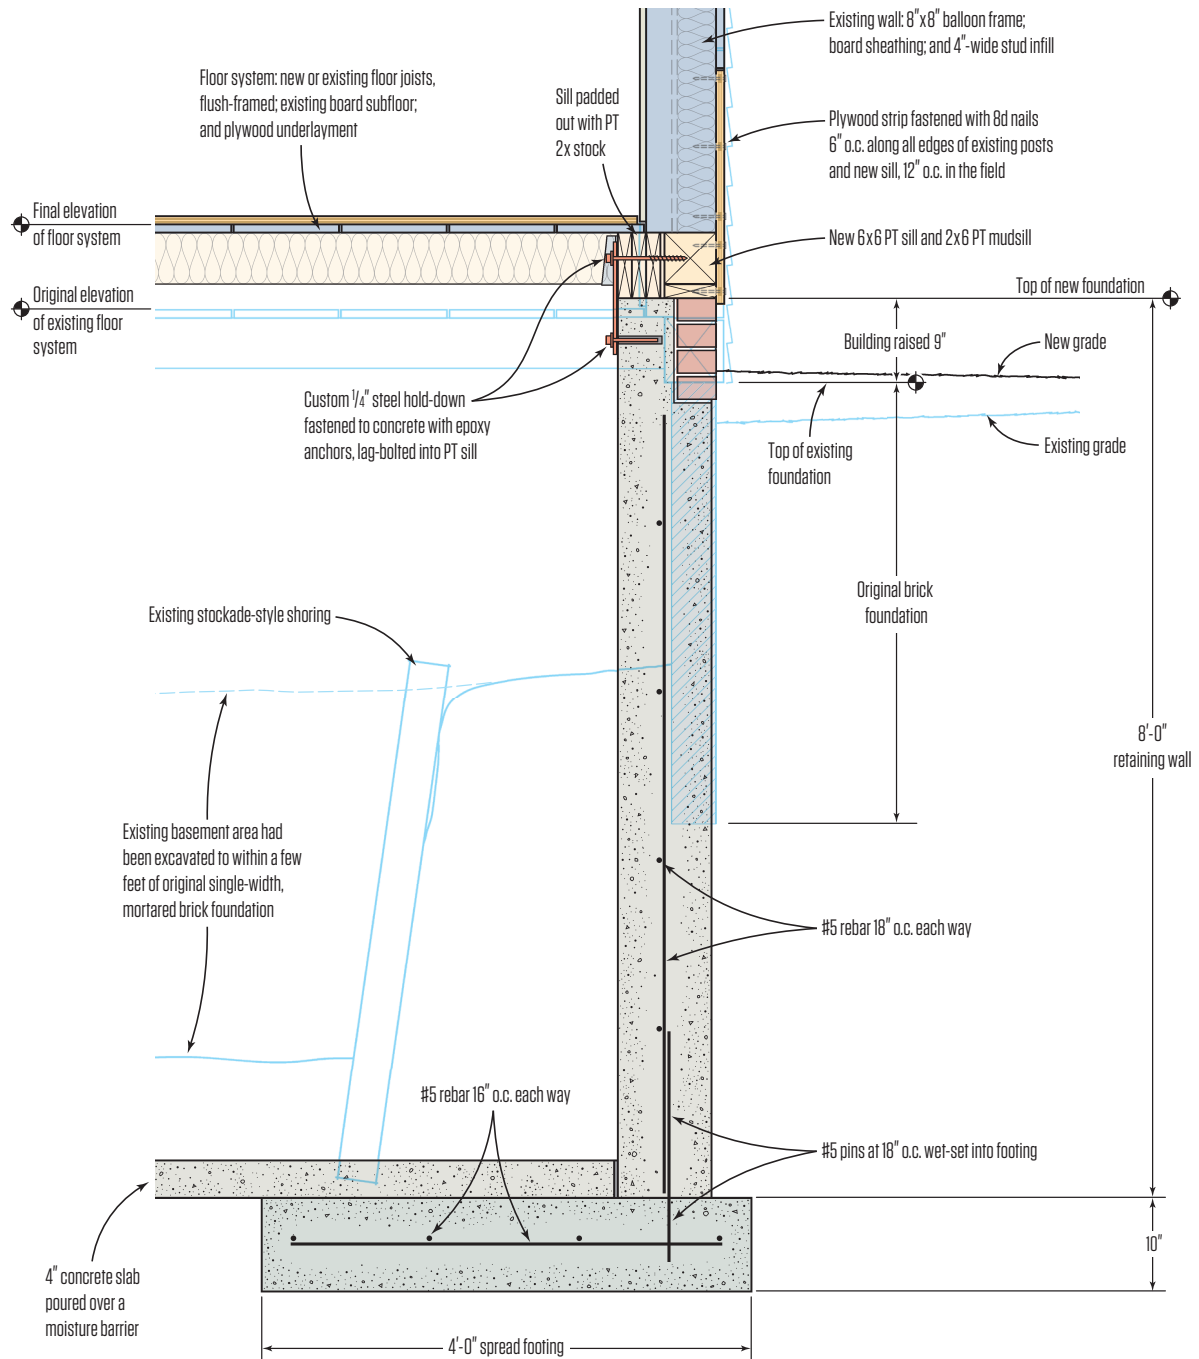
Retaining Wall Detail

Because the front of the building was not far from the road bed, it called for a foundation that also functioned as a rugged retaining wall (see “Retaining Wall Detail,” next page). Here, we formed a

4-foot-wide spread footing reinforced with #5 rebar set on chairs. After placing the concrete, we set #5 pins at 18-inch intervals to engage the 10-inch-thick wall. For reinforcement, we wired vertical and horizontal #5 bars in a uniform 18-inch grid (14) and laid a final piece of rebar across the topmost form ties. We wanted to preserve the historical appearance of the foundation where it faced the street, so we formed in a ledge to support veneer brick across the front and part of one side. As was the case with all of the walls, we boxed pockets in the forms to allow room for the I-beams to project through when we lowered the building. These pockets were a little wider in the front section to make it easier to snake the steel crossing beams out from under the house.

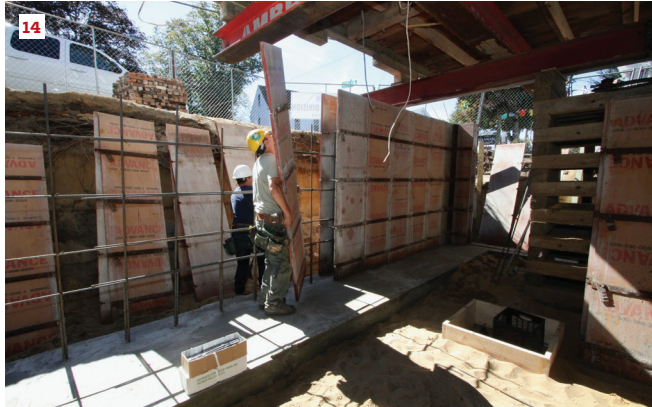
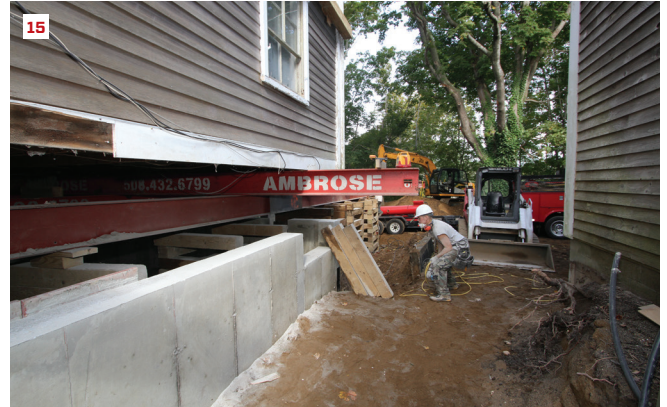
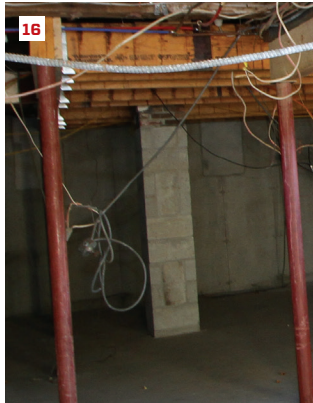
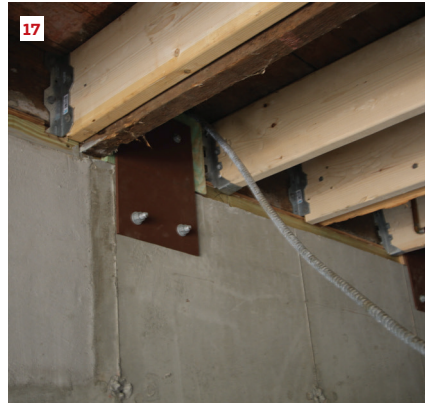
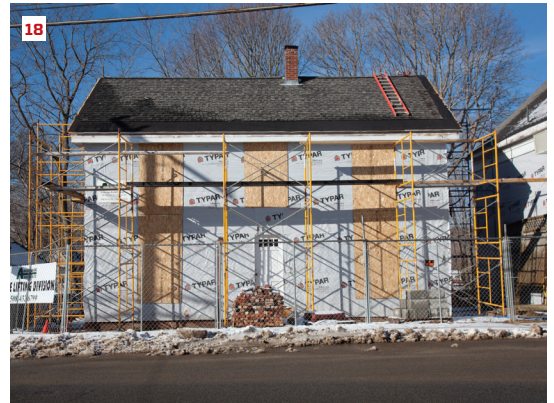
After stripping the forms, we gently lowered the building onto its new bearings (15). We pulled out the beams—including the welded-up 50-footers (which are already in use on another job)—one at a time, and then filled in the beam pockets with concrete block.

Before pulling the beam supporting the decommissioned chimney, we built a concrete-block pier to carry it (16). To tie the building to the foundation, we had a steel supplier cut and punch bolt holes in $\frac{1}{4}$ -inch steel plates, which we prime-painted and lagged to the foundation (17) using a Simpson SET-XP epoxy anchoring system (strongtie.com).

There was a considerable amount of re-framing needed to reinforce the old floor system, which we did mostly by sistering in new joists and piggy-backing some others. With a 4-inch concrete slab poured over a moisture barrier, the basement is complete, and we've turned our attention to helping the building face the next 200 years (18).
