## Replacing an Underbuilt Foundation

## Revitalizing an Urban Row House

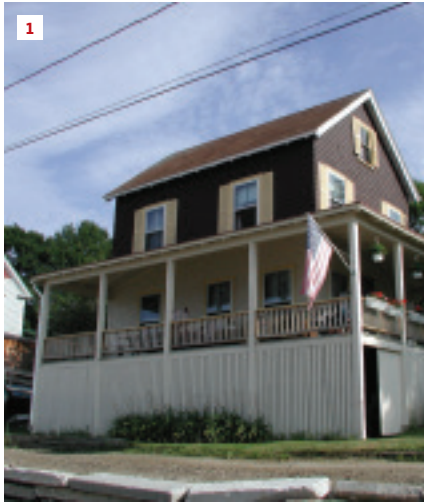
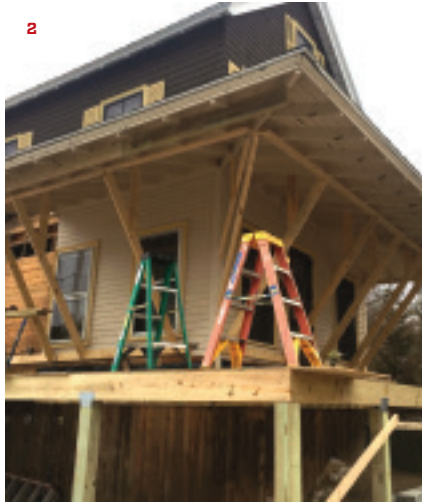
The proposal was fairly simple. The owners of this seaside home, built in 1900, wanted to rebuild a weathered and worn porch from the roof eaves down to the ground (1, 2). We would also enclose a portion of the existing porch to extend the living space, and renovate the kitchen. The house is an existing, non-conforming structure located within 75 feet of the area's high-tide line—in

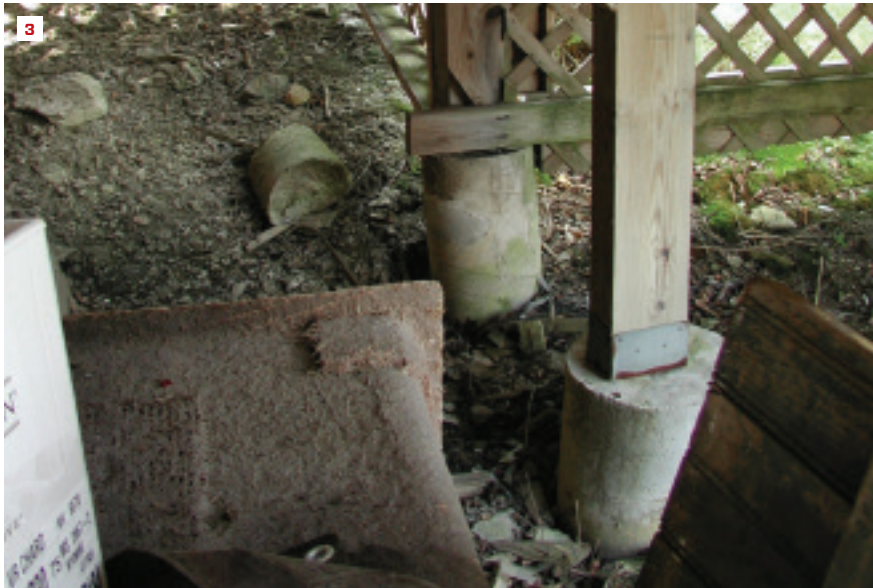
The house was built on concrete piers. Some of them were obviously tilting (3), and the home's floors were uneven. Clearly, the foundation had moved in response to winter frost action in the clay soils. As a result, the house was hinging at the first floor, toward the beach. So, right from the start, the scope of work grew to include an

investigation of the existing concrete piers (which had been replaced once already, improperly, not long ago) to determine whether they all reached 4 feet in depth (as required in Maine) and whether they were set on solid footings.

We knew we would have to fix a select few, but after some digging, we discovered that none of the existing concrete piers extended below the 4-foot frostline. Many were only 18 inches deep. We also didn't find any spread footings under the piers. So, Heather wrote up a change order to cover the cost of replacing every pier.

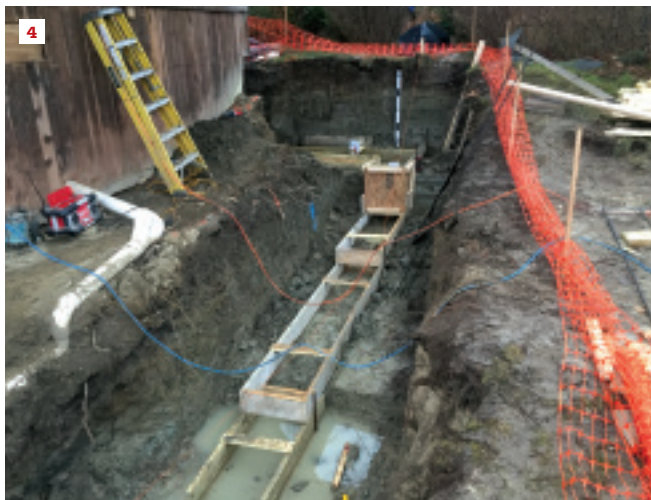
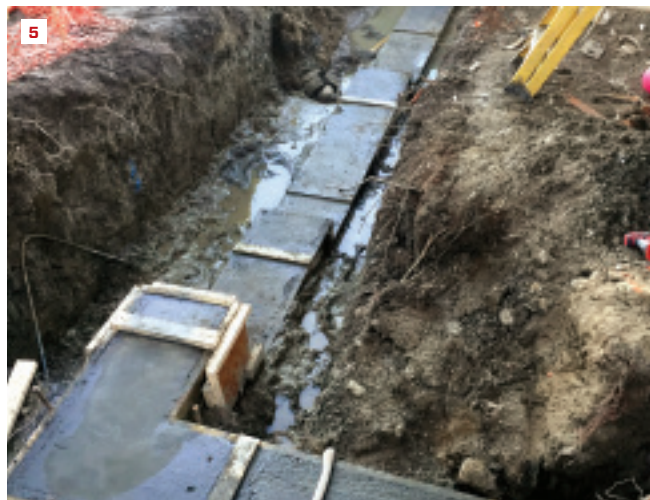
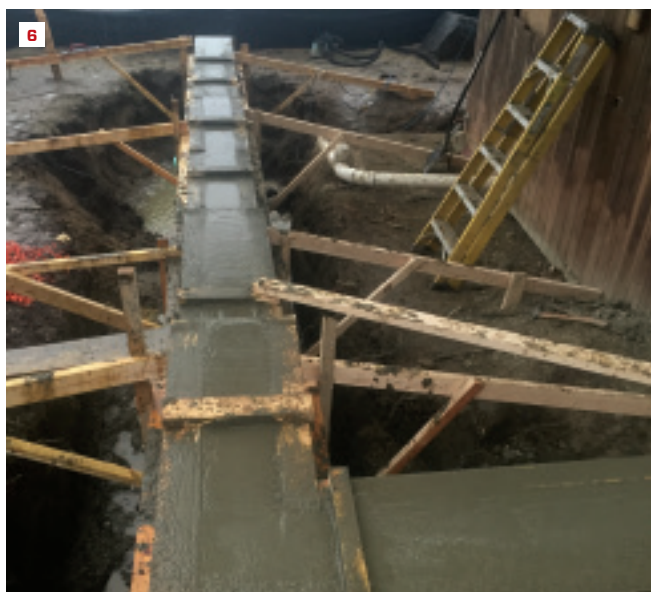
below the frostline, build wooden forms (4), pour a spread footing (5), and form up and pour our stepped frost wall (6).

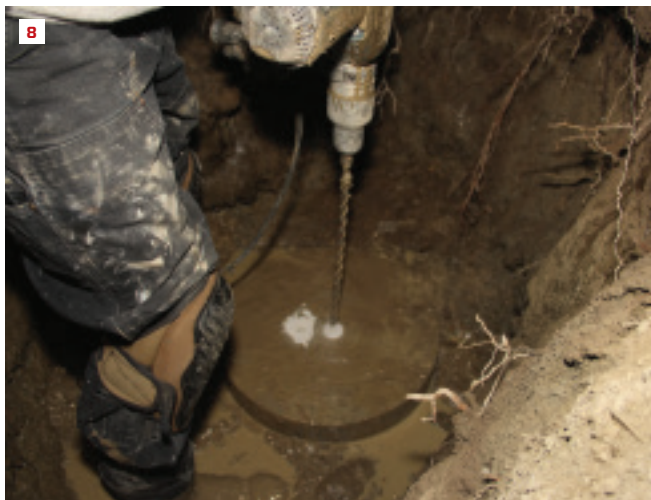
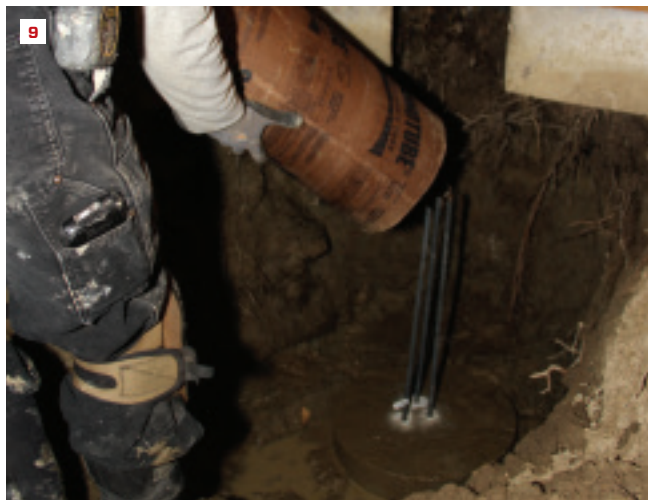
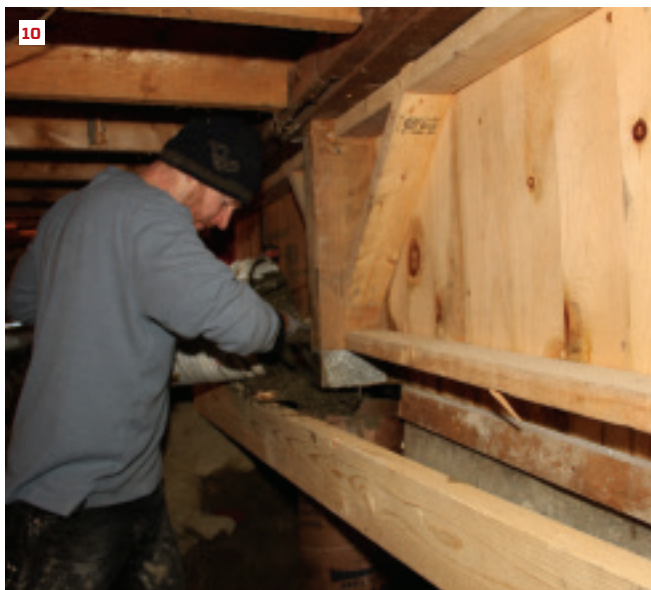
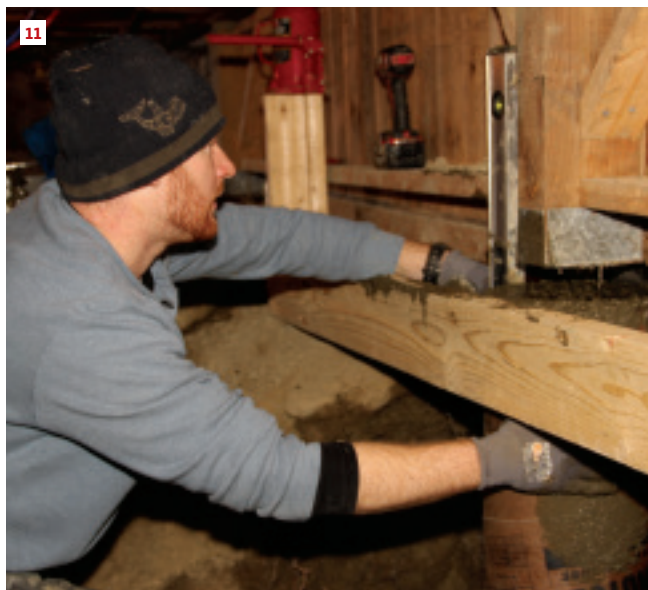
the footing disks **(8)**, hammer  $\frac{3}{8}$ -inch rebar into the holes, set Sonotube forms over the rebar **(9)**, backfill around the bases of the tubes to stabilize them, and fill the forms with concrete **(10)**.

concrete mix into the tube with their hands. They plumbed the freshly poured piers under the existing floor frame supports and braced the tubes with 2x6 lumber **(11)**. After the piers set and cure, they'll reframe the posts down onto the new piers.

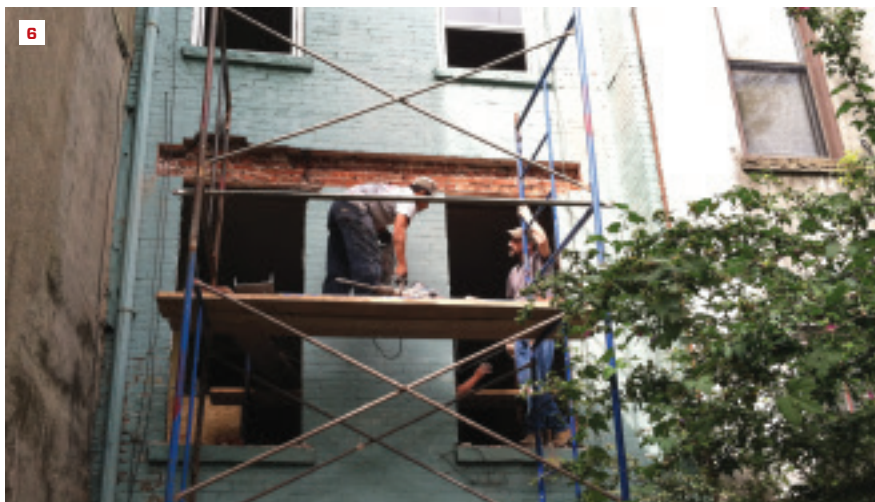
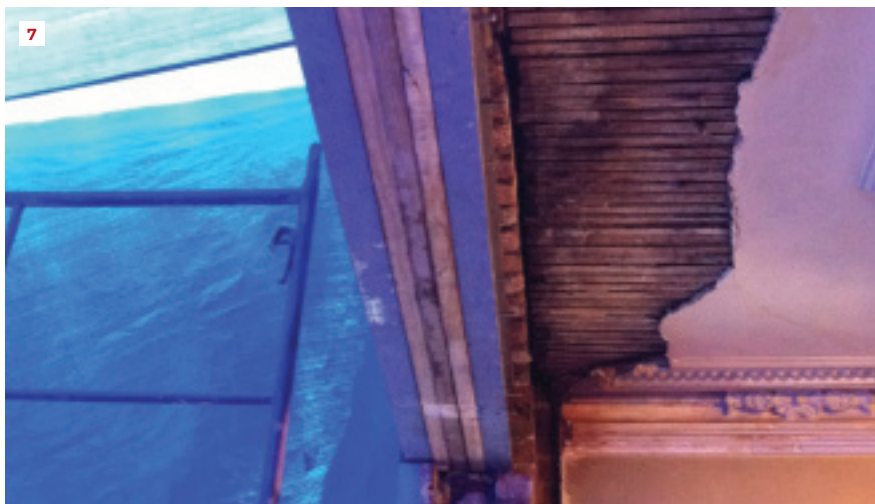
the outer brick (6) to fit the first structural steel channel for what would eventually be a built-up steel and 2-by flitch-beam assembly (7).

With the outer steel channel in place, the remaining two brick wythes were removed from the inside, allowing us to install 2-by stock and a second steel channel for the flitch-beam assembly. The assembly was bolted together, completing the flitch beam (8). The finished masonry opening was roughly 10 feet wide by 17 feet high.

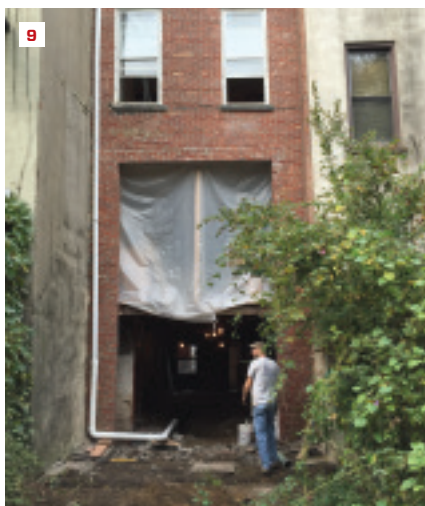
Drainage to keep the grade-level basement dry required new drain lines and a new slab (9). The under-slab prep work consisted of running the storm run-off and wastewater in two separate, parallel lines with check valves to the street as required by the city. We joined them together just before they exited the basement into one line to the city sewer—the storm and sewer lines are still one and the same in Hoboken, N.J.

After the plumbing rough-in was complete, we prepared to pour the new slab by installing compacted gravel, a vapor retarder, rigid insulation, and welded-wire mesh. When it was time to pour, the concrete was off-loaded onto a temporary, site-built chute (10). We had to close down the street for a day for the concrete truck, and this required that we hire an off-duty police officer to keep the peace.

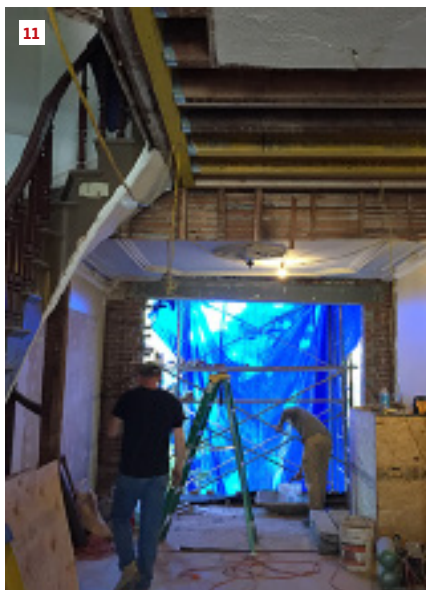
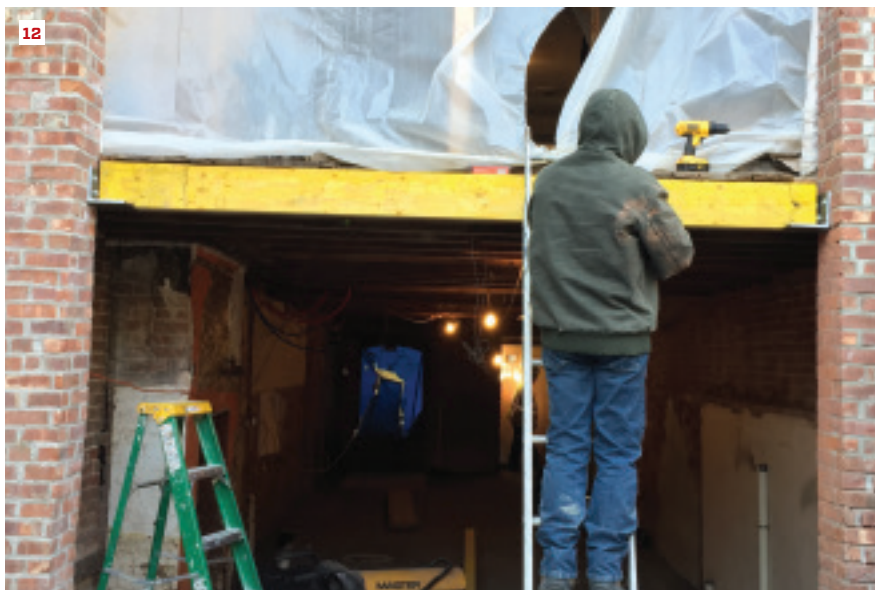
We started reframing on the first floor. As with most of the row houses we work on, the existing floor framing runs parallel to the front and back walls and is pocketed into the side party walls. At stair locations, the joists are mortise-and-tenoned into a header for the stair box-out. Usually this header is undersized and ends up splitting along the pocketed mortises. To remedy that, we install a new LVL header and re-attach the existing joists with hangers, as we did here (11).

Next, we turned our attention to framing within the masonry opening to receive the new doors. Rather than infilling with a bunch of 2-by stock, we installed a couple of LVLs ripped (we took off about  $\frac{3}{4}$  inch) to

match the existing joist depth (12). We weren't too concerned about compromising their structural integrity; in this case, the LVL was essentially just blocking. However, the clients are thinking about adding a deck off the kitchen in a year or so, and the LVL should provide good anchoring for a ledger, if they choose to do that.

We installed steel angles to support each end of the LVLs, securing the angles to the brick with lag bolts and shield anchors (13). We then sistered the inner LVL to the existing floor joist and fastened the

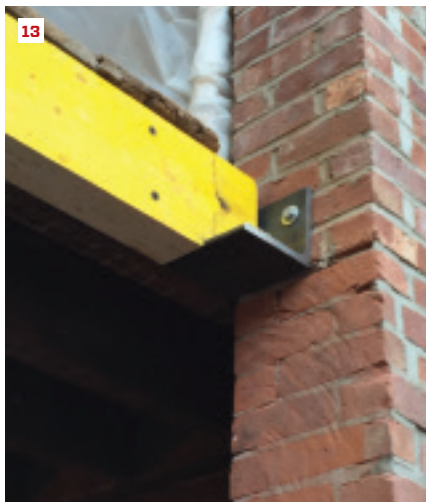
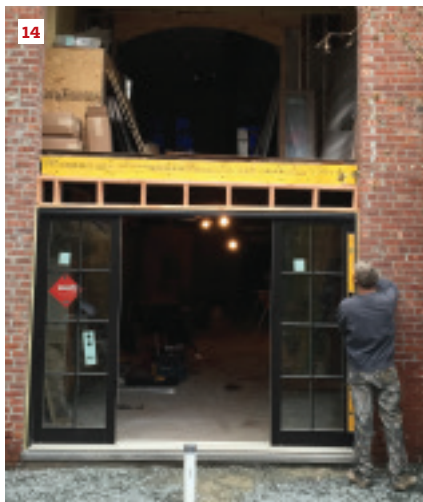
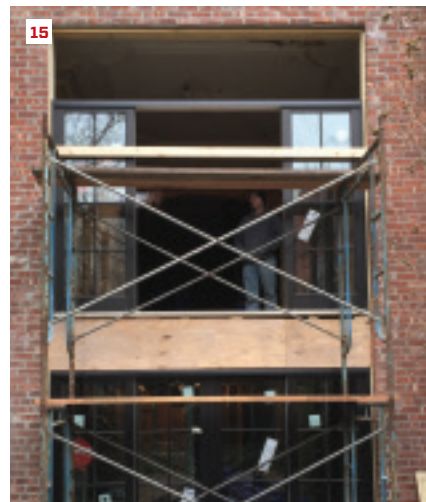
Starting at the garden level, we began installing the sliders. We had to contend here with the out-of-level first floor, as can be seen in the decreasing series of cripples above the door (14). Normally, we build everything as close to level and plumb as possible. But in this case, the clients were willing to live with the settled floors because they wanted to leave as much of the existing plasterwork in place as possible.

With the garden-level door installed, we moved on to the kitchen slider. The first-floor ceiling height allowed for an 18-inch-high finished transom above the door (15). This helped bring in more natural lighting.

feel in the center of the house. We opened up this area, installing an archway at the kitchen entry (16).

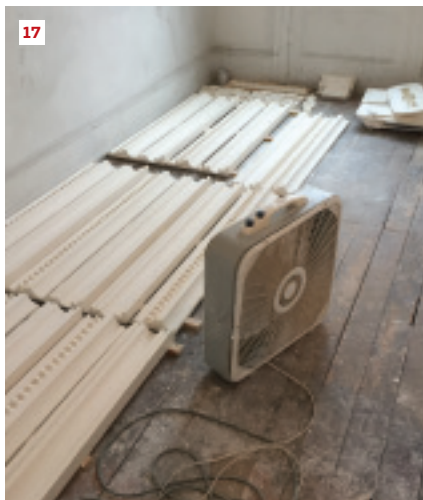
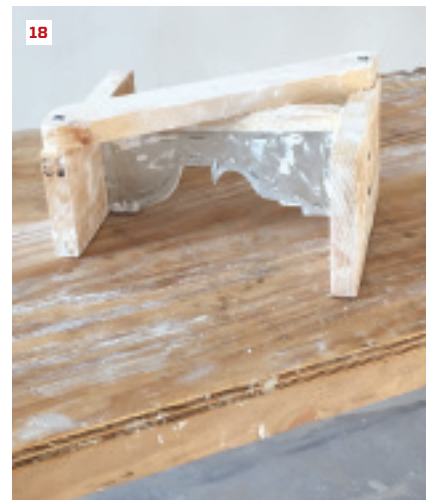
Plasterwork usually runs us anywhere from \$100 to \$150 per lineal foot. Our plaster sub typically makes crown molding on site in 3- to 4-foot sections. To form the crown molding, the sub pours plaster into molds, as he does for more complicated profiles, like these with egg-and-dart trim (17). He does this extrusion work on an 18-inch-wide by 6-foot-long table. The sections of crown are butt-joined together and fastened with dry-wall screws. The seams are then filled with joint compound and sanded. In addition to the molded sections, he also works by hand, extruding the plaster with a knife cut to match the existing profile (18).
