BY GLENN MATHEWSON

How a New Roof Poisoned a Family

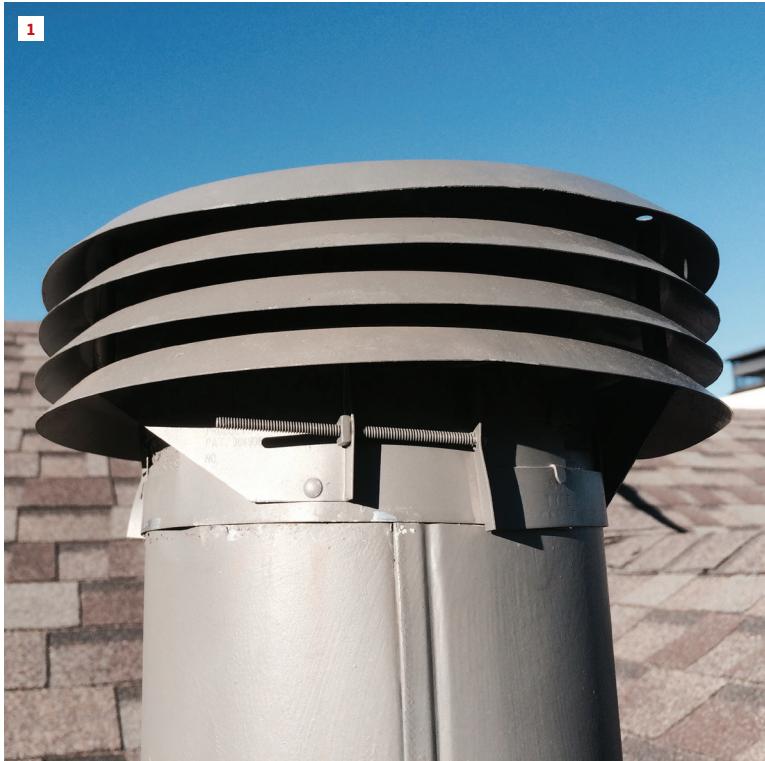
Matching a new roof cap to the specific manufacturer of an existing vent pipe is almost impossible on older homes because of the differences in the locking joints. So roofing contractors typically replace a damaged hood with a universal model that doesn't connect with a twist connection but rather just slides over the end of the vent. To function properly, these replacement caps must be installed at the proper height above the end of the vent before being tightened in place with the integral clamp (1).

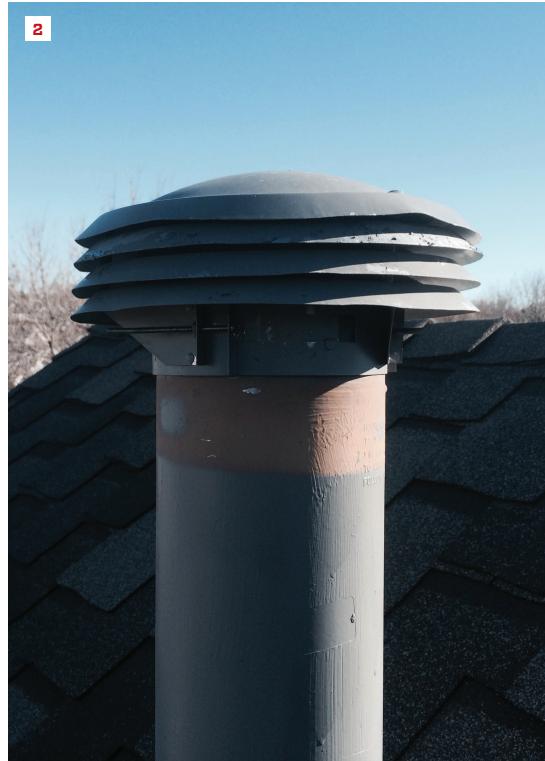
On this particular job, the cap had been pushed down too far over the vent, ultimately blocking off the top of the vent. With

the vent blocked, the hot exhaust gases from the furnace could no longer escape, introducing carbon monoxide into the home. Then as these gases began to cool in the sections of vent that passed through the cold attic and outside air above the roof, moisture vapor in the gas condensed into liquid water inside the vent. This explained the moisture that the HVAC technician found in the vent, a red flag that was misread. The roof replacement had created a problem with the furnace venting, and as a result, the family was suffering from carbon monoxide poisoning.

Raising the cap and securing it at the proper level (2) solved the problem of the condensation, which stopped the “leak.” But more importantly, it removed the source of carbon monoxide entering the home, and the family’s health improved immediately.

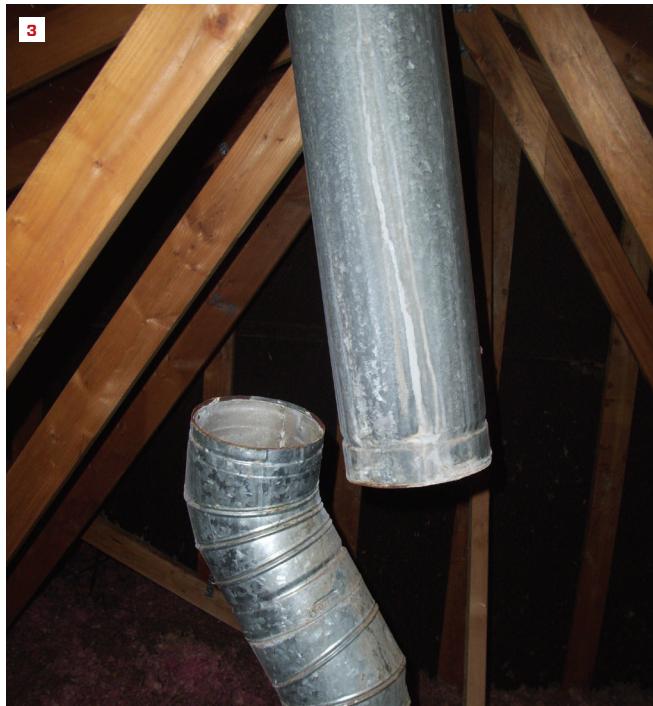
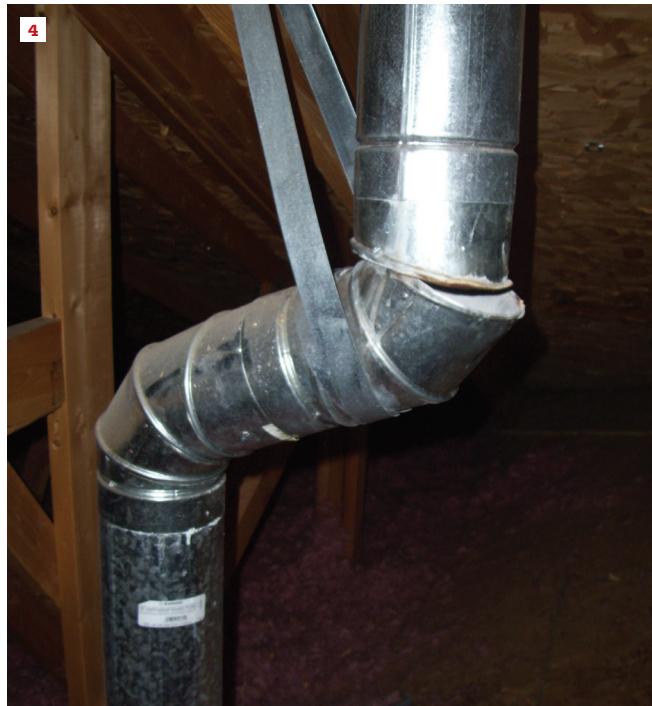
Besides installing the roof cap too low, another common mistake is accidentally turning the whole vent when removing a cap, instead of turning just the cap. Once the joints between the sections of pipe are no longer interlocked, the sections can disconnect inside the building—and reconnecting them is often impossible from the top of the roof. A sure sign of a disconnected joint is B-vent that moves horizontally in all directions on the roof instead of being rigid (3, 4).

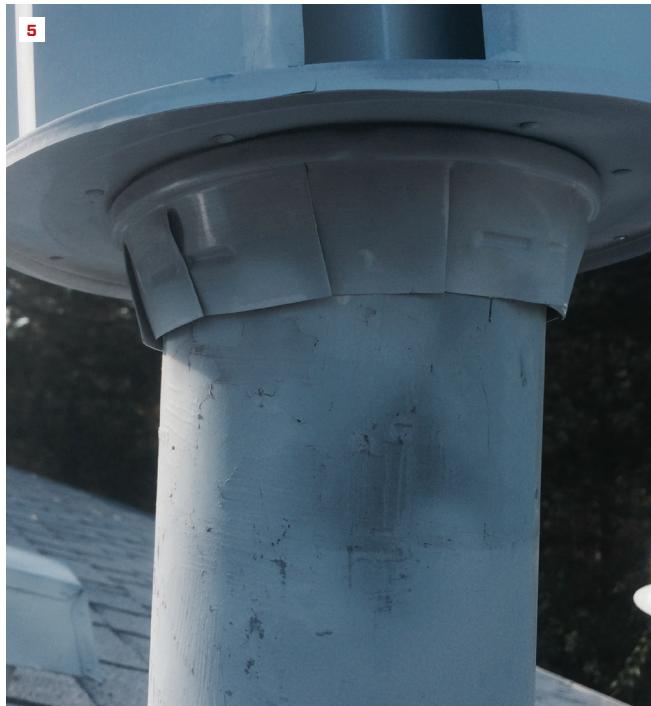
Yet another mistake is snipping the flange around a cap that has a larger diameter than the vent (5). It is then impossible to clamp or secure the cap to the vent.

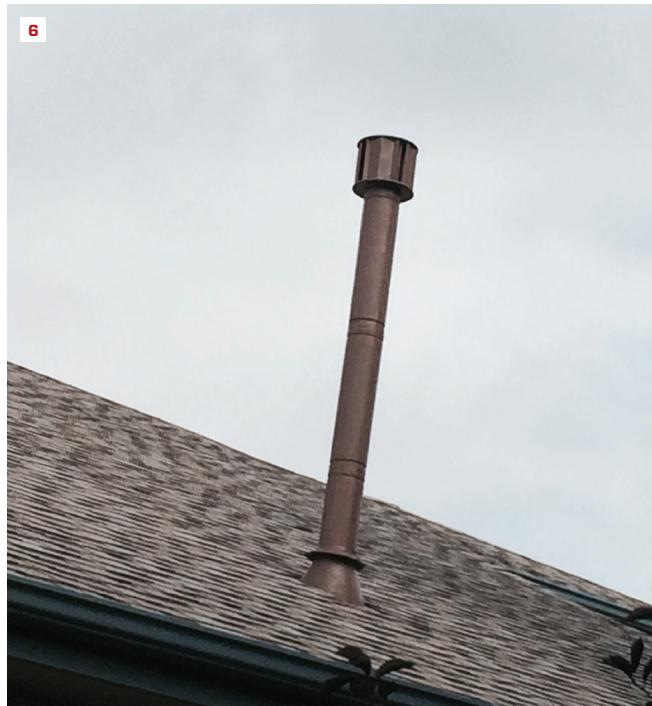
face because of a nearby air inlet (like an evaporative cooler) or the adjacent sidewall of an upper floor. (Generally, vents must be at least 8 feet away from a wall or extend above it). In these cases, braces extending from the pipe down to the roof must be installed to provide lateral restraint. Without these braces, the vent is subject to movement and possible disconnection caused by wind (6). I’ve had to fail many roof replacement jobs where these braces were not reinstalled.
