Moisture in Fat Walls—A Closer Look

Last summer, *JLC* reported on research by Kohta Ueno of Building Science Corp. (BSC) into moisture accumulation in double-stud walls (see “Studying Moisture in Fat Walls,” Jun/14). Ueno had planted moisture meters on the sheathing of a 12-inch-thick stud wall in a zero-energy house in Devens, Mass., built by Transformations Inc.

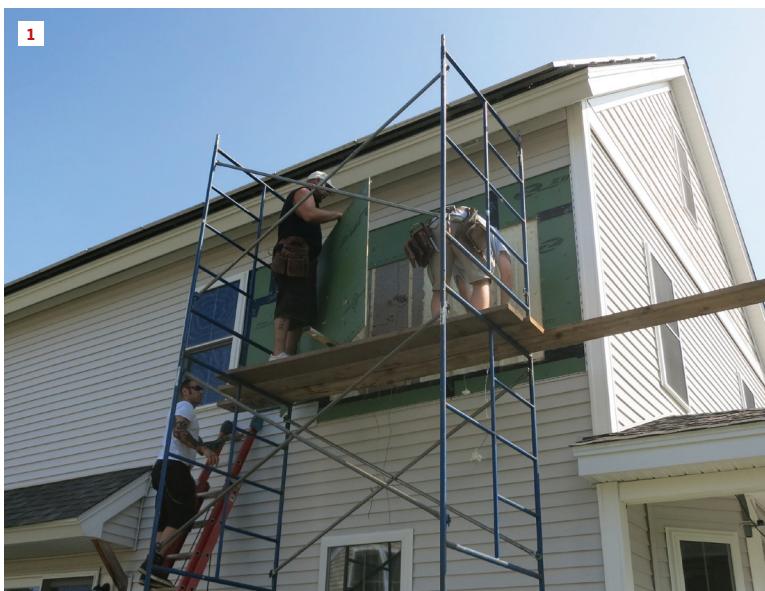
1. After three seasons of moisture and temperature monitoring, workers pull sections of Zip sheathing panels from the test wall section of a house in Devens, Mass.

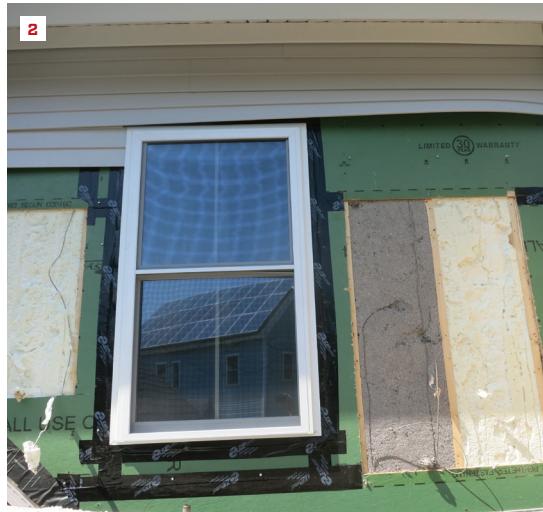
2. The wall system has good drying potential to both the inside (through the painted drywall) and the outside (through the permeable Zip sheathing), but the cold OSB on the exterior does suffer increased moisture and condensation during the coldest months of the winter.

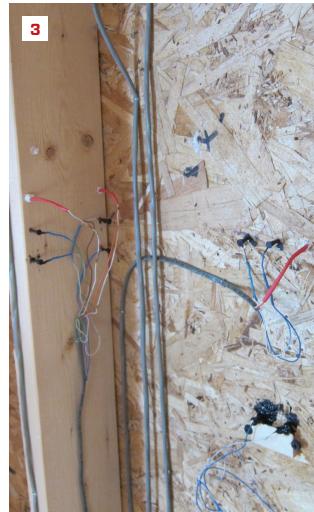
3. Moisture sensors in the building walls allowed the Building Science Corp. research team to remotely measure and record the moisture content of the framing and sheathing throughout three winters of house operation.

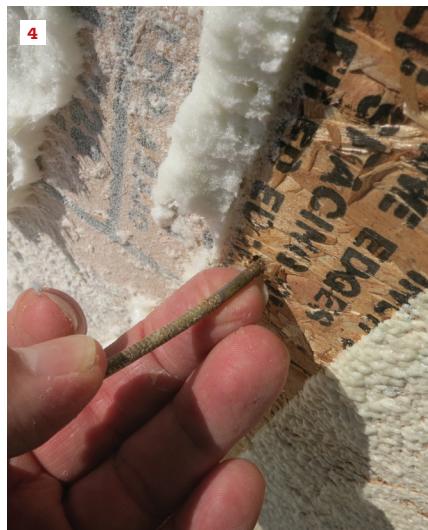
4. Nails rusted slightly after three seasons of moisture accumulation—clear physical evidence of moisture attack, but not as grave as the data had suggested.

"All the instrumentation and monitoring said that these walls got hammered in terms of moisture content, relative humidity, condensation, anything like that," Ueno told *JLC* in a phone interview. "And the current analysis tools in the toolbox say this wall should be toast. But we opened it up and it was like, 'Huh. Well, there's a little bit of grain raise. The fasteners are a little bit rusty. That's about it.'"

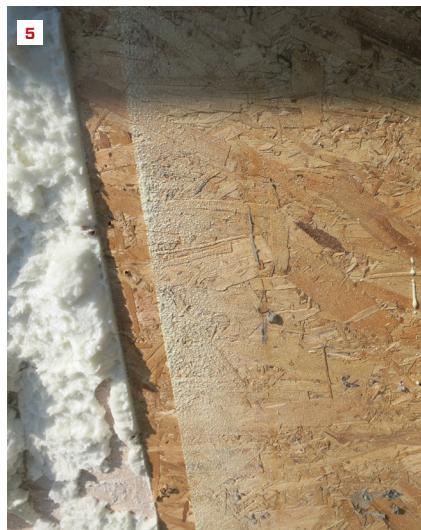
5. A close-up of the OSB sheathing removed from contact with the low-density spray foam of the insulated wall cavity shows no sign of fungal attack at all, much less any deterioration that might compromise the sheathing's function.
