# New Columns For an Old Porch

**Matching classic  
millwork with  
composite columns  
and PVC trim**

by Emanuel Silva

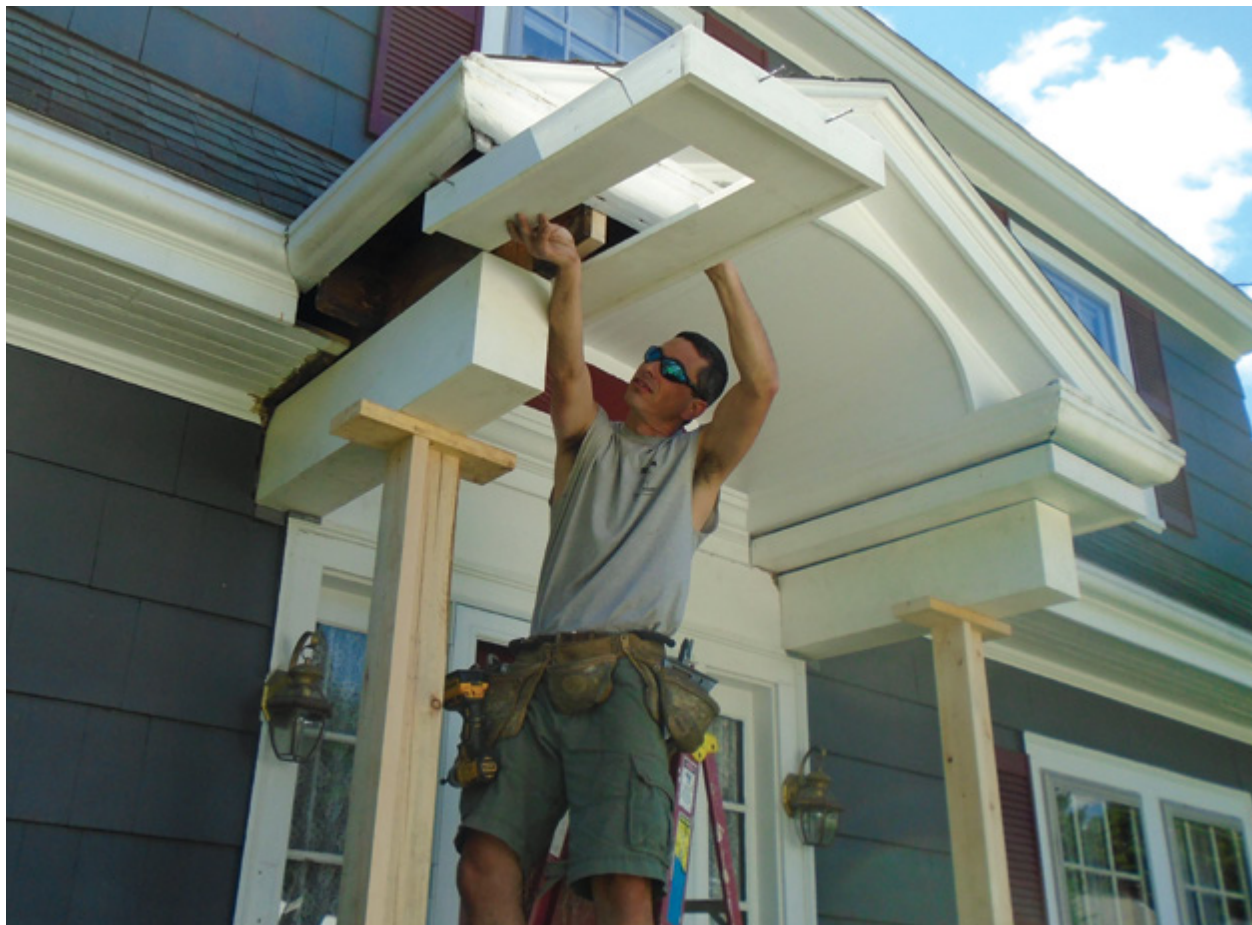
It was then I discovered that water had damaged the porch structure above the columns as well. The crown molding used to finish the fascia on the eaves doubled as a gutter. Though the top of the mold-

**Figure 1.** The original beams—which were actually framed like short knee walls and clad with board sheathing—had water damage, so the author reframed them with PT lumber and clad the new beams with PVC trim. Then he prefabricated U-shaped PVC soffit/fascia assemblies and slipped them into place.

ing was capped with metal flashing where it wrapped around the porch, it looked like water had still managed to collect there and leak into the short box beams that sat on top of the columns and supported the porch roof framing.

To fix the problem, I first removed the old beams—which had been framed like short knee walls and clad with board sheathing. I used PT lumber to frame new “knee wall” beams and clad them with PVC trim. Next, I assembled U-shaped PVC soffit-fascia assemblies and slipped them into place (**Figure 1**).

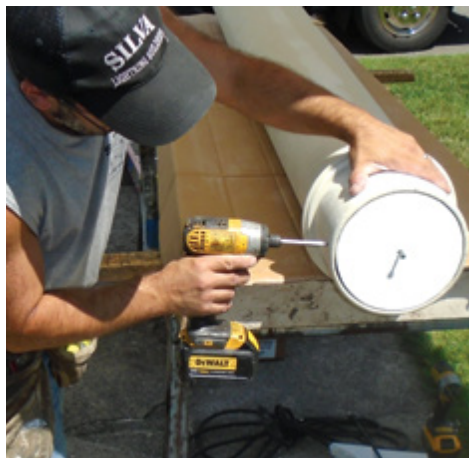
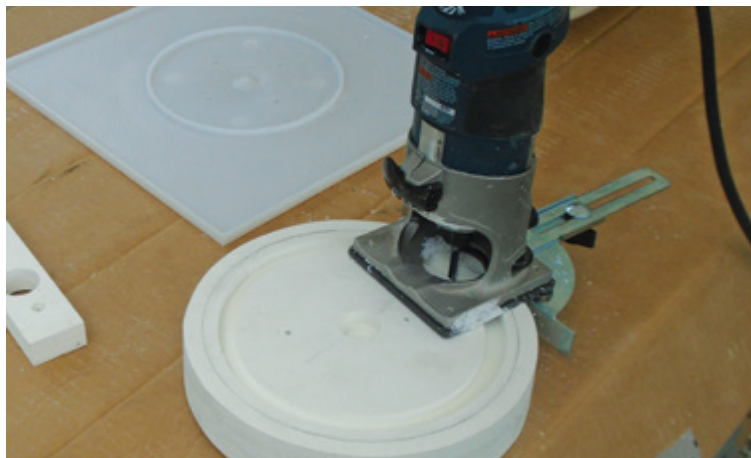
**Figure 2.** The author extended the columns by first inserting a plug made from a double layer of  $\frac{3}{4}$ -inch-thick PVC into the top of each column (above left). The plug serves as an attachment point for another, slightly larger PVC plug that's sized to match the outside diameter of the column and routed with a channel to fit into the flashing cap (above right). The column extensions effectively lower the position of the column's decorative trim rings.

I started by gluing together 1-foot-square sections of  $\frac{3}{4}$ -inch-thick PVC trim to make 1 $\frac{1}{2}$ -inch-thick stock. Then I used a jigsaw to cut out a pair of round plugs that matched the inside diameter of the top of the columns. I fastened the plugs to the columns with screws (**Figure 2**).

Next, I cut a pair of slightly larger plugs to match the outside diameter of the columns and act as column extensions. Because these extensions needed

to fit into the flashing cap (which prevents water and debris from getting into the column), I routed out a channel and center hole to match the flashing cap profile. Then I screwed the extensions to the plugs with stainless steel screws.

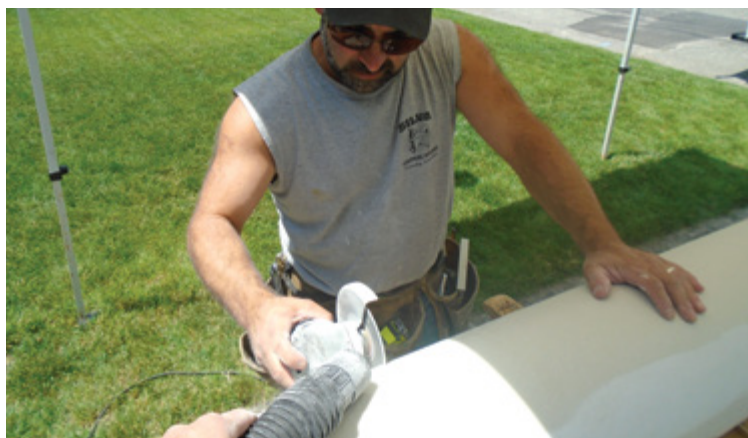
**Figure 3.** A 4½-inch angle grinder equipped with a diamond masonry blade was used to cut the columns to length.

To mark cut lines that were square to the base of the columns, I rolled up a length of 4-inch-wide aluminum coil stock and wrapped it around the column to use as a straightedge. The manufacturer says that PermaCast columns can be cut with a carbide blade in a circular saw, but I find that the resulting edge is pretty rough. Instead, I make these cuts using a 4½-inch angle grinder equipped with a diamond masonry blade, which results in a smoother and more controllable cut (**Figure 3**).

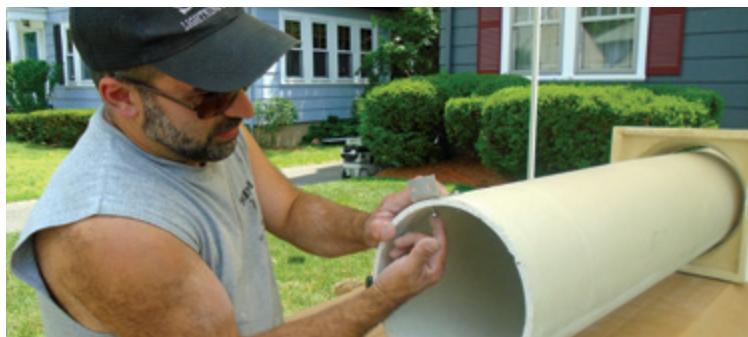
**Figure 4.** The author used stainless steel bolts and nuts instead of the supplied screws to fasten the installation clips to the column bases.

The installation kits that came with the columns included a pair of galvanized metal installation clips, along with screws to connect the clips to the columns. Because I was concerned about the screws eventually corroding or working loose, I substituted stainless steel bolts and nuts. That allowed me to bolt rather than screw the clips to the bases of the columns (**Figure 4**).

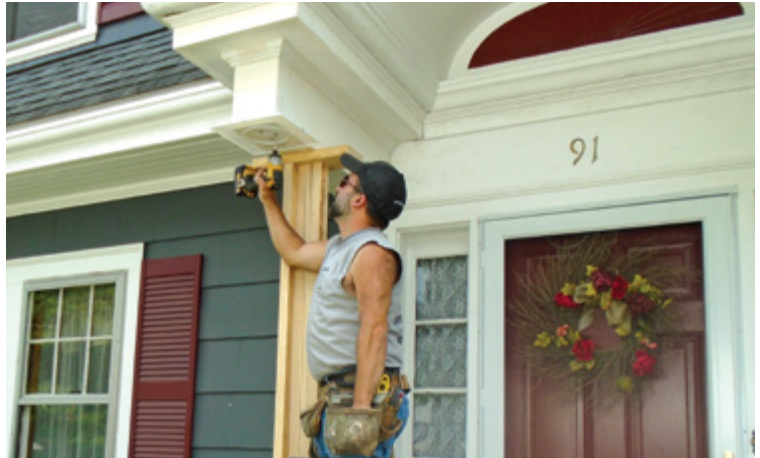
**Figure 5.** The top of the column fit into a flashing cap that was screwed to the underside of the beam.

Before I fit the columns in place, I jacked up the porch roof assembly slightly so that they would slide easily into position. After screwing the flashing caps to the underside of the beams (**Figure 5**), I inserted the columns, then removed the shims and temporary supports so that the roof assembly was fully supported by the columns. In this installation, I wasn't too worried about wind uplift, so I didn't reinforce the connection to the roof framing with additional clips or long structural screws.

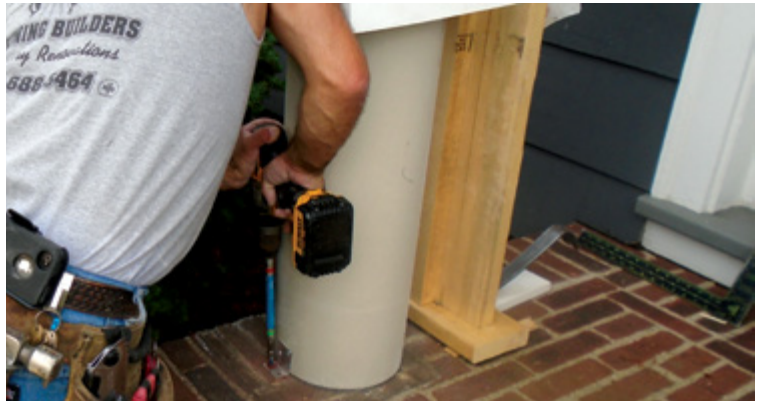
**Figure 6.** The bases of the columns were secured to the porch with  $\frac{5}{16}$ -inch-diameter by  $2\frac{3}{8}$ -inch-long Tapcon masonry screws driven through the installation clips and into holes drilled into the brickwork.

When I was satisfied that the columns were plumb, I drilled pilot holes into the brickwork, then fastened the brackets to the porch with  $\frac{5}{16}$ -inch-diameter by  $2\frac{3}{8}$ -inch-long Tapcon masonry screws (**Figure 6**).

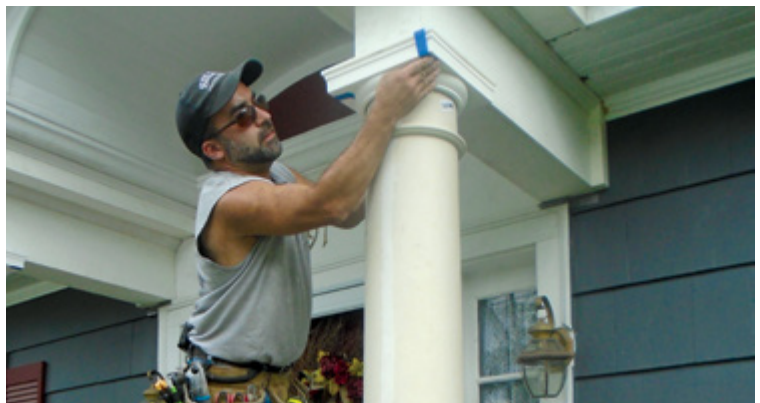
**Figure 7.** After gluing the capitals to the flashing caps with OSI Quad Max sealant, the author used masking tape to hold the capitals in place until the sealant cured.

To block moisture and insects, I filled the gaps between the column bases and the uneven masonry with a generous bead of OSI Quad Max, an extremely flexible window and door sealant. Then I applied a glob of sealant at each corner and set the column bases in place, tweaking the bases slightly until they looked square and level. I also glued the capitals to the flashing caps with the same sealant, using masking tape to hold the capitals in place until the sealant cured (**Figure 7**).
