## Floating a Boathouse Working under water to raise a landmark above water

## Temporary Support for a Sinking Building

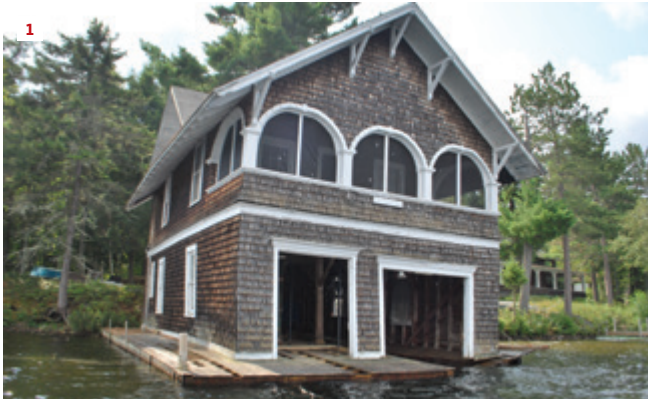
The owners of one such boathouse hired our construction firm, West Branch Inc., to repair the structure, fearing that it wouldn't survive another winter without falling into the lake (1). No strangers to unique projects, we accepted the job, which would be completed in two phases. The boathouse obviously would need a new

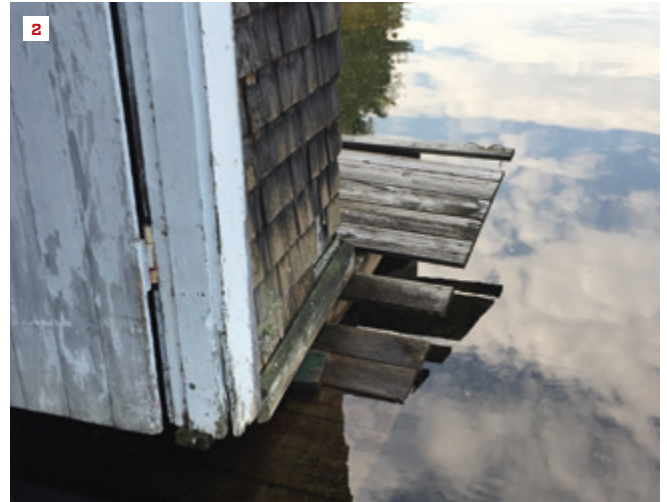
From above the water, the urgency for a repair was evident. After many years, support for the boathouse had given way, letting the building sink into the lake. The west side of the structure (2) had dropped much further than the east (3), and the structure needed to be stabilized before going through another winter. Through our investigation, we determined that the deterioration of the support was due to a number of factors: fastener corrosion, rot, and the forces of lake ice.

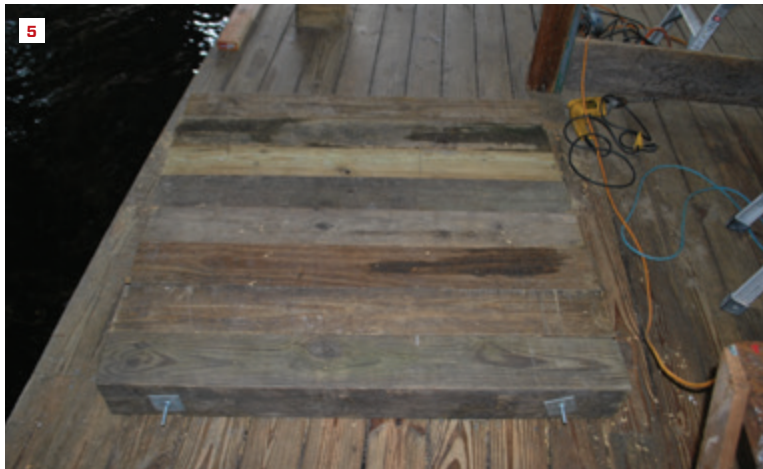
The bottom layer of each cribbing was a mat of 6x6s bolted together with threaded rod (5). We built the cribbing mats on the nice, flat surface of the boathouse floor and then slid them into the water. We built the rest of the cribbing on top of the pads, log-cabin style. One of our crew members, Brett, toe-screwed timbers to the mat and then to one another (6) so that the stacks of cribbing would stay together and could be moved as a unit in the water. Attaching cribbing timbers to one another is not necessary in a typical jacking operation on dry ground.

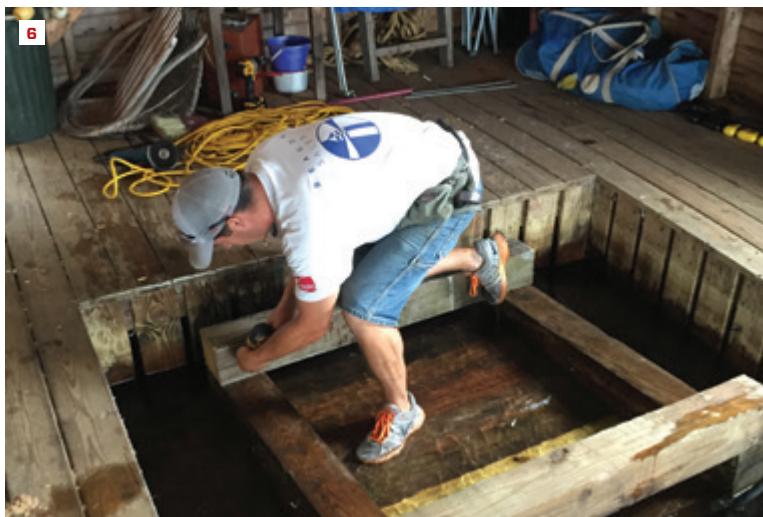
We donned scuba gear and examined the situation below the water. The original boathouse had been built on a “foundation” that consisted of timbers stacked log-cabin style around the boathouse perimeter to form cribbings (4). Large rocks inside the cribbings formed a base upon which the boathouse was built.

We found that some of the cribbing timbers were missing (because of rot or fastener failure). Foundation rocks had then fallen out through the resulting gaps, and the slow sinking process began. The timbers had been pinned together by long spikes, which over time had corroded to the extent that they could no longer resist the

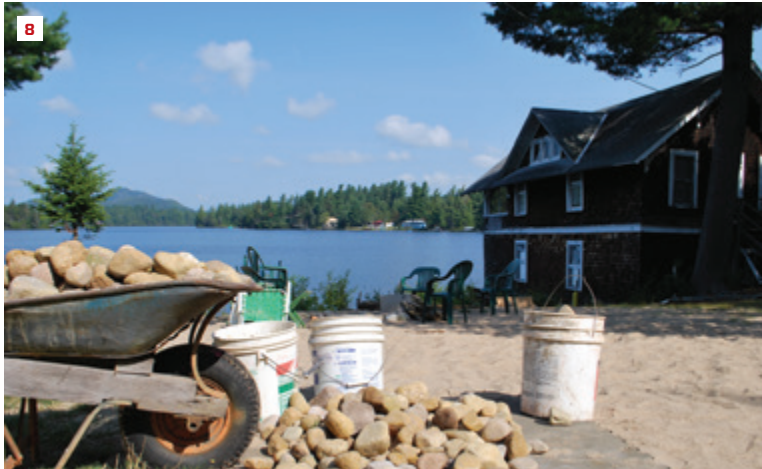
To give the cribbing stacks a flat and stable base on the bottom of the lake, we gathered melon-size stones from the site (8) and hand-placed them at each location where the cribbing was to be positioned. We compacted the stones, using a 6x6 beam in a pile-driver fashion to create a flat base, and a furring strip to check the depth (9).

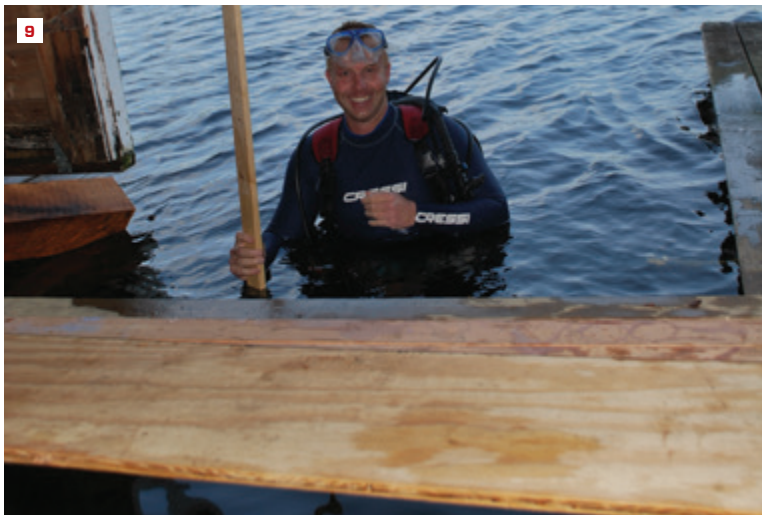
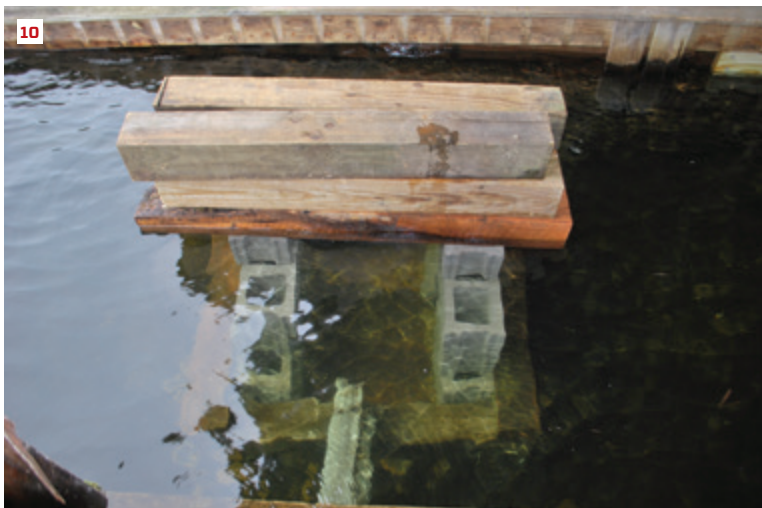
water at the shallow end of the boat bay was only about 18 inches deep; from there, the gravelly lake bottom dropped off rather quickly to a depth of 5 to 6 feet at the outer wall of the boathouse. With the mat floating at the shallow end, Brett screwed together the first couple of cribbing layers. Then we floated the assemblies out to deeper water as their weight and height increased (7), saving us from having to lift and move the massive stacks into place.

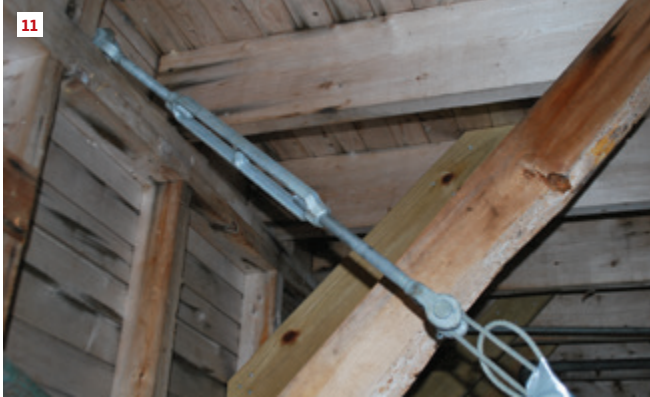
Before we started jacking up the boathouse, we installed a cable and turnbuckle to keep the building from racking further as it was lifted (11). The turnbuckle would also let us plumb the walls after the lift. We used a ½-inch turnbuckle with a working limit load capacity of 2,200 pounds for this particular application.

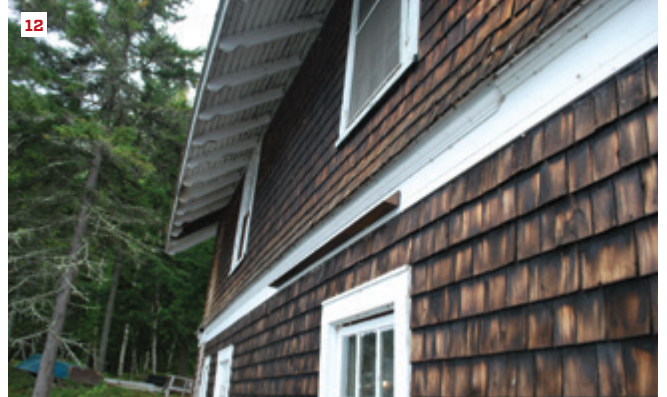
To attach the end of the turnbuckle eyebolt, we installed a 3x3 by ¼-inch-thick steel angle on the outside of the east wall at a height that would catch both the double top plate and the second-floor joists (12). The angle spread the load from the turnbuckle assembly over several joists and the plates. To start out, we attached the lower end of the cable to the east side of the boat bay.

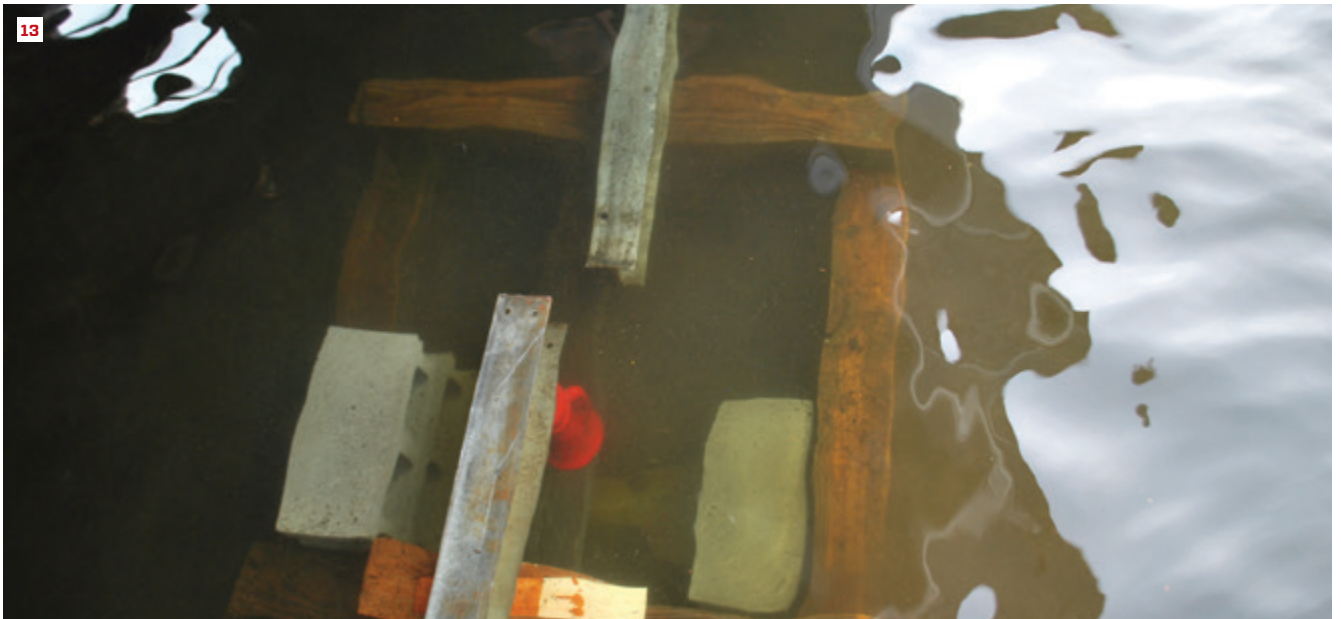
With the cribbing in position and the walls stabilized, we were ready to begin the jacking process. We removed rock from the original underpinning and threaded the needle beams under the structure, resting the ends of the beams on the cribbing. We then set blocks on a lower tier of cribbing to support the jacks and started raising the needle beam until it made contact with the 6x6 support beams under the floor (13).

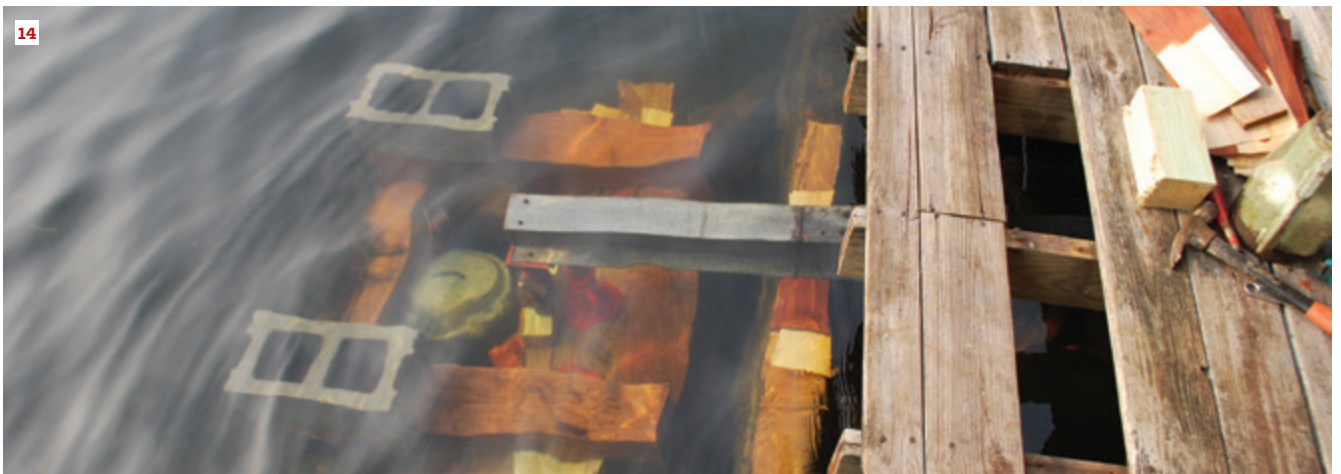
We used hydraulic bottle jacks and screw jacks to raise the needle beams. The bottle jacks did the lifting, and then we inserted screw jacks to hold the needle beams while we repositioned the bottle jacks (14). We

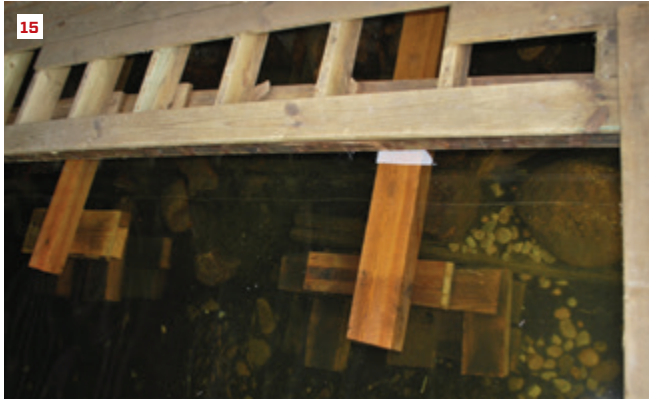
The existing 6x6 support beam on the west side of the boathouse developed a significant sag as we raised the needle beam. To overcome this sag, we added smaller, less elaborate supports at two other places along that side (15).

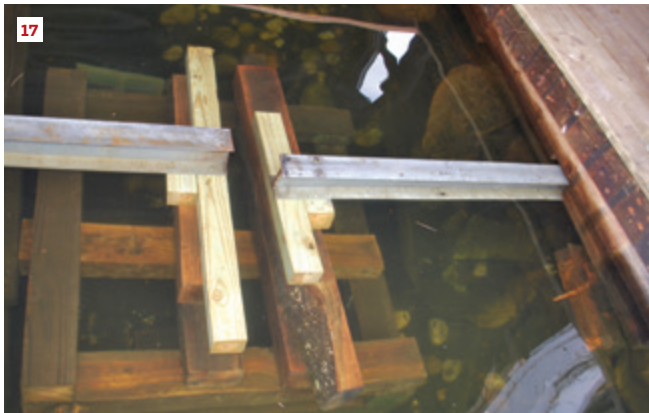
Even with three cables, we weren't able to pull the walls plumb, so we reattached the cables to the west wall. This decreased the cable angle, allowing us to apply greater force. But then we ran the danger of pulling that wall in, so we added a couple of spreaders across the boat bay to stabilize the bottom of the wall (16).

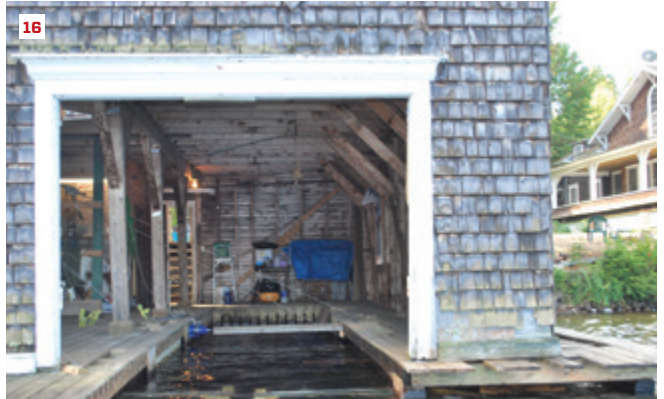
As we raised the needle beams, we blocked and shimmed until the sides of the boathouse were level. Then we replaced the shims with more permanent solid blocking to carry the load over the coming winter (17). We kept the cables in place along with the spreaders in the boat bay, and we left with the boathouse high and mostly dry (18). The owner also installed a bubbler system around the cribbing, which will keep ice from forming.
