Air-Sealing a Chimney Chase

Refinishing a Hail-Damaged Home

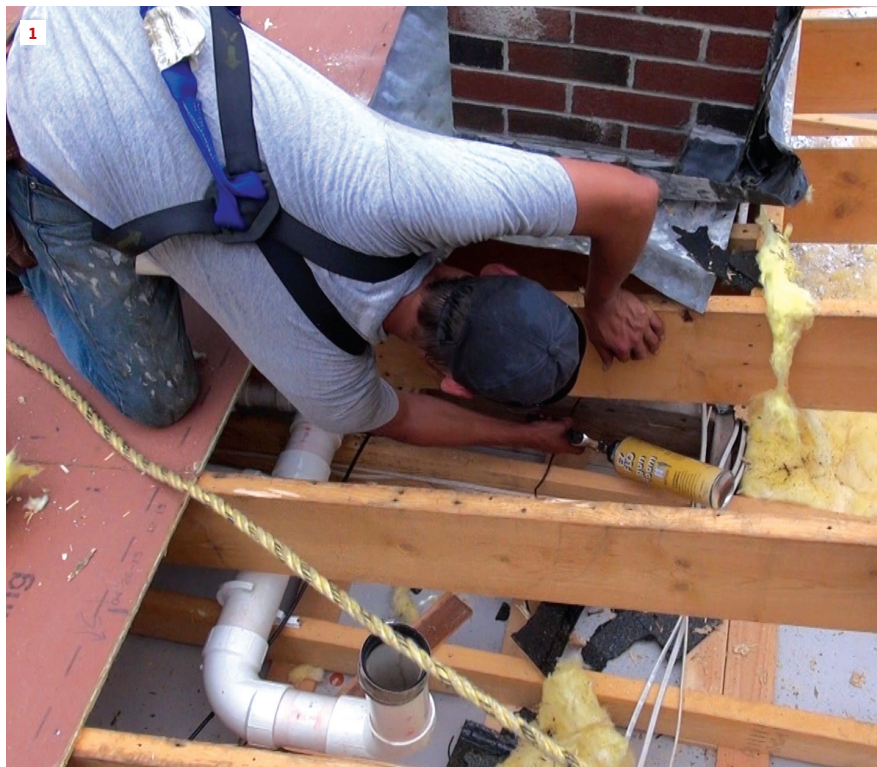
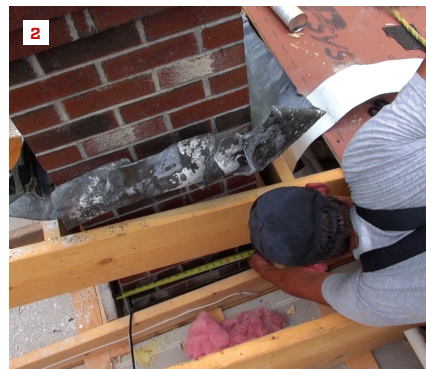
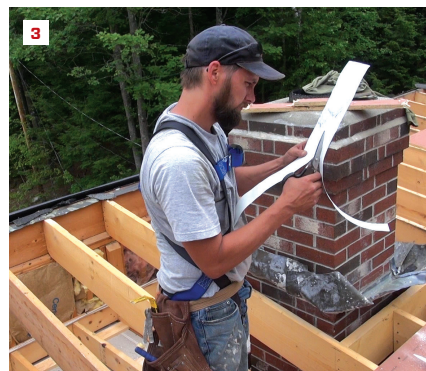
With the roof off, Upright Frameworks weatherizing tech Scott Phillips took advantage of the situation to air-seal the brick chimney chase from above. Phillips started by air-sealing the joints in the existing framing, using gun foam (1). Then he measured the opening around the chimney (2) and installed metal flashing to cover the 2-inch gap.

Using a pair of Cutco metal shears, Phillips cut pieces of flashing to span the opening (3). The shears, which retail for around \$110, are Phillips' tool of choice for

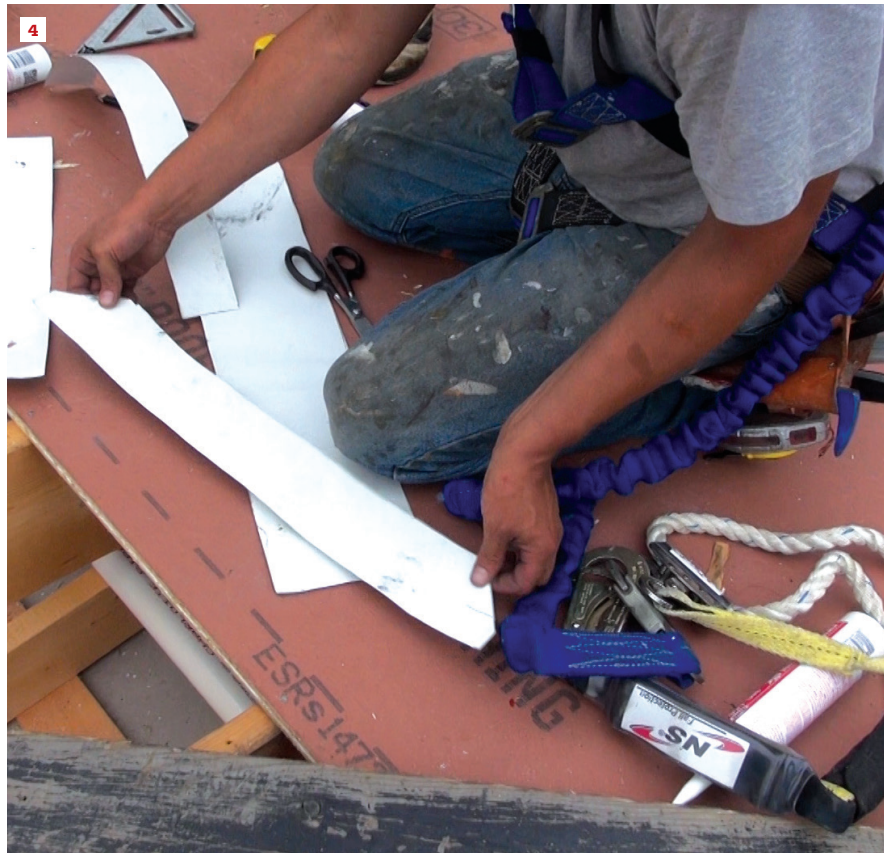
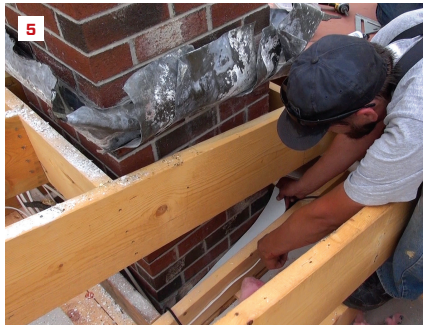
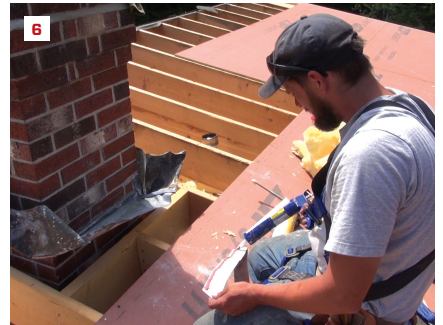
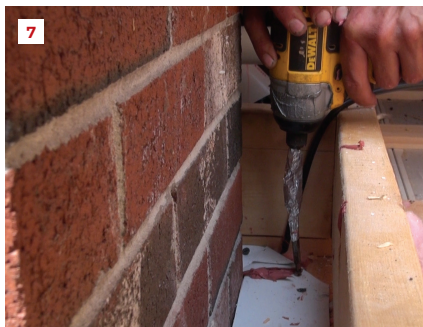
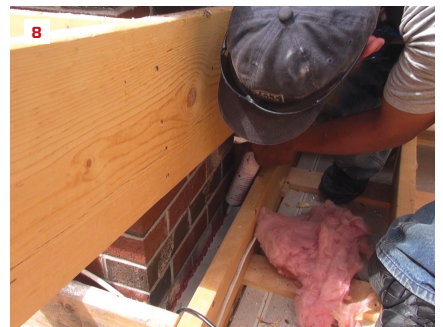
After cutting flashing to the required length and width for one side of the chimney, Phillips snipped off the corners at two ends to leave space for existing TV coaxial cable that had been routed through the chimney chase into the attic from below. To avoid damaging the coax cable’s plastic insulation, he folded small scraps of flashing over the sharp edges at the cuts **(4)**.

Working his way around the chimney, Phillips maneuvered the strips of flashing into the small gaps between the wood and the masonry, operating as much by feel as by sight **(5)**. Once he was sure of a good fit, he applied high-temperature sealant to the underside of each metal piece **(6)**. When the metal was screwed down, the caulking would seal and reinforce the connection, blocking the flow of air at the joint where the metal lay on top of the ceiling framing.

To secure the metal flashing in place, Phillips screwed the pieces down onto the ceiling framing **(7)**. Finally, he sealed the joint between the metal and the chimney with high-temperature caulk **(8)**.

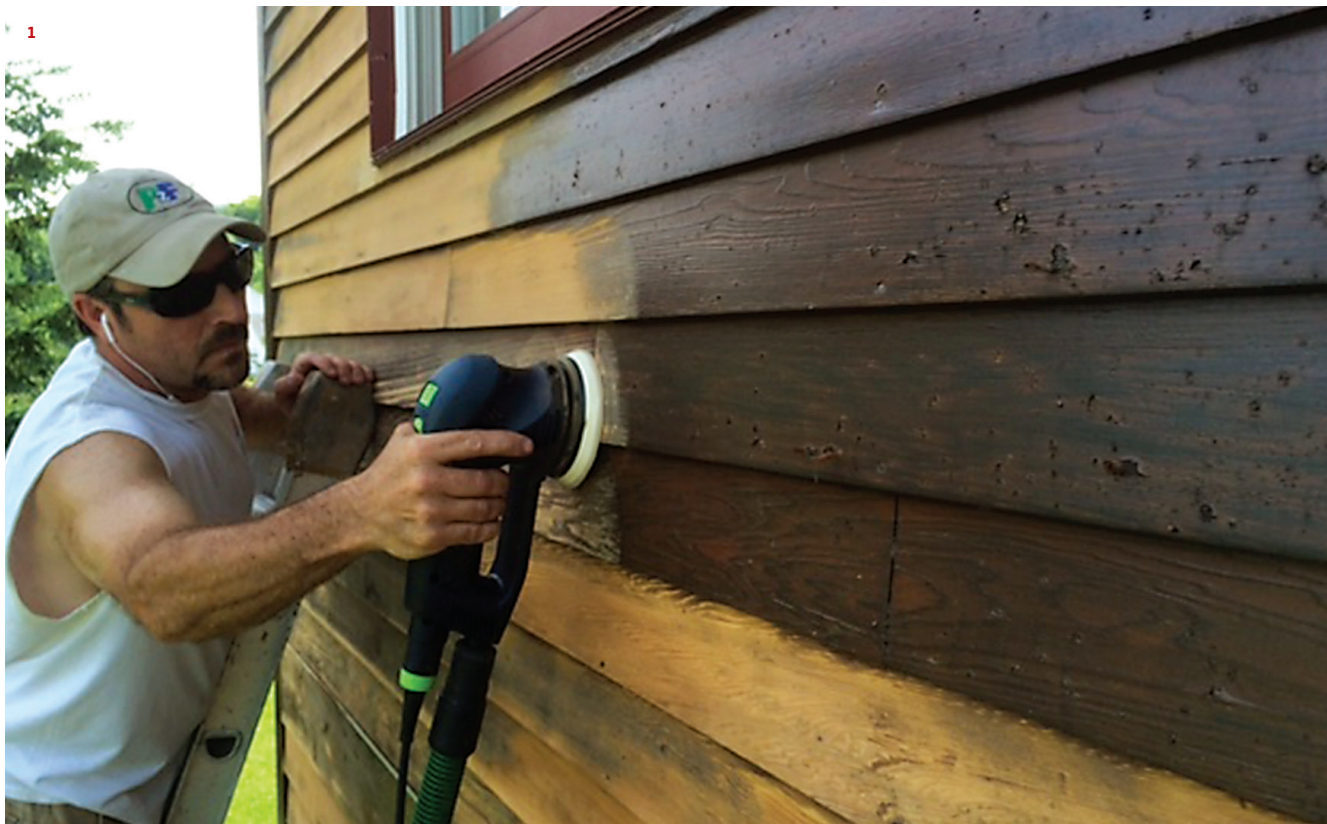
A year ago, I was called in to assess damage done to a home's exterior walls during a severe thunderstorm. Large hailstones had pelted the siding on three of four walls, with the front, northwest facade taking the brunt of the storm. The existing siding and trim had been finished with Sikkens—an alkyd-based stain that, when dry, produces a hard, glossy film—and on the facade that was spared the hail, and in protected areas such as under roof overhangs, the Sikkens was undamaged and still well-bonded. (Though in a few exposed, sunny areas, the finish had begun to peel before the storm.)

On close inspection, I realized that the damage looked far worse than it was. Much like a rock hitting a windshield, the hail had essentially “shattered” the Sikkens film coating on impact, resulting in a pockmarked surface—but the compression wounds left by the hail pene-

trated only $\frac{1}{32}$ inch, leaving the underlying red-cedar siding relatively untouched. Still, the finish was beyond repair and needed to be replaced.

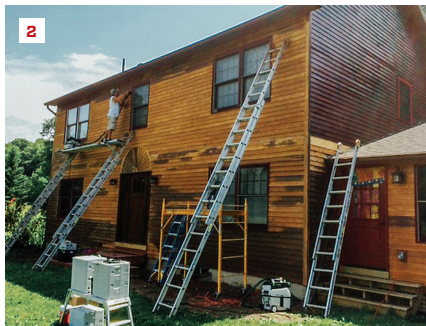
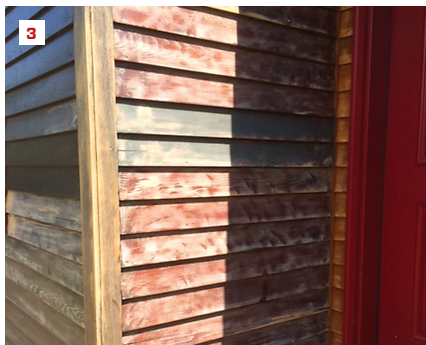
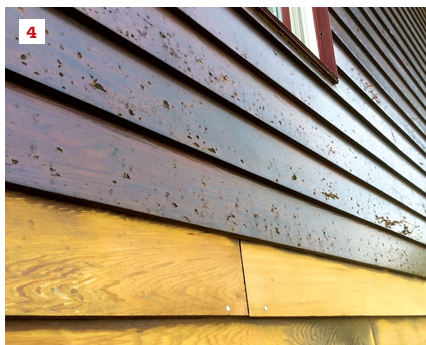
Festool CT Midi HEPA Dust Extractors, we worked our way up toward the soffit (1), sanding off most of the finish (2). The pitting was random in intensity and location, and a small return wall adjacent to the front facade needed only to be scuff-sanded (3).

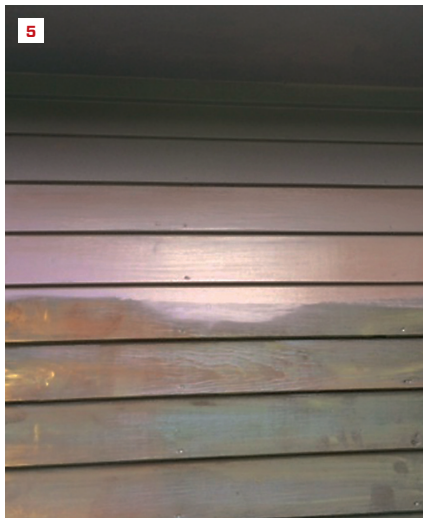
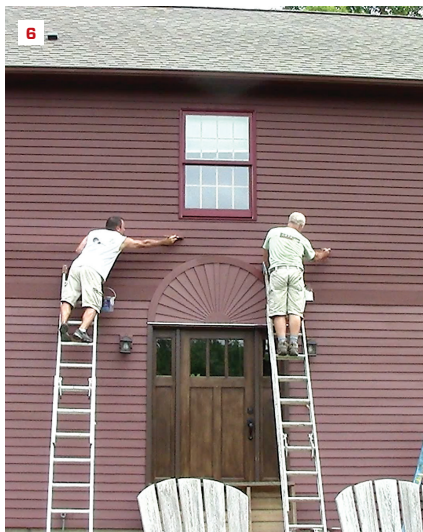
Sanding down to raw wood eliminated 95% of the pitting (4); in the few spots where bigger stones hit the siding just right, we spent a little more time sanding out the deeper dings in the wood grain. Where the clapboards met corner boards and trim, we sealed the gaps using a brown-colored acrylic latex/silicone caulk by DAP.

Multi-Purpose Latex Primer/Sealer primer, a high-adhesion primer that helps hide imperfections from the surface prep (5)—in this case, the occasional sanded-down deep pockmark and swirl marks left from scuff-sanding. Working from the top down, we applied it by brush rather than spraying it; the brush mechanically puts the primer into the grain of the wood for better adhesion. We like using 2 1/2-inch Purdy XL medium/stiff angled brushes for both the primer and top coats, which we applied liberally and fast to keep them wet. This size of brush works well in clapboard reveals to spread paint in long passes while still allowing us to point and cut where needed.

We used Sherwin Williams' Duration Satin on the trim and Sherwin Williams' Woodscapes on the siding. Woodscapes is a solid stain with a flatter finish and would help hide any cosmetic defects left over from removing the Sikkens. We applied the top coat as we did the primer, generously and continuously to keep it wet. Todd and I worked quickly to keep material flowing in the hot summer sun, applying it in sections that we could cover alone (between windows) or working together on sections where we needed to blend longer runs into each other without flashing (6).
