ROOFING

Common Roofing Errors Details that matter on asphalt shingle roofs

BY MARK PARLEE

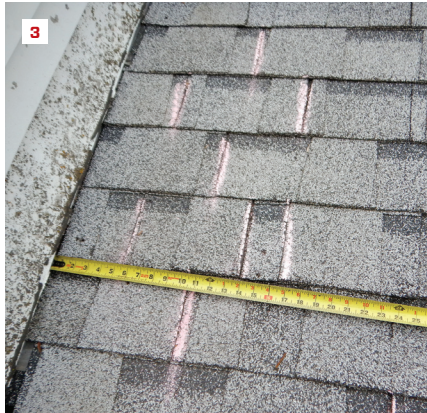
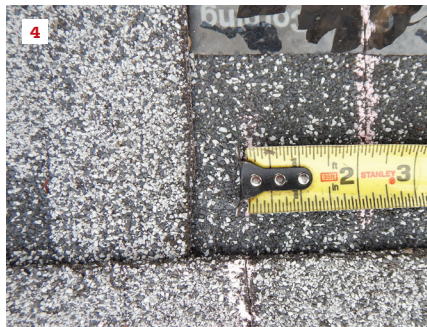
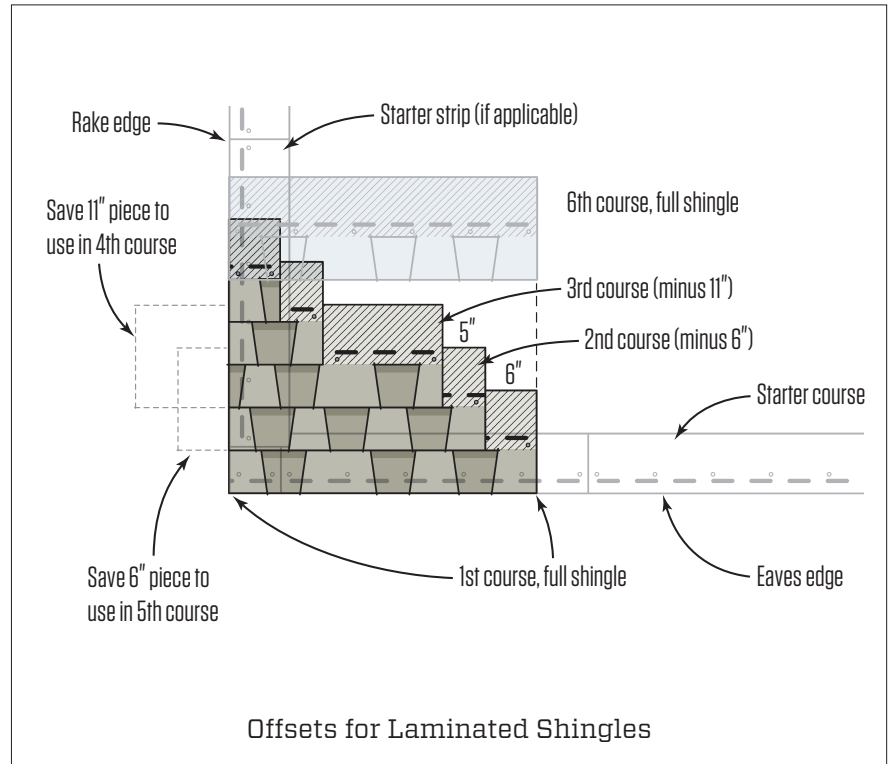
Shingle offsets. Chalk lines on the roof indicate the breaks in each course of shingles, showing clearly that some of the offsets are less than the required 4-inch minimum (3), which is set by the shingle manufacturer. And in some cases, the offset was only about 2 inches (4). Since most roof dimensions are not an even multiple of standard shingle sizes, fractional shingles—preferably of equal size—are needed to fill out courses. Provided the fraction isn’t smaller than the minimum offset (as it is on this roof), this is an aesthetic issue and is much less noticeable with laminated shingles, because of the random appearance of the overlaid pieces, than it is with three-tab shingles.

Shingle manufacturers specify a minimum overlap, usually in the range of 4 inches to 5 inches. On this roof, the minimum overlap specified by the manufacturer is 4 inches, and the recommended overlap is 6 1/2 inches.

But the way the shingles were installed, the offset was often less than 4 inches—and even as small as 2 inches—which may have accounted for some of the leaks that occurred in the interior near the center of the house. (Bear in mind that it’s often difficult to track the exact location of a roof leak, as water often runs down framing members and may end up spoiling interior finishes far from the actual leak site.)

Sticking to the minimum offset helps to keep end joints between

shingles at least 2 inches away from the nails at the end of the shingles in the course below.

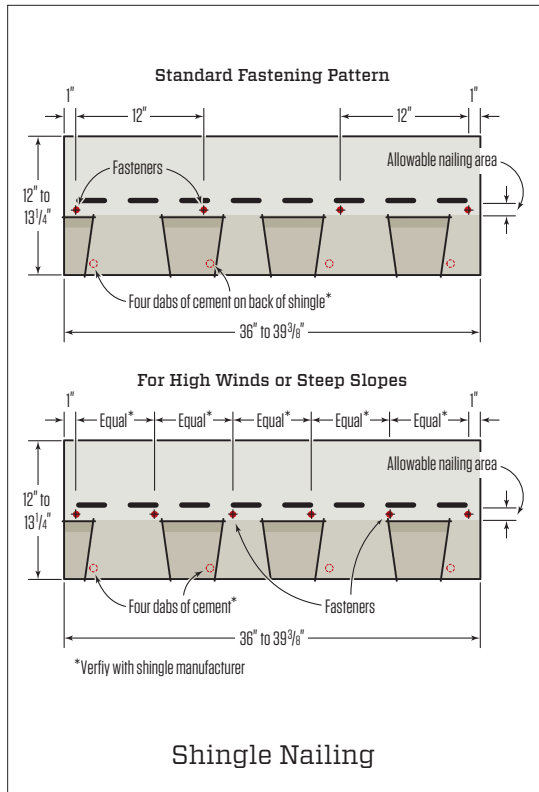
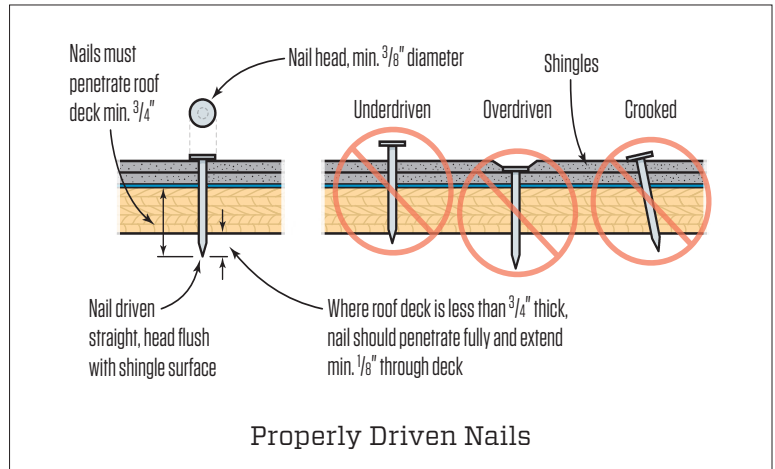
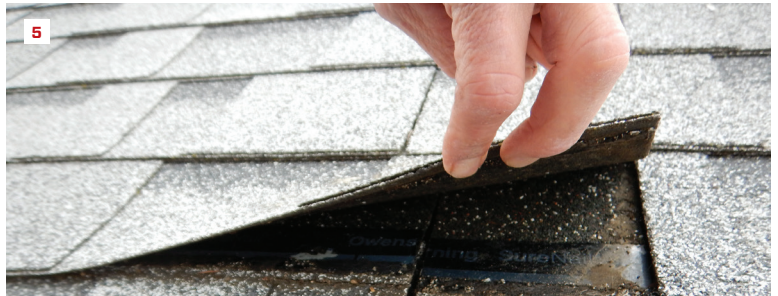
Photo (2) shows that the roofer on this particular job did not install any drip-edge flashing, and you can see how the edge of the sheathing has weathered from exposure to water.

Shingle nailing. When the author inspected the project, no nails were evident at the ends of many of the shingles (5). The standard nailing for asphalt shingles is a four-nail pattern, with nails placed 1 inch from each end of each shingle and then two nails placed 12 inches in from the end nails, as shown in the top of the “Shingle Nailing” illustration (above left). On laminated shingles, this nail spacing is not as immediately apparent as it is on three-tab shingles, where the nails are placed above the cutouts. In high-wind locations and steep-slope applications, a six-nail pattern should be used, as shown in the bottom of the same illustration (above left).

Most asphalt shingle roofs can be fastened with a four-nail pattern. The key is to keep to a consistent pattern—1 inch from the edges and uniformly spaced across the shingle length.

On this roof, the nailing was sporadic, and in many places, there were no nails visible at all. This is often the result of installers trying to blow through an installation as fast as possible, machine-gunning their way across the roof with pneumatic roofing nailers. When this happens, the likelihood for overdriving nails and driving nails crooked increases (see Properly Driven Nails, top right).

In high-wind regions and on steep roofs, a six-nail pattern is required to reduce the risk of blow-offs (see Shingle Nailing, facing page, left).

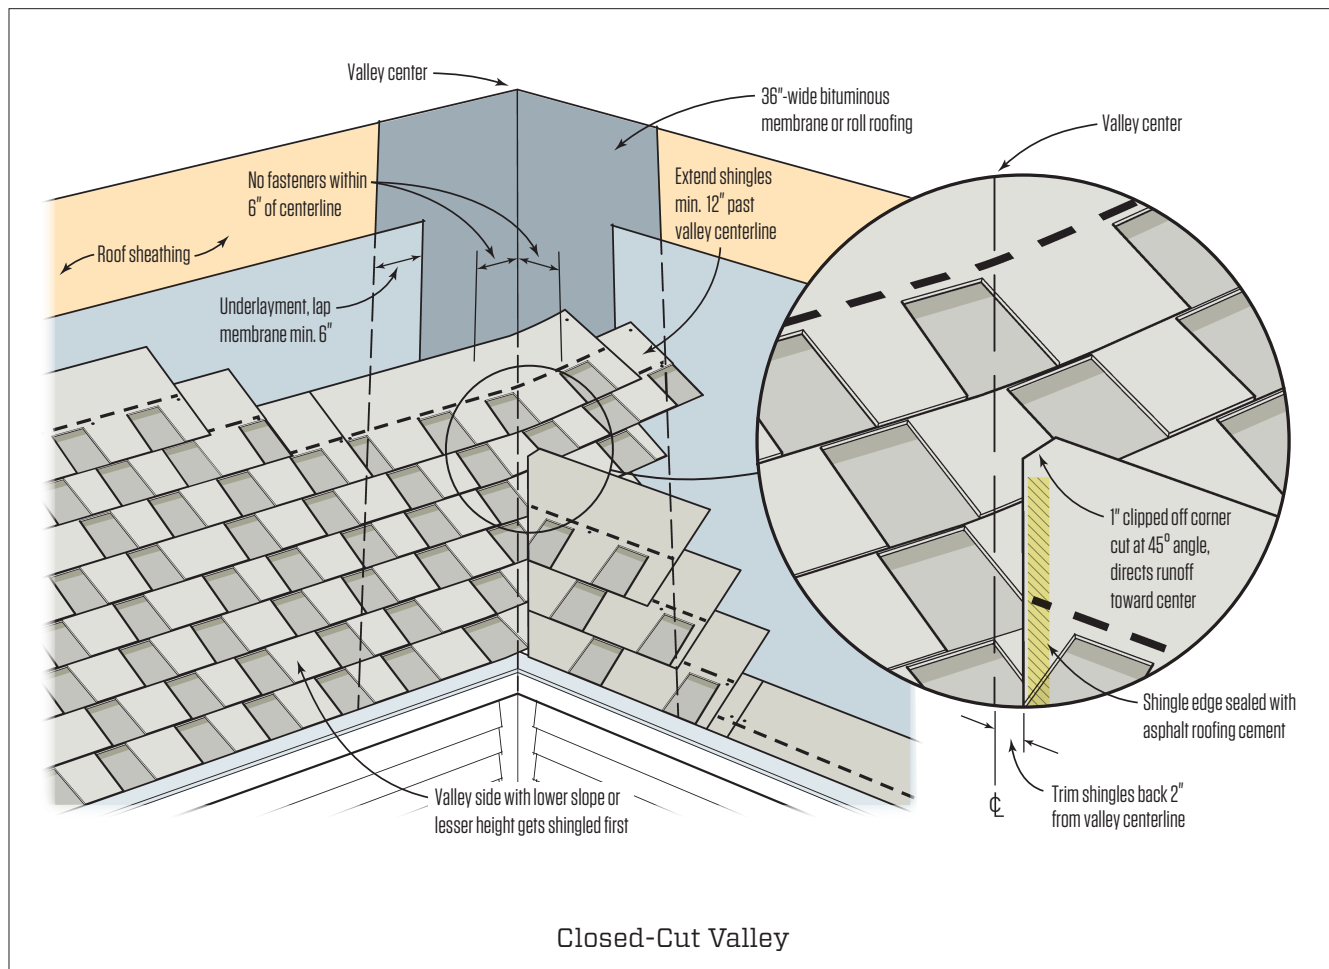
All valleys, regardless of type, should be lined with a minimum 36-inch-wide peel-and-stick membrane. This membrane should be run with the width of the material centered along the length of the valley. The peel-and-stick needs to be installed directly to the roof sheathing before a roofing underlayment is installed.

The majority of roofs in my area have closed-cut valleys, which only require a cut along one side of the valley and can be installed relatively quickly. The right way to do these is shown in the illustration above.

The two most common errors with closed-cut valleys are failing to take the time to seal down the cut edge with roof cement, and failing to clip the top corner of the shingle at the top of the cut (see detail bubble in Closed-Cut Valley, above).

Clipping the leading corners on a closed-cut valley is almost never done around here, even though it is very important. As water runs down the valley, it tends to get pulled in by the acute angles at the top edge of each course of shingles along the cut edge of the valley. These points can divert water down the concealed top edge of each shingle course. When the corner is clipped, the water will still slosh onto the corner, but now the edge is pointed into the valley and water is much less likely to run along the top edges of the shingles.

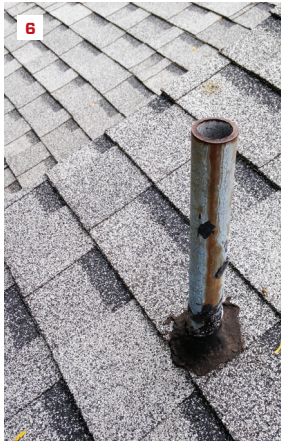
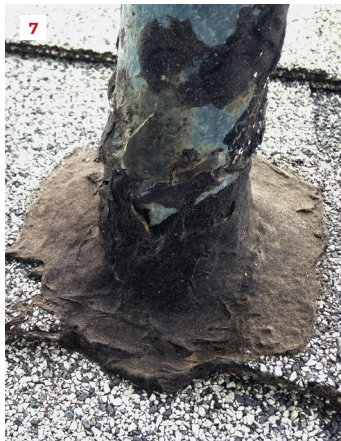
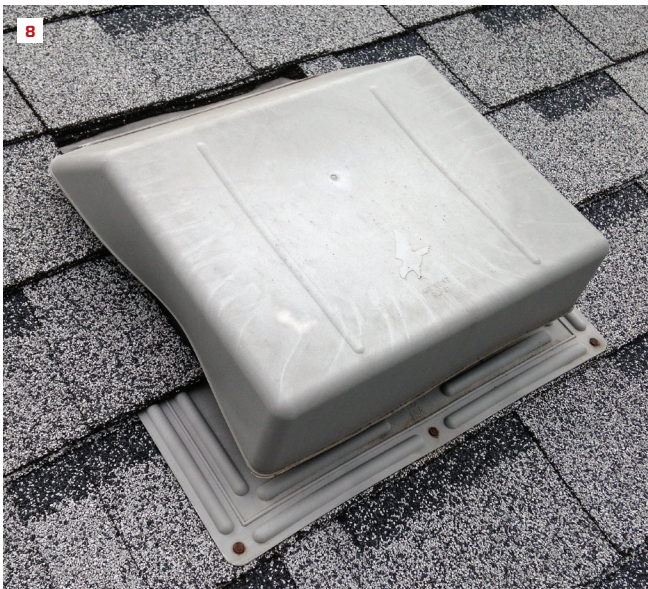
Penetrations. “Black jacked” plumbing vents are all too common, but this is not a good way to flash a roof penetration (6). Roofing cement dries out and becomes brittle and will crack. Also, gaps and thin spots open up as the cement dries out and these essentially create funnels running straight into the roof assembly (7). Also shown here is a very poor installation of a self-flashing roof vent (8). The shingles were not cut carefully around the vent but were instead jammed up against the vent, distorting the hood.

Any roof penetrations, including plumbing vents, roof vents, chimneys, and skylights, present direct opportunities for leaks. Plumbing vents and pop-in roof vents are the most common problem areas, and unfortunately, on a lot of reroofs, very little effort is paid to these other than cutting the shingles around them—usually quickly, while running shingle courses.

That, of course, does not justify not installing a proper plumbing boot, but it does speak to the idea that selling a quality roofing job begins with educating the client about long-term roofing performance issues. This will be an uphill battle, particularly as DIY home-improvement media continues to push oversimplified ideas of what it takes to remodel a home.
