# EXTERIORS

## Repairing Stone Patios Over Living Space Thorough waterproofing is essential for a leak-free job

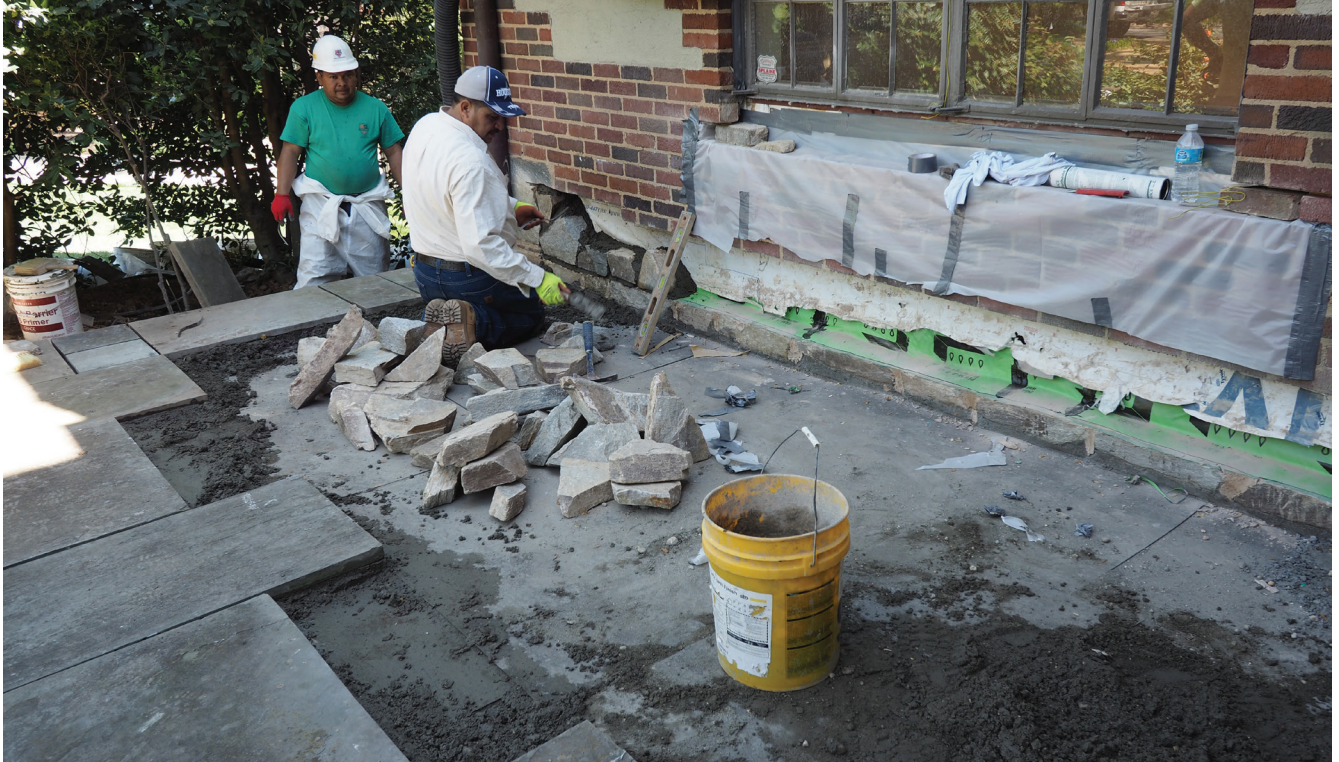
In the example shown under repair in the photo above (and also on page 49), the original patio had flagstones set in a mortar bed on top of an 8-inch reinforced concrete slab, which in turn was supported by basement foundation walls at the ends, and steel I-beam girders in the middle. In the example shown on pages 45 through 48, the slab

At those complicated intersections, the waterproofing and flashing details require considerable thought, careful planning, and careful execution. The drawing on page 48 and the photo above show our preferred way to handle this condition, and reflect how we repaired each of these wall-to-roof intersections. But that’s not what we originally found when we tore each example apart.

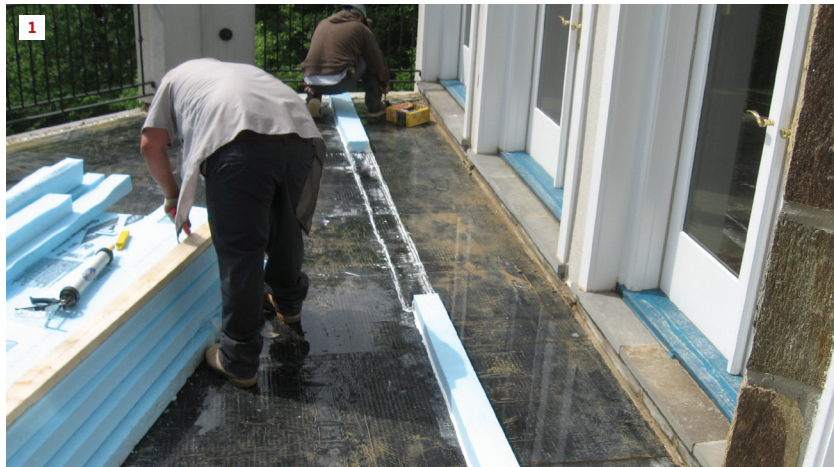
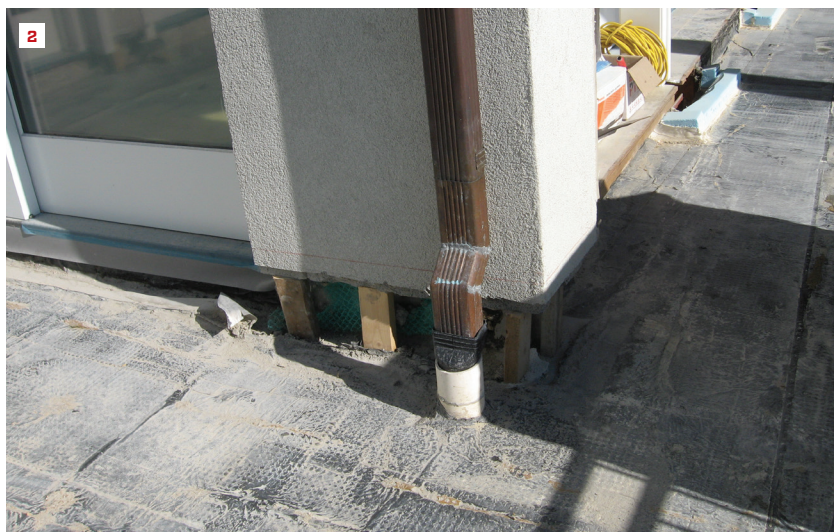
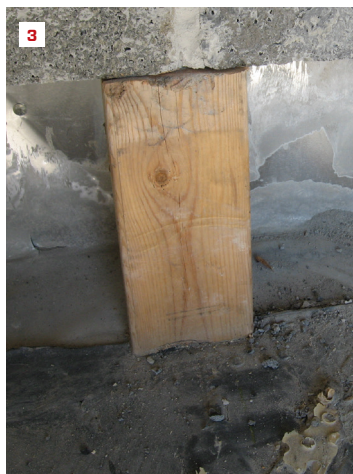
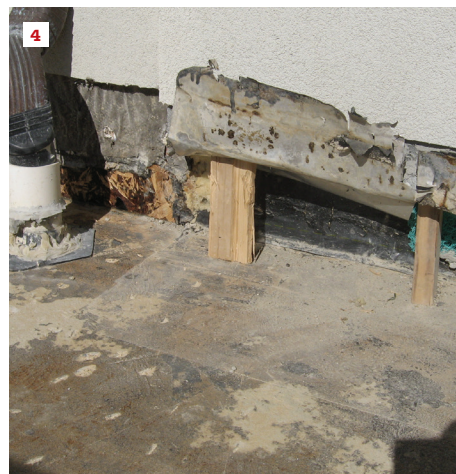
With the stone pavers removed, the crew conducts a test for leaks, focusing on the critical locations where the patio meets the house wall. They build a low dam using strips of foam caulked to the existing waterproofing, and flood the roof edge (1). After observing leaks at the wall joint, the crew strips away a portion of stucco and the lowest course of concrete masonry to reveal the flashing and waterproofing, supporting the block wall with pieces of 2x4 (2, 3). The joint where the rubber roofing met the masonry is seen to be compromised, and aluminum flashing behind the block is corroded and leaky (4).

In the case shown on this page, we removed the stone patio, mortar, and dimple-sheet drainage board (which left little circles all over the bitumen-sheet waterproofing). We could not see weeps or flashings in the masonry veneer on the walls, so we tested the intersection of the wall and terrace with water: We built a little dam near the wall, gluing strips of foam insulation to the roof membrane with adhesive caulking. Then we added water with a garden hose to create a shallow pool by the wall, and checked for leaks below the roof. Sure enough, water began to drip from the ceiling in the room below.

Next, masons removed the lowest 12 inches or so of masonry (4-inch block with a stucco veneer) and temporarily supported the block walls with short pieces of 2x4. The previous contractors had applied waterproofing to the flat concrete sub-deck,

then a piece of coil stock flashing was placed on top and bent up the wall. Housewrap on the wall was tucked behind this flashing instead of in front as it should have been, but that probably didn't matter—because water was free to run across the waterproofing and into the wall underneath the aluminum flashing. Also, aluminum flashing will corrode in contact with masonry. That process was well underway in exposed areas.

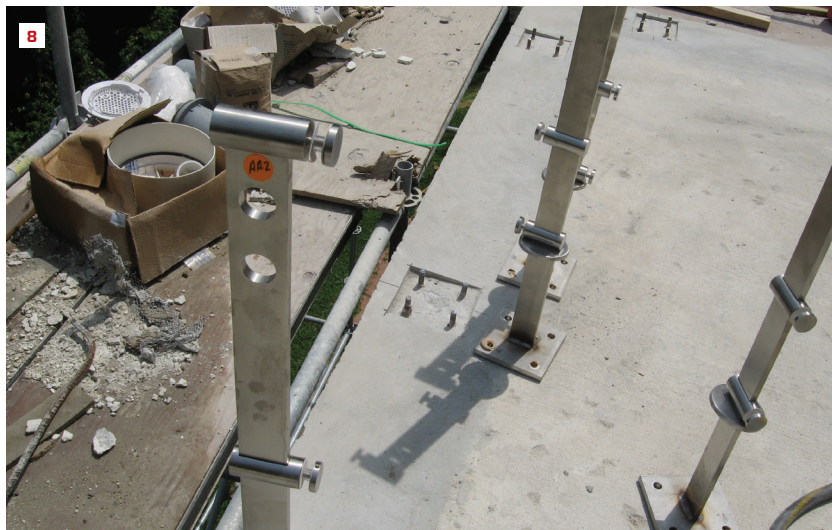
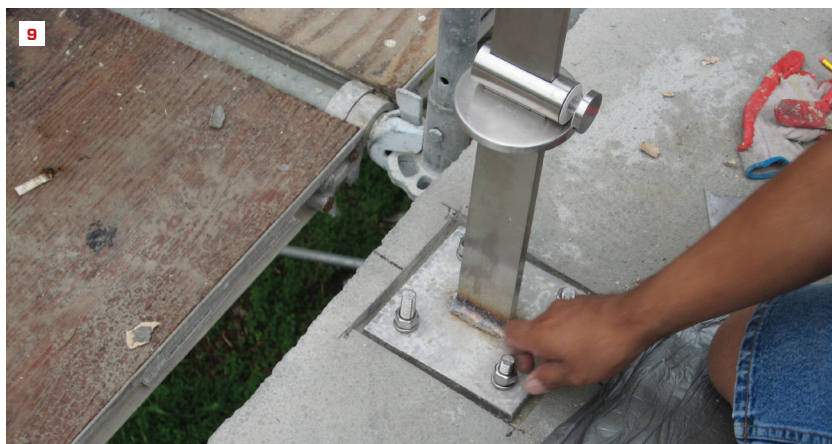
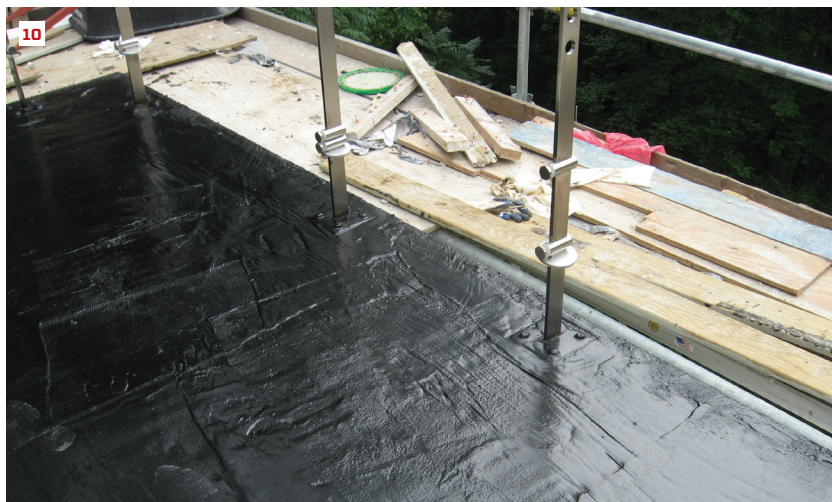
**Railing post bases** are a common source of leaks in a rooftop patio. One typical practice that can create a leak point is to drill holes and set anchor bolts after waterproofing is applied, penetrating the waterproofing. The author's preferred method is to set the bolt in the concrete before waterproofing (8). Next, the metal-post base plate is connected to the bolts. (9) A coat of primer is applied to the metal and the concrete, and finally the reinforced rubberized asphalt is applied over the post base for a robust waterproof seal (10).

Railing mounts are a typical trouble spot on a masonry patio. For a patio on grade, railing companies often come to the job after pavers are installed and drill holes through the pavers into the concrete, then cement the rail-post bolts into the holes. That's not a problem if there's nothing under the patio but ground. But if they do that on a waterproof roof deck, it will make a hole in the waterproofing, and there will be a leak into the space below.

When you need to preserve effective waterproofing, one good approach is to mount the railing posts before doing the waterproofing, or at least set pins for mounting the posts. That's what we did in this case (see photos, right): The crew set stainless steel bolts into the concrete, then mounted the post bases in place, before applying Henry primer and two coats of rubber to the deck.

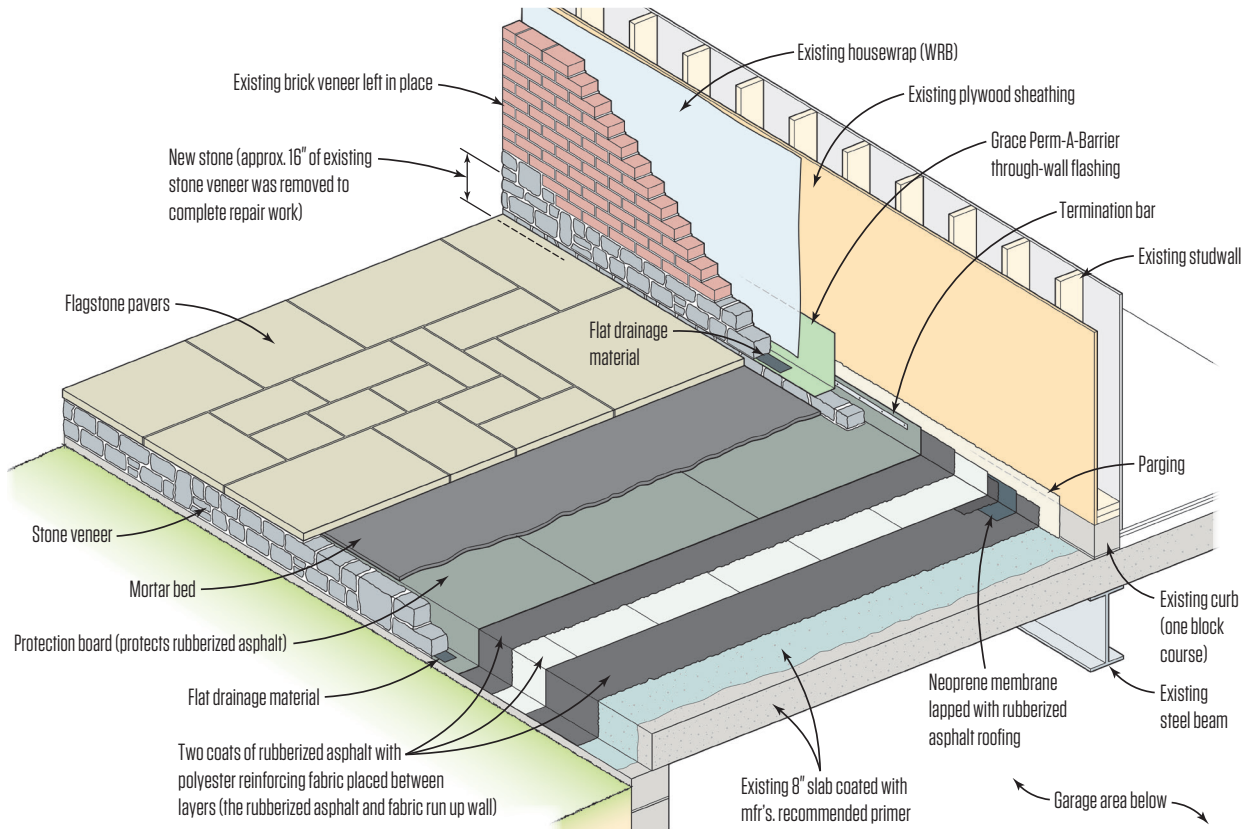
## Patio Waterproofing Over Basement Garage

**Protection at the transition.** In the author's preferred detail, fiber-reinforced rubberized asphalt membrane extends from the slab up onto the wall sheathing, with neoprene rubber flashing embedded in the hot asphalt at the corner. Protection board on the patio also extends up the wall and is secured with a mechanically fastened termination bar. After the base course of masonry is set, a through-wall flashing and weeps are applied to direct moisture from the wall masonry out to daylight.

The drawing above depicts the typical solution that we've developed over time for masonry paver decks over living space, based on the recommendations of materi-

The joint between the wall and the concrete slab is the critical point. Ideally, we address that situation with the dual-flashed assembly shown above. The reinforced fluid-applied waterproofing adhered to the concrete slab extends all the way to the pre-primed wall and laps up onto the wall, secured with a termination bar that will hold the material even if adhesion fails. Dimpled drain board or a fiber protection board—or both—improves drainage and protects the waterproofing.

A base course of wall masonry is laid on the waterproofed slab. Next, a through-wall flashing membrane is applied to the top of that base course and lapped up onto the wall. The wall's weather-resistive barrier (WRB) is lapped down over the flashing. Then more courses of masonry are laid, with weeps provided for drainage above the through-wall flashing.

With this assembly, water in the wall cladding is directed out of the wall onto the surface of the patio. The waterproofing beneath the patio, extending up onto the wall, provides a second line of defense.

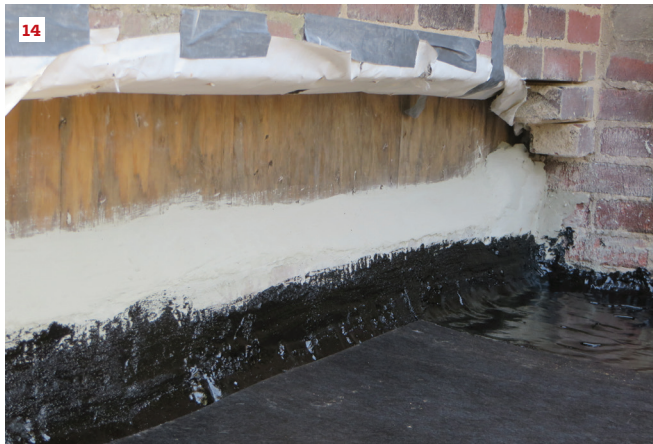
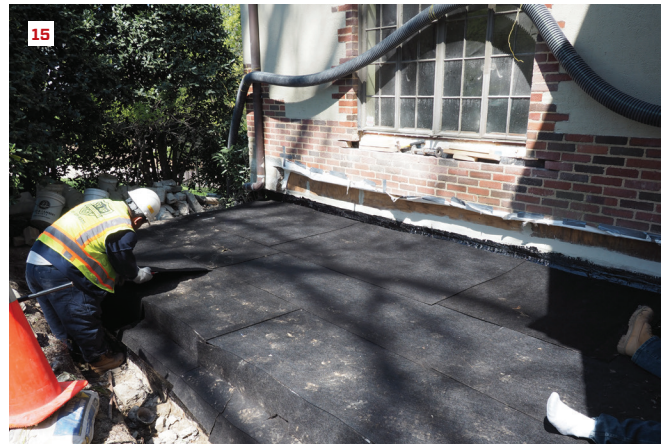
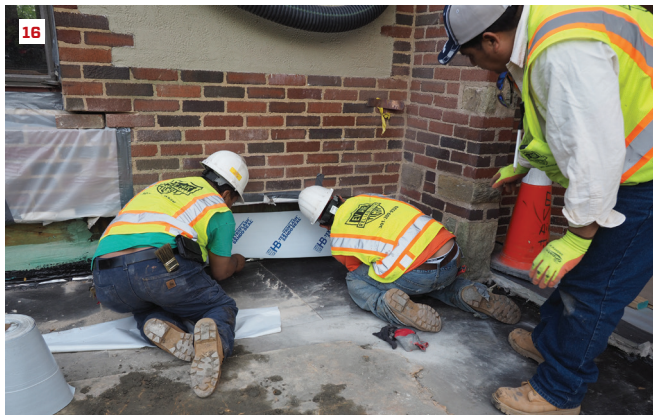
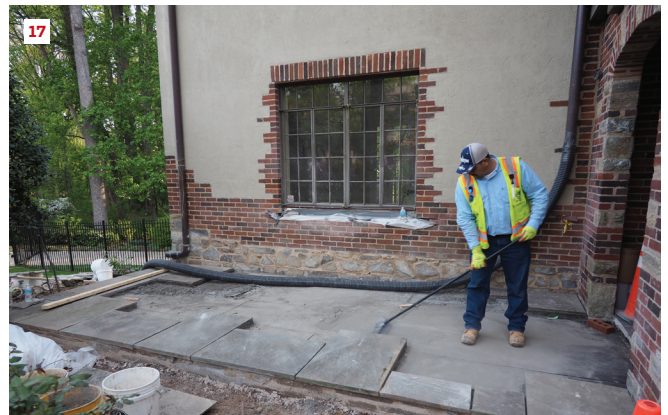
The photos above show the retrofit sequence for a grade-level patio over a basement and garage space. Hot-applied rubberized asphalt is applied to the concrete deck and lapped up onto the primed plywood wall sheathing (14). A course of protection board is laid over the waterproofing (15). Flashing membrane is applied to the wall as a backing for the new stonework (16), then a base course of stone is set against the flashed wall (see photo, page 43). Another through-wall flashing is installed before upper courses of stone are laid (leaving weeps that allow the wall to drain). Finally, new pavers are set into a fresh mortar bed (17).

In the example shown above (and in the photo on page 43), the patio is located at grade, but it's not sitting on the ground—it's over occupied space. The room at the back of the patio is built over a basement-level garage, which extends past the room on both sides, so there is a 10-foot patio over the garage on either side. Like our earlier example, this patio was leaking into the space below because of ineffective waterproofing and flashing at the patio-to-wall juncture.

that intersection. In photo 14 above, the crew has taped back the housewrap, primed the plywood wall, and applied rubberized asphalt to the slab and up the wall. Next, they laid down sheets of fibrous protection board, which allowed the masons to rebuild the wall masonry without getting themselves covered in the soft, sticky asphalt, and then to pave the patio without damaging the waterproofing.

The masonry detail at the wall base includes two layers of fully adhered flashing. Before the base course of stone was set, masons applied a peel-and-stick mem-

brane to the wall, lapping it onto the hot-applied asphalt. After setting the base course, they installed a through-flashing membrane over that course, lapping up under the WRB.

This relatively small patio had a good pitch, and so we decided it would be safe to omit the layer of dimpled drainage sheet. So in this case, the masons installed their mortar bed directly on the protection board.
