## Blower Doors and Energy Retrofits

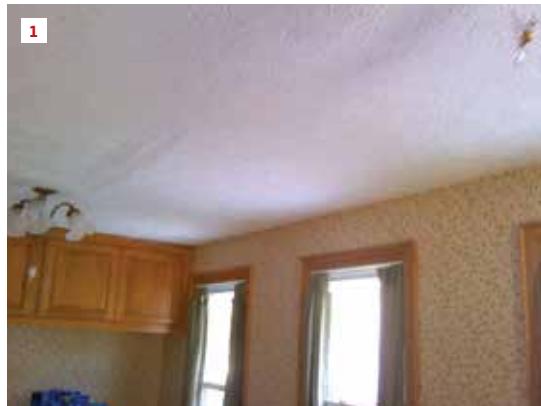
Combined with a blower door, an infrared camera can reveal cold air leaks. While the naked eye can see a water stain on the ceiling (1), the infrared image reveals the reason for the ice dam that caused it: heat loss through the ceiling and roof of the kitchen bump-out (2). In the bonus room over a garage, a cold wall and floor brought comfort complaints (3). The infrared camera revealed the cold air infiltration's leak point (4).

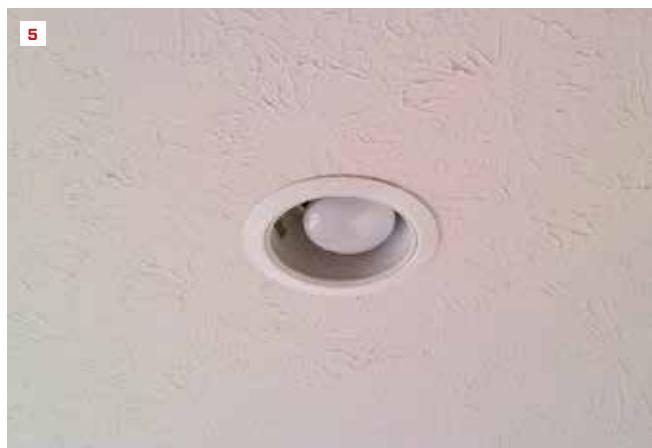
Recessed light fixtures in ceilings (5) are a common source of heat loss in modern homes. When a house is depressurized with a blower door, the infrared scan reveals tell-tale “fingering” as cold air gets pulled along the ceiling (6). Many older can lights of this type are not rated for contact with insulation. In that case, the repair involves building a sealed box of rigid foil-faced insulation around the fixture, making sure the box is large enough to provide the required air space (7).
