# Saving a Hilltop Pool

**This engineered solution includes a cantilevered concrete slab supported by pan decking and a repaired retaining wall**

by Ray Petrin

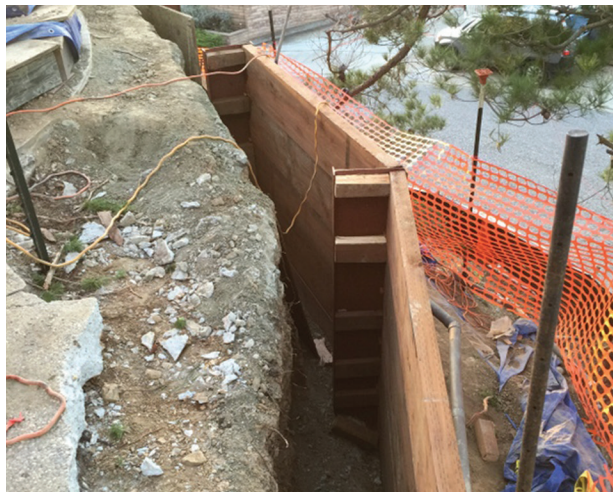
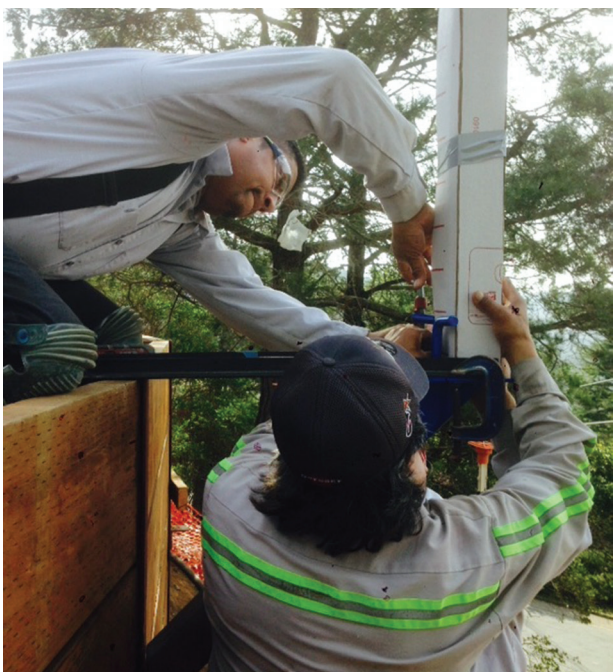
**Figure 1.** The existing concrete slab flanking the edge of the pool was demolished to expose the steel columns supporting the retaining wall. Blocks held the new 3x12 PT timber laggings in place until the excavation could be backfilled (top left). The prefabricated guard-post assemblies were temporarily clamped in place, then welded to the columns (center left). Horizontal steel tubes welded to both the columns and the guard posts stabilized the posts and helped support the Formlok panels when the concrete was poured (bottom left).

After we completed demolition and exposed and inspected the I-beams, it turned out that only one (out of 17) had damage that required repair. That consisted of a 2-inch hole that we repaired—to stronger than new—by welding two 8-by-12-by- $\frac{1}{4}$ -inch patches of steel plate onto the I-beam. Then we cleaned and wire-brushed the I-beams, primed them with two coats of metal primer, and installed stout, 3x12 pressure-treated number one or better Douglas-fir timber laggings (**Figure 1**).

To save a great deal of cost, we fabricated and powder-coated off-site the many tubular-steel knee braces that were needed to support the pan deck (all welding for the entire project—except for the pan deck itself—had to be performed by a certified welder, with special inspections). Then the knee braces had to be welded into place onto each I-beam to form the tremendously strong support system engineered to handle the load of the wet concrete that would lie on top of the pan decking.

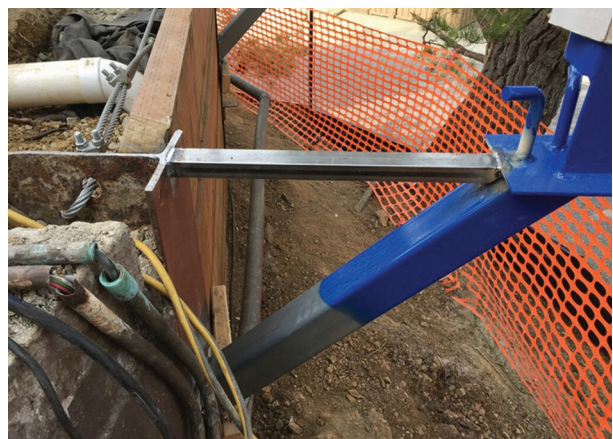
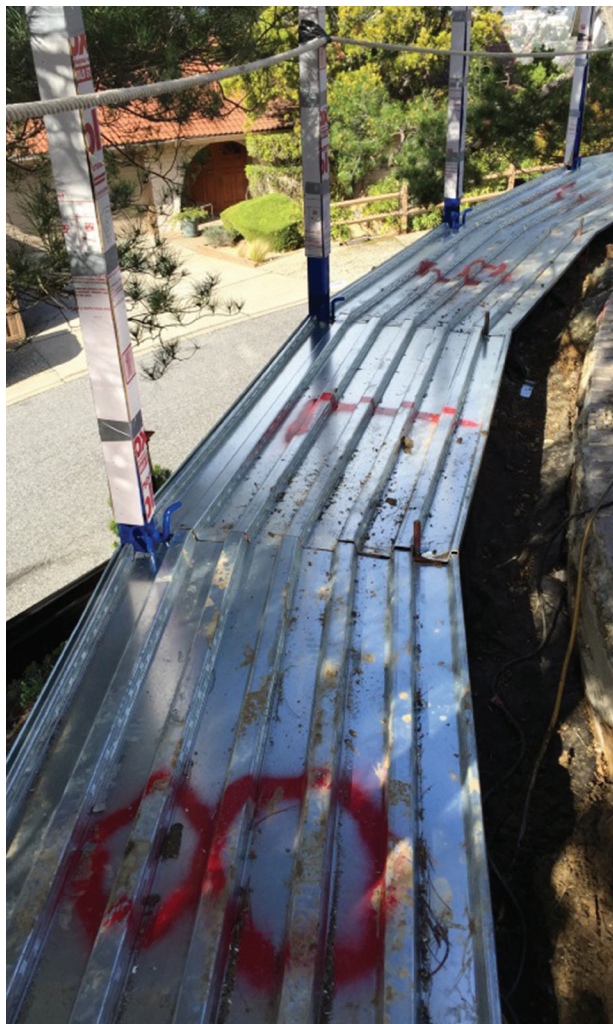
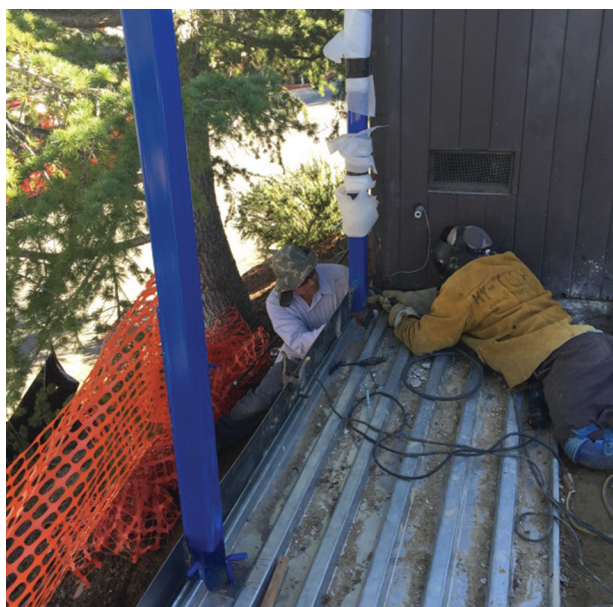
**Figure 2.** After the guard posts were welded to the columns, workers cut and fit the B Formlok galvanized steel panels that would support the cantilevered portion of the new concrete slab (top left). A pour stop of 1/4-inch-by-6-inch steel welded to the posts forms the edge of the slab (bottom left).

The pan decking was needed and installed only in the areas that cantilevered out over the retaining wall (**Figure 2**). Next, we tied up the matrix of steel rebar that would reinforce the slab, as specified in the drawings. When Bob Peek and the crew from Burch Brothers Concrete poured the monolithic slab that tied the whole assembly together, they colored the concrete and stamped it with its finish surface. All of this was done without attaching to the pool at any point, just as the engineer had promised (see illustration, page 28).

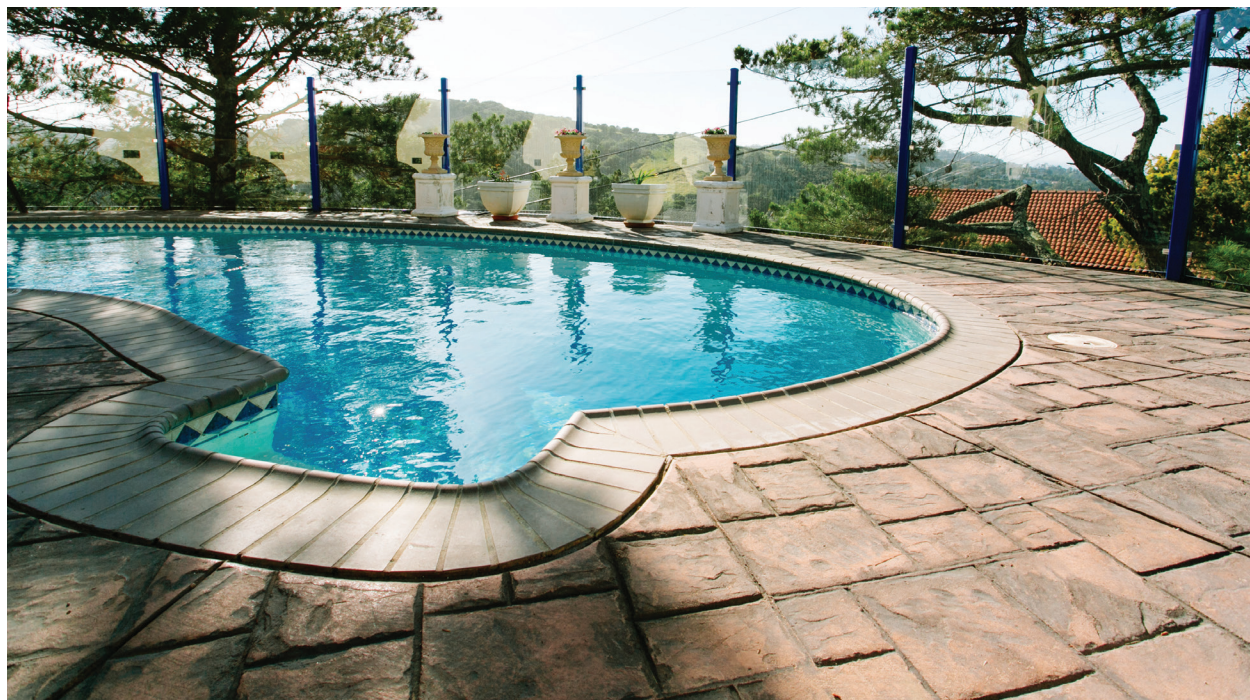
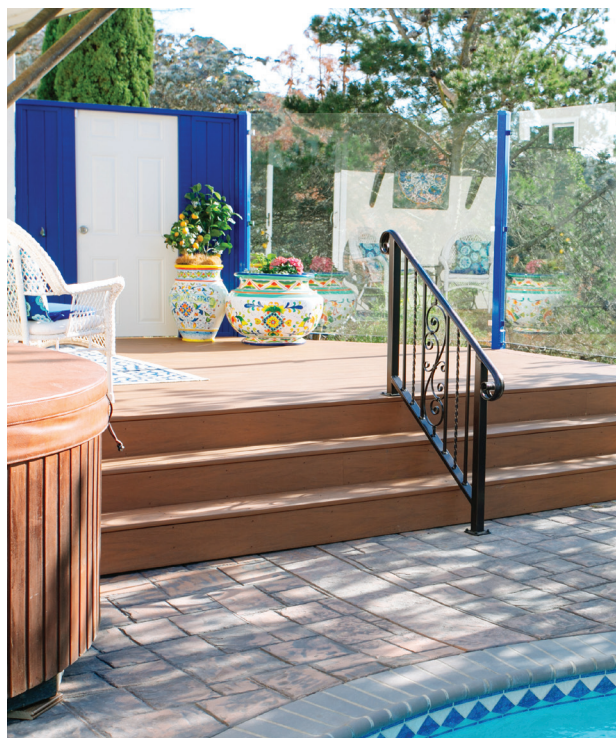
**Figure 3.** Although the new concrete slab is important structurally, it has a decorative colored and stamped finish, flush with the original coping around the gunite pool (top). Partially cantilevered steel framing supports the new composite deck at one end of the pool (above).

Meanwhile, we framed a new deck at the end of the pool, which we later finished with Azek composite decking, again taking advantage of a cantilever design concept. Using the I-beam retaining wall and various tubular steel arms, knee braces, and additional pressure-treated supports, we cantilevered the deck out over space. Much of the steel work was non-welded and consisted of drilling holes through the steel and then mechanically fastening the components together with bolts, a technique that we've often used on other hillside projects in the San Francisco Bay area.

the owners, our structural engineer, Dave Capps of D.J. Capps Glass Company, and me—consists of blue powder-coated engineered 3-inch-by-3-inch steel posts and chrome-plated shower panel brackets, with the backs machined on the various angles required to compensate for the radius of the pool. The 6-foot-by-6-foot by  $\frac{3}{8}$ -inch-thick tempered-glass panels rest on rubber support pads on metal brackets welded to the posts (**Figure 3**).
