High-Performance Insulated Wall Retrofits

Vapor-open assemblies correct durability and comfort problems while saving energy

HIGH-PERFORMANCE INSULATED WALL RETROFITS

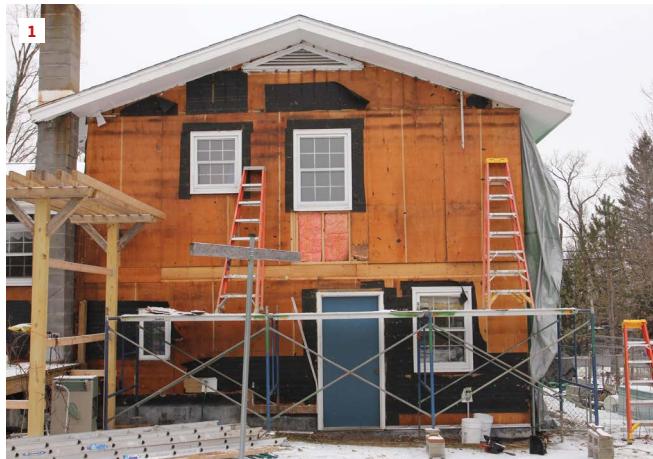
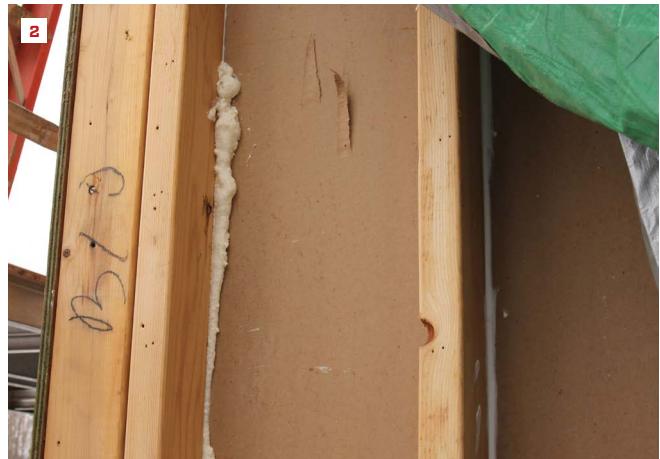
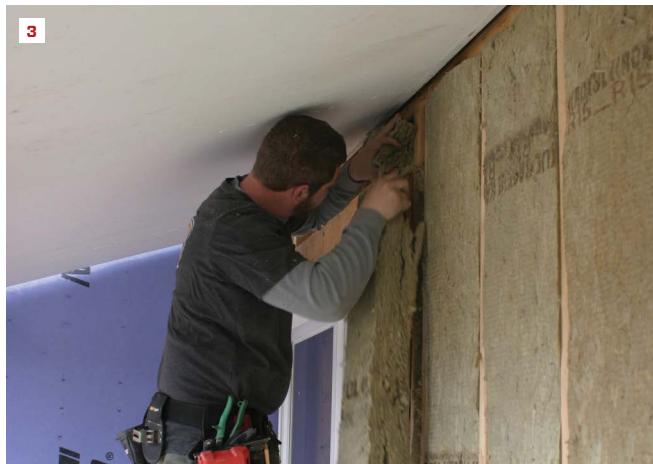
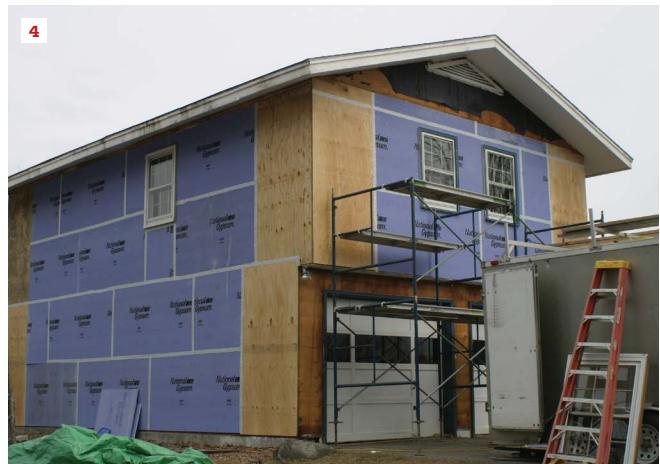
Bradley's crew removed the home's siding and sheathing from outside while the homeowners continued to live in the house (1). They stripped out any poly vapor barrier they discovered, and air-sealed a few obvious leak points using gun foam (2). Then they filled the stud cavities again with Roxul mineral-wool insulation (3). Finally, the crew resheathed the walls using vapor-open materials: National Gypsum Gold Bond eXP gypsum board, and CDX plywood (4).

Bradley decided to remove the home's siding and sheathing from the outside, pull out the cavity insulation, strip away any poly vapor barrier that he encountered, and reinsulate the wall cavities with Roxul mineral-wool batt insulation. Next he would

After carefully reinsulating the stud cavities, Bradley's crew resheathe the wall—not with OSB, but with plywood at the corners and Gold Bond eXP gypsum board sheathing in the field. The plywood at the wall corners is for structural bracing of the walls, Bradley explained, while the eXP gypsum board is chosen primarily for its vapor-transmission characteristics. Panel joints are taped for airtightness, but this step also is not strictly necessary, Bradley said, because the Siga Majvest applied later as a drainage plane, and sealed with tape at the seams, is substantially airtight.

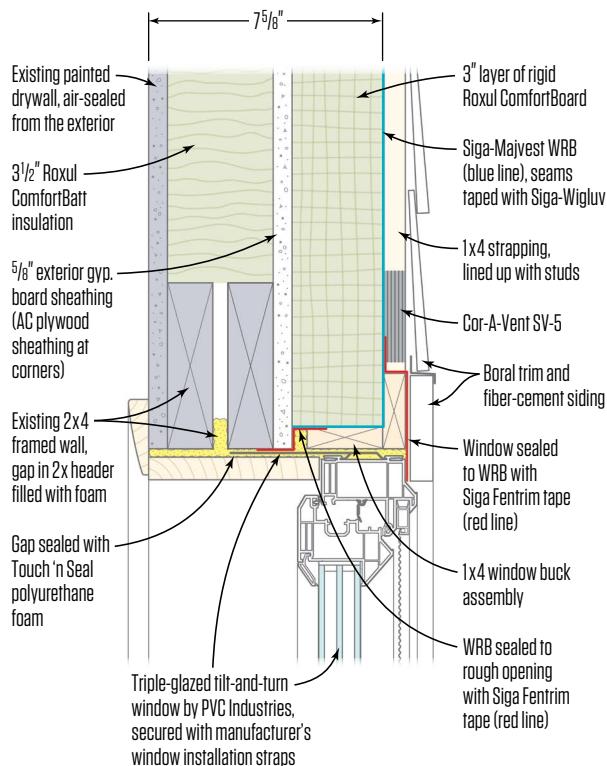
2x4 Wall (Work Done From Exterior)

Bradley's two wall-reconstruction projects followed different pathways to a similar result. In the first case (above left), the crew removed the existing plywood sheathing from outside, reinsulated the cavities, then resheathed the wall with vapor-open material. In the second case (above right), they opened the 2x6 wall from the inside to reinsulate the cavities, but left the existing sheathing in place. In both cases, they insulated over the wall and constructed a vapor-open, watertight rainscreen.

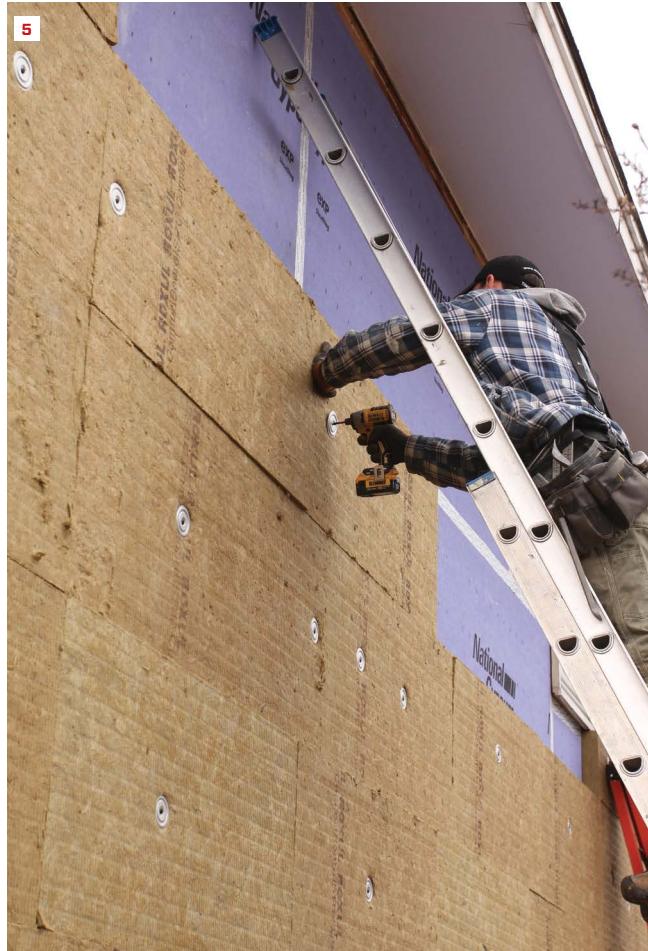
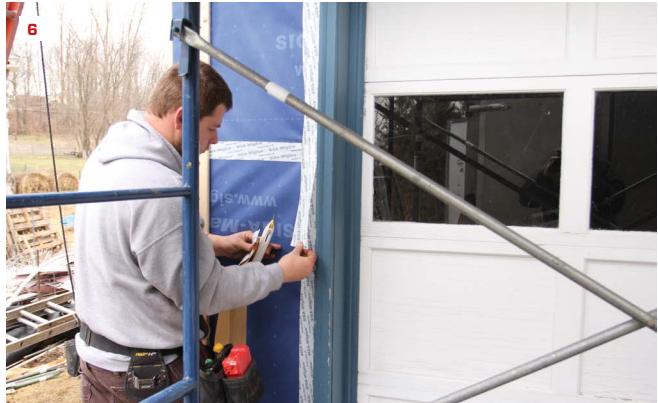
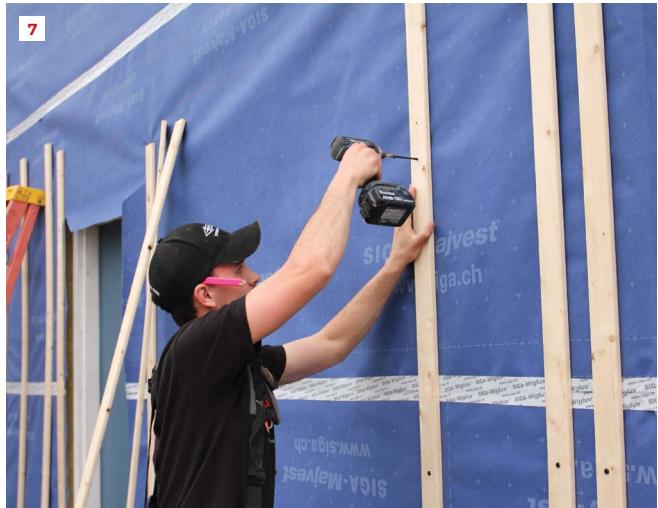
Bradley's crew attached 3-inch batts of Roxul ComfortBoard insulation over the new vapor-open wall sheathing (5). This way, the sheathing would be kept warmer in winter, further reducing the risk of vapor condensation. The crew covered the insulation with Siga Majvest membrane, taping the membrane seams (6) to maintain airtight protection for the insulation, while still allowing vapor to escape. Next, the crew applied strapping over the sheathing (7) to create a rainscreen air space.

ComfortBoard. The crew fastened the ComfortBoard with long screws and washers, using just enough screws to hold the batts in place. Then they applied the Siga Majvest, taped the membrane's seams with Siga Wigluv tape, and strapped out the wall with 1x4 strapping. To fasten the strapping, the carpenters used screws long enough to go through 3 inches of Roxul and the $\frac{3}{8}$ -inch sheathing, and sink 2 inches into the wall framing.

The Roxul in the walls' 2x4 cavities is rated at R-15. The extra 3 inches of ComfortBoard, rated at R-4 per inch, boosts the wall's R-value by R-12, for a total of R-27. The exterior ComfortBoard blanket also keeps the wall's plywood and gypsum board sheathing warm, reducing or eliminating the risk of vapor condensation at the sheathing plane. And because the material is vapor-open, it allows moisture that passes through the plywood or gypsum board

to continue outward and escape to the exterior. The watertight Siga Majvest membrane is also vapor-open: Rated at 68 perms, it is the most vapor-permeable material in the wall.

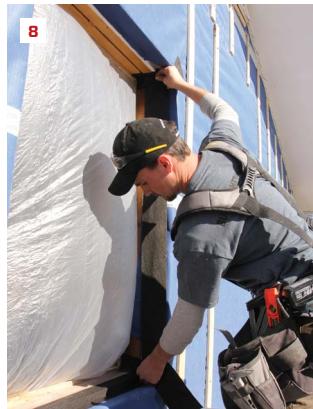
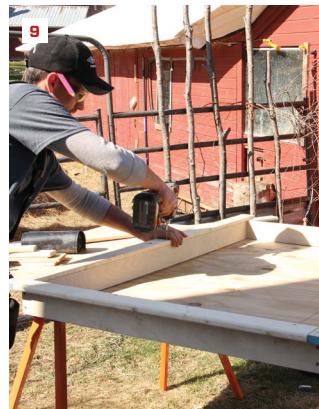
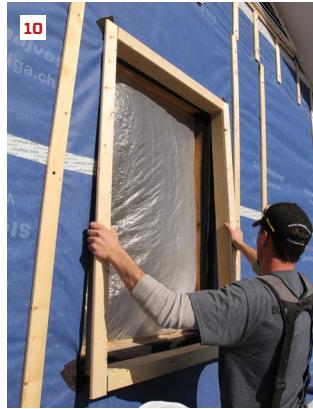
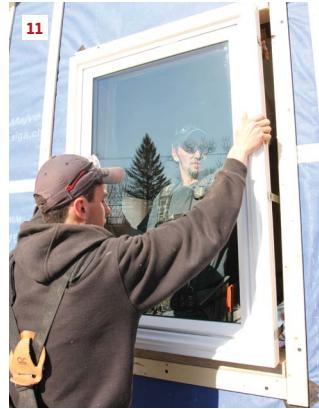
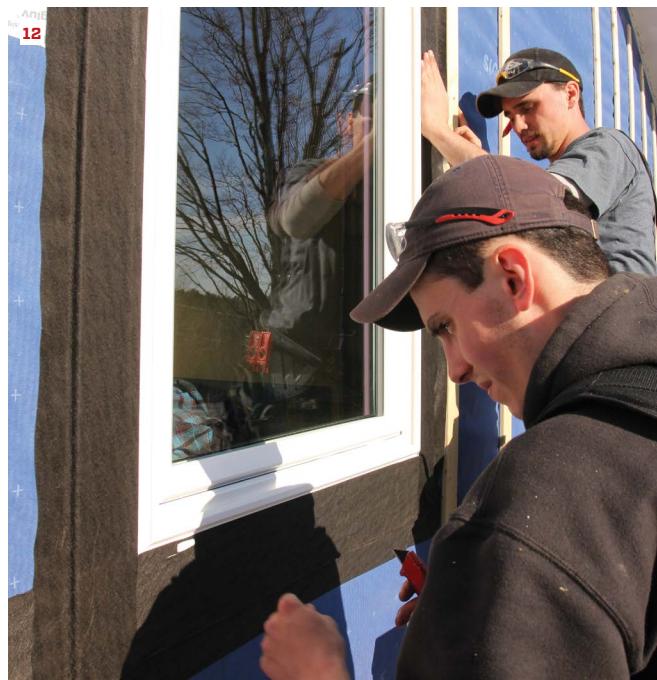
The carpenters taped the Majvest membrane to the windows using vapor-open Siga Fentrim tape to make this juncture airtight and waterproof (8). They assembled window framing bucks on a worktable next to the building (9), then installed the bucks into the rough openings (10). They installed the triple-glazed vinyl windows flush to the outside face of the wall (11), and taped the window edges to the vapor barrier with Fentrim tape (12).

With the basic wall build-out complete, Bradley's crew got ready to install windows. The first step was to wrap the Siga Majvest into the window openings and connect the membrane to the window's rough framing with Siga Fentrim vapor-open waterproof tape. Next, the carpenters assembled window bucks from 1x4 stock and strapping and set the bucks into the rough openings. Then they set the window units into the openings and sealed the windows to the drainage plane with Fentrim tape.

For this project, Bradley chose to install the windows flush to the outside face of the building. "It gives the customer a bigger windowsill on the inside," he explained. "We have found that if we install the window more to the interior of the wall surface, and you have a bigger windowsill on the outside, it's a great place for animals to sit. But, it gets dirty too. The building-science side is, if your window is more to the middle, it's going to perform a little bit better. But that's a negligible difference."

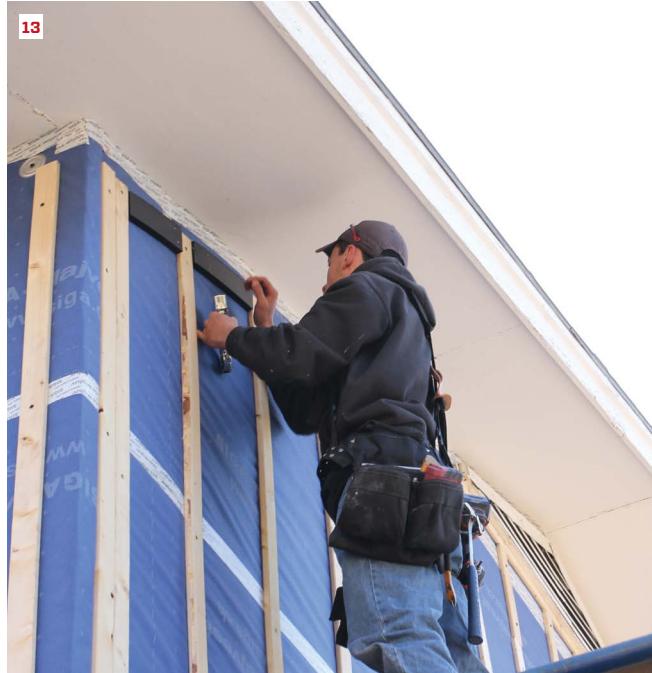
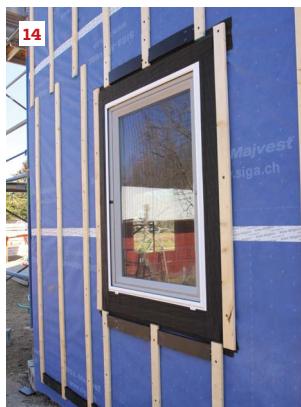
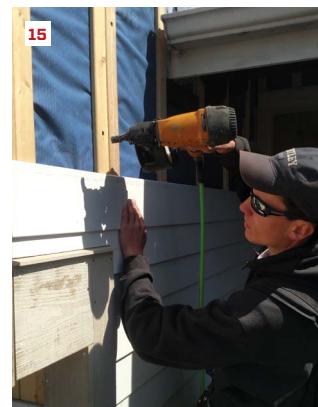
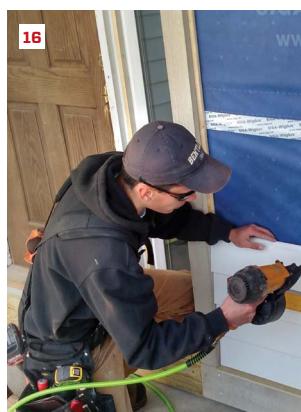
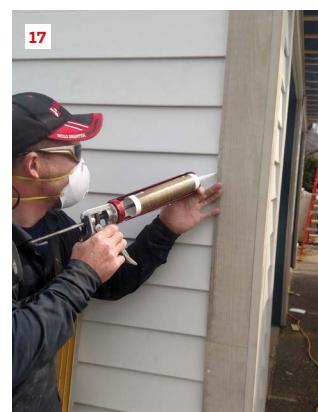
The **3/4-inch air gap** behind the siding is open to air-flow at the top and bottom (facing page), but protected from insect intrusion with Cora-Vent **(13)**. Cora-Vent was also installed above and below the windows **(14)**. The crew installed Boral trim and HardiePlank siding over the strapping **(15, 16)**, caulking HardiePlank joints according to the manufacturer's instructions.

Over the strapping, Bradley's crew applied Boral trim and HardiePlank fiber-cement siding. But first, the carpenters installed Cora-Vent at the tops and bottoms of the walls and also above and below the windows.

important, whether you do anything else for efficiency or not. Even if you are just replacing your siding, you need to put a rainscreen in there." Bradley recommends a minimum $\frac{3}{4}$ -inch gap behind the siding to allow air convection. He installs the Cora-Vent to keep insects out, he explained: "It's honeycombed through the vertical section, providing some structure with breathing channels, and it has felt on one edge. You install it with the felt side down at the bottom, and with the felt side up at the top."

The HardiePlank is a prefinished, wide lap siding chosen by the customer, Bradley said. It's important to follow the manufacturer's instructions carefully when you install fiber cement, he noted: James Hardie's specifications include caulking the ends of boards where they butt into the corner-board trim, but leaving an uncaulked gap, backed by flashing, at joints in the field.

For trim at the wall bases and corners, Bradley installed Boral, a composite product that is 70% recycled fly ash (a coal-burning power-plant byproduct), bound together with fiberglass and polyurethane.

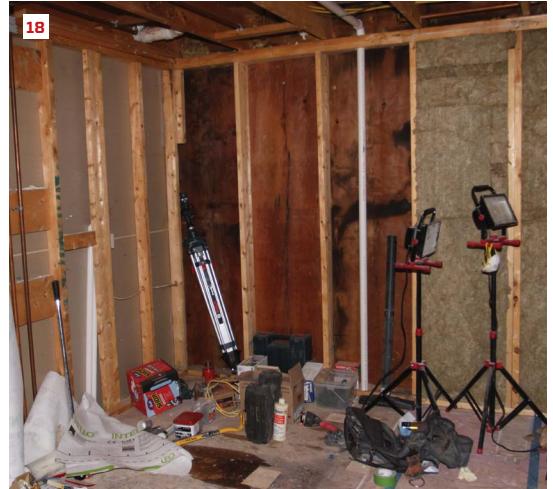
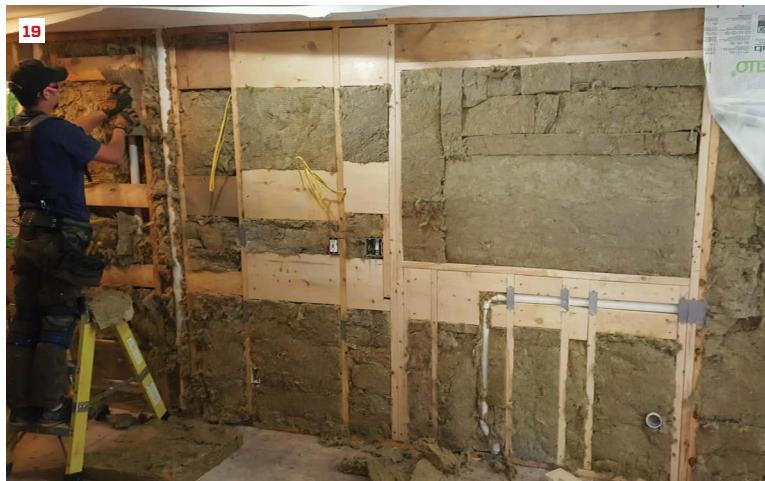
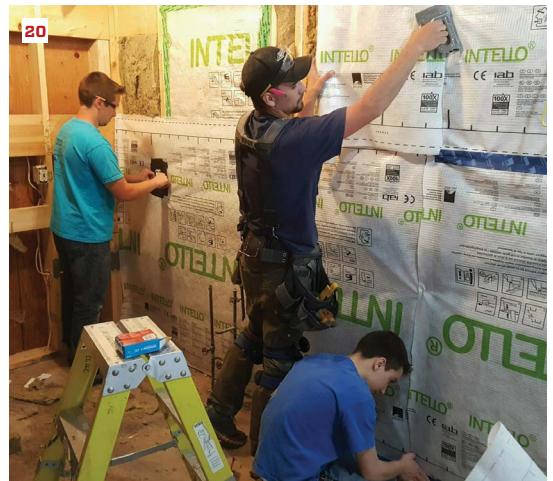
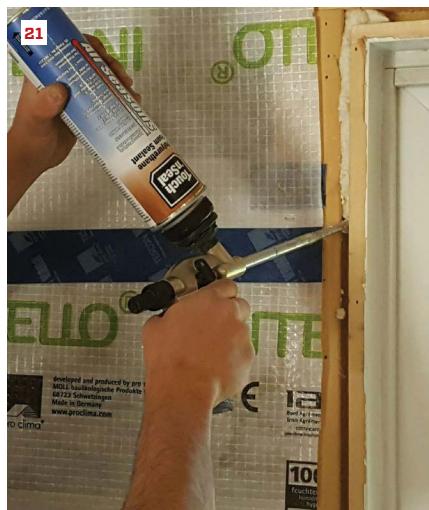
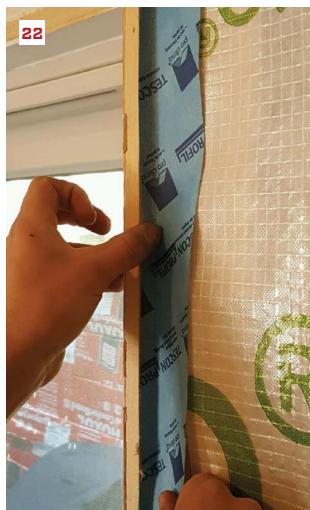
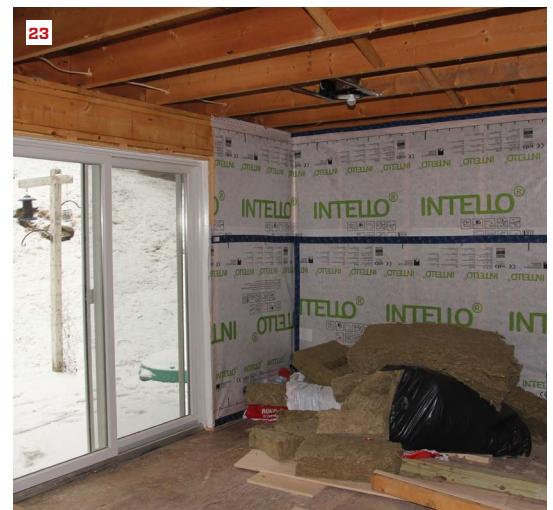
For a second, similar project, Bradley chose to demolish and rebuild the wall from the inside out. The wall sheathing was found to be blackened by mold in some areas **(18)**. The crew reinsulated the walls with Roxul **(19)**, then applied Intello smart vapor-barrier membrane to the walls **(20)**. They filled cracks around the newly installed windows with low-expansion gun foam **(21)**, then taped the Intello to the window edges using Pro Clima Tescon Profil tape **(22)**. The reconstructed interior air barrier **(23)** prevents outward vapor diffusion or air transport of moisture, but allows inward drying of the wall if the framing or sheathing do become damp for any reason.

For a major remodel of another house, Bradley chose a different pathway: He gutted and reinsulated the walls from the inside out. The 2x6 wall had fiberglass in the cavities, building paper on the outside, and poly behind the drywall, Bradley reported, "and the area we opened up in the old section—and this was only 1989 construction—was full of black mold, and a lot of rodent activity as well."

Bradley replaced only one section of plywood, which was badly damaged and behind a shower. The rest of the wall sheathing was cleaned and left in place. The cavities were reinsulated with Roxul. Then Bradley took advantage of the exposed interior to install Pro Clima Intello, a variable-permeability vapor-control membrane that adjusts to ambient conditions, keeping vapor out of the walls in winter but allowing vapor to escape into the house during summer.
