## Replacing a Rotted Rim Joist Behind Brick

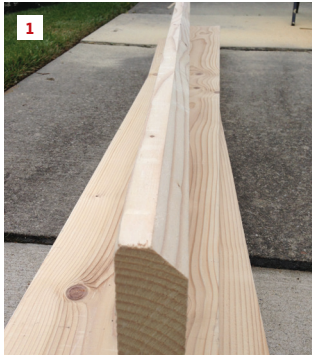
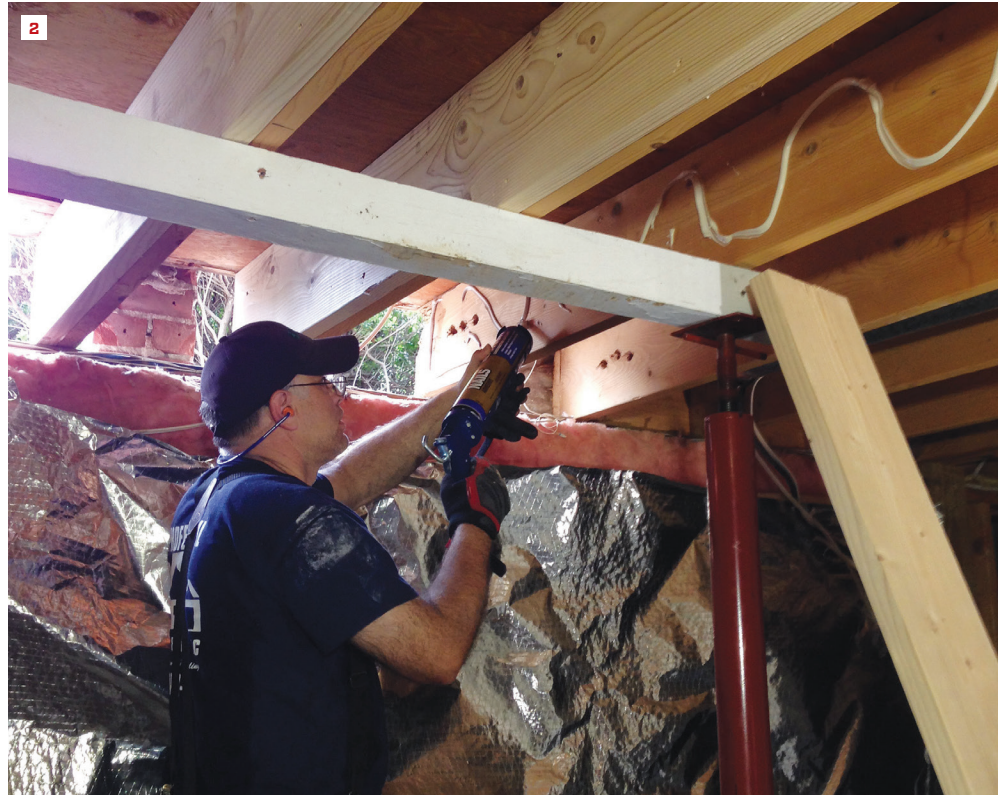
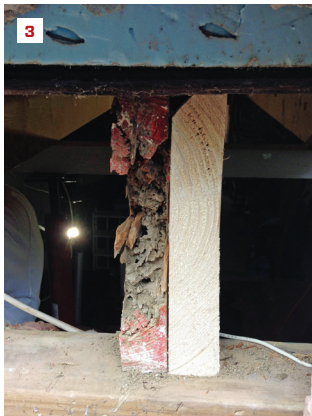
To repair the termite-damaged joist ends, the author needed to sister-on new joists. To simplify getting these new joists between the sill plate and the floor, he first rip-beveled one edge for the length of the joist (1). He then applied construction adhesive to the old joists (2). After threading the new joists past the temporary support and into position, he rolled the new joists into place against the old ones (3).

After removing the damaged rim joist, we cut our new floor joists so they could be sistered to the existing ones. Given the tight quarters and the fact that the new joists had to rest on top of the sill plate, we cut the inside edge off of each joist. This simple step permitted us to set the new joists on the sill plate and simply roll them into place with minimal prodding from a hammer. Prior to installation, we applied construction adhesive followed by clamps to insure a good marriage between old and new work, and then nailed the two joists together in a staggered nailing pattern.

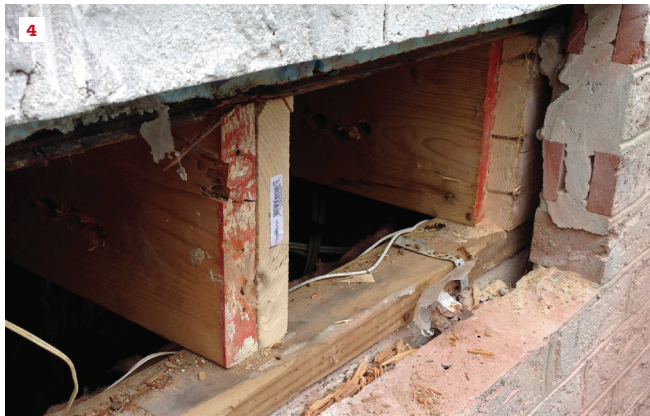
The rim joist completely crumpled, the surface being paper thin while the rest of the material had been hollowed out by termites. It was bad. I estimated that approximately 10 feet of rim joist and as many as five floor-joist ends had been completely destroyed. To make matters worse, this area was near the home's 200-amp panel box and all of the wiring to the home ran through the damaged floor joists. I took copious

The termite damage was isolated to one section of the house. The mason had to remove four courses of brick to expose the entire rim joist, which was cut back until only undamaged wood was exposed (4). With all the new sister-joists in place, the author nailed on a new rim joist (5). Before the finish brick was replaced (7), the author applied a flashing membrane to the new rim joist (6) and tucked it up behind the existing weather-resistive barrier that covered the sheathing behind the brick.

Upon receiving the homeowner's approval to complete the work, Nicholson and his crew started first. They cut out a section of brick with a gas-powered concrete saw and a small rotary demo hammer with the precision of surgeons. With the brick out of the way, we were able to confirm that the damage to the rim joist was extensive.
