## Moving a Carriage House How to resite a 15-ton historic structure

BY ELIOT LOTHROP

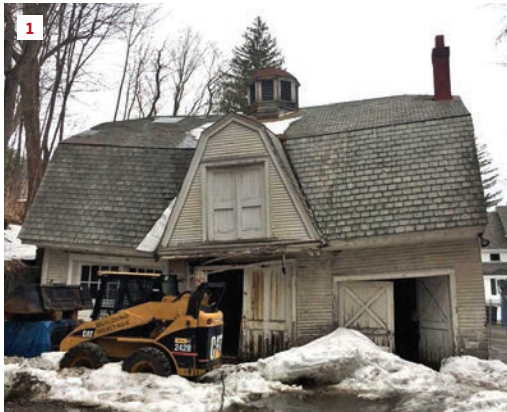
When we arrived on site, we discovered the worst damage to the structure was to its west-facing front façade (1). One side of the large gambrel dormer had collapsed. This failure had been caused by rot from a reverse-flashed valley and by an undersized beam rolling (it had been used to replace a bearing wall in an earlier remodel).

The worst damage centered around a transverse dormer **(1)**. I-beams were inserted longitudinally to help level the second floor **(2)**. Sheathing the second floor helped square up the building **(3)**, and adding Zip System sheathing to the upper roof slope helped prevent racking **(4)**. The lower I-beams were inserted with the help of an excavator **(5)**. Cribbing supports a main beam (running right to left), which supports the needle beams (red). Running parallel to the needle beams was the I-beam track **(6)**.

The rolled beam had contributed to sagging of the second-level hayloft floor, as well. The ground-level stable's original wood floor was long gone, and what remained was a thin layer of asphalt over dirt. Finally, the building itself had severely racked and was out of square 6 to 8 inches. Clearly, in order to safely move the structure, we first had to jack it up and straighten it out.

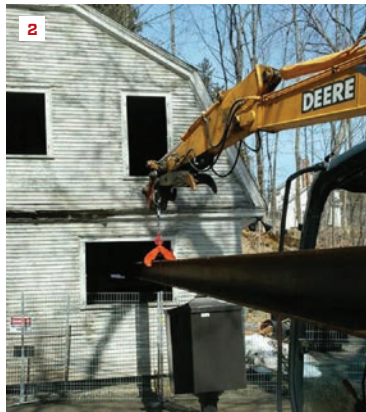
Next, we dug down about a foot to good bearing and carefully leveled four bases built from 6-inch-by-6-inch-by-4-foot lengths of cribbing (normally, we dig down all the way to the footing, but in this case, we didn't have to). As we assembled the cribbing towers, we checked for level at every layer. When we arrived at the desired height, we inserted the upper, 40-foot-long W10x45 main I-beams through the length of the building with the help of an excavator, placing them on beam rollers secured to the cribbing **(2)**.

We then inserted three smaller (W8x31) needle I-beams, running perpendicular to the main beams. The first two were placed on either end of the sagging gambrel dormer and ran on top of the main beams to take the sag out of the second-floor framing and to support the valleys. The third needle beam supported the chimney. We suspended the needle beams from the main beams with four heavy-duty, 12,500-pound-capacity Crosby clamps, then lifted the building approximately 2 feet off the ground.

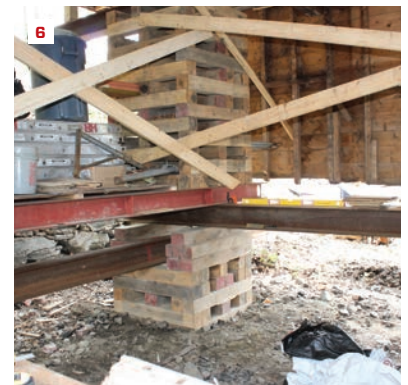
As we assembled the towers, we needed to build-in the support gridwork of beams, starting with the needle beams. For the final lift, the cribbing stack also needed to be slightly reconfigured to allow us to insert the track rail I-beams; a "pyramid" stack of cribbing was assembled perpendicular to the main beams (6). We installed Crosby clamps at the beam intersections.

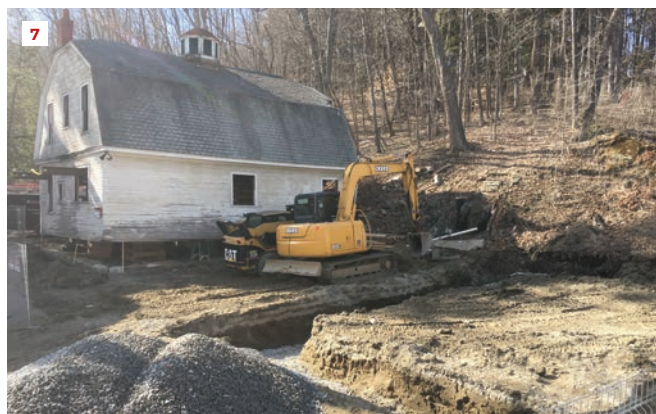
While the author's crew restored the structure's framing, the excavation sub broke ground on a new foundation (7). A freestanding retaining wall was part of the foundation design (8), which was built in line with the existing house (9). A granite capstone, reclaimed from the existing foundation, lined the remaining foundation perimeter; here, the masonry sub maps out the rebar locations and angles to accurately line up boring holes (10). Some capstone was installed prior to the move (11).

While we restored the framing on the building, our excavation sub began work on the new foundation **(7)**. The basic plan was for the foundation to be built in line with the existing house, so the move would be in a straight shot. We knew ledge was located in the vicinity of the new foundation. So, last fall we dug out the site and mapped out the ledge locations, which our structural engineer was able to incorporate into the new foundation design; we pinned the foundation to the ledge in several places.

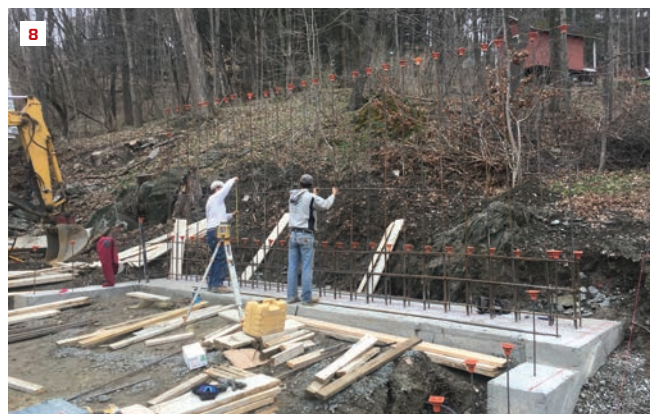
The new foundation was unique. A 10-foot-high freestanding retaining wall was required to support the gable-end wall on the north side. Because there were no return walls to stiffen this wall up, it needed to be heavily reinforced with a 12-inch-on-center #5 rebar grid **(8)**. The wall was 12 inches thick at the base with a 4-inch brick shelf a couple of feet from the bottom (the lower north wall would be

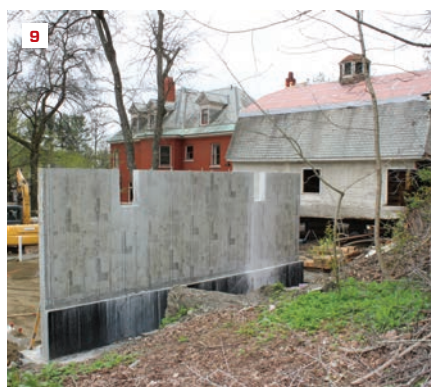
brick veneer). #5 L-shaped dowels 12 inches on-center joined the wall to its 12-inch by 5-foot-wide oversized footing. Beam pockets for lowering the upper beams were cast into the top of the wall **(9)**.

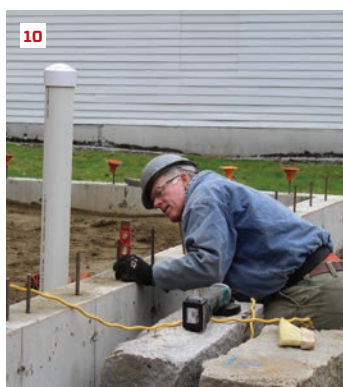
The remainder of the new foundation consisted of 5-foot-deep frost walls capped with the reclaimed 8-inch-thick granite blocks, which would serve as a capstone. Our concrete sub left rebar sticking out of the top of the frost walls, which our mason cut to the same height and plumbed upright using a rubber mallet and level. The mason then mapped out the rebar locations and their angles to accurately lay-out holes into the block **(10)**.

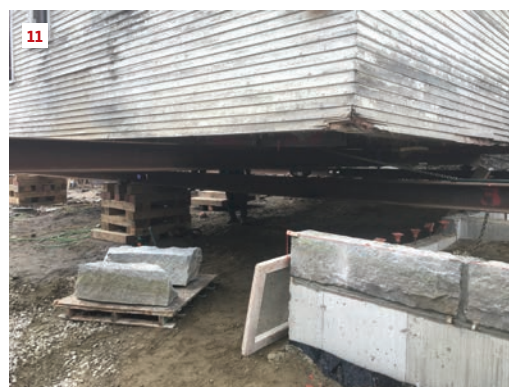
Once the capstone blocks were ripped down for uniform height and bored, they were installed on top of the foundation and mortared in place **(11)**. We later pinned the blocks to the wall, as well, by drilling down through the granite (and new wood sills) into the concrete, and setting threaded rod in adhesive grout.

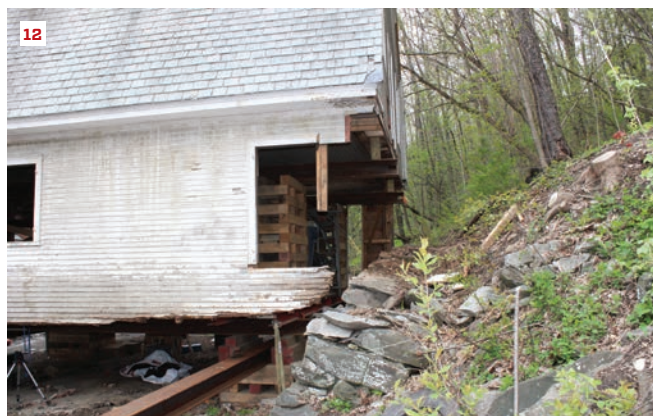
The crew installed the first I-beam track into the north gable-end cribbing **(12)**. An excavator and a beam roller placed on mid-span cribbing helped insert the south track **(13)**. Beam rollers were placed on a “pyramid” stack of cribbing; the pyramid stacking formation was used throughout the lifting process to transmit loads through cribbing towers **(14)**. The I-beam track needed to be ground smooth to eliminate imperfections **(15)**. Waste-blocks rolled into place served as anchors for moving the building **(16)**.

The I-beam track was composed of four, 40-foot-long W10x45 I-beams (two per track, butted end to end and bolted together). We began with W10x45s inserted into the cribbing, starting with the north rail (12).

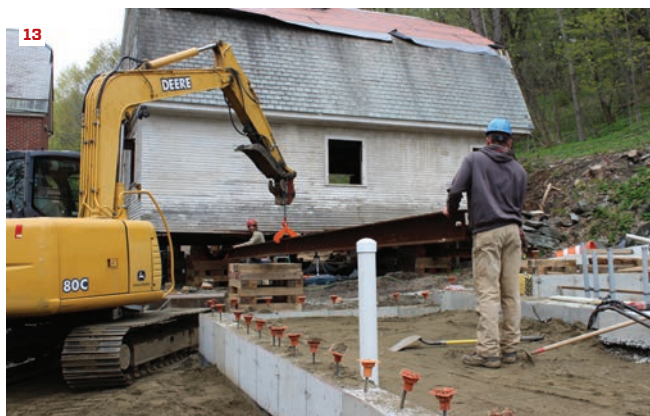
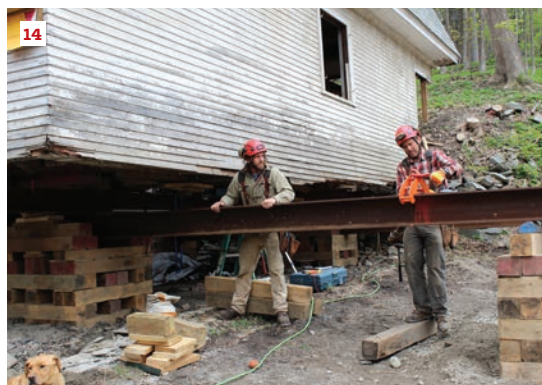
We assembled shorter, mid-span cribbing towers to pick up the track "in space" to a height where the track would be dead level. The crew maneuvered the beams into place using beam rollers on each mid-span tower and used an excavator with a beam-clamp attachment to help position the beams (13, 14). The I-beam track needed to be ground smooth (15), particularly at the ends of the beams where burrs were likely to occur. "Jumping" from one track section to the next is tricky enough (transferring the weight of the building from one track section to another) without having to deal with any imperfections.

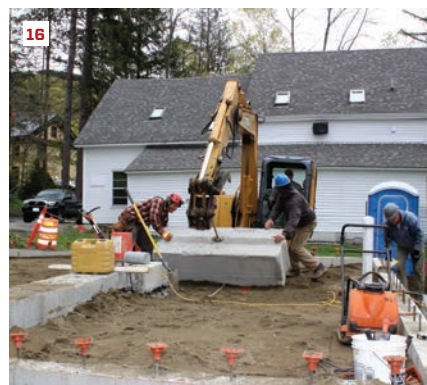
We planned to pull the building into place with a couple of come-alongs, so we positioned a couple of three-ton concrete waste-blocks to serve as anchor points (16). We chained the come-alongs to the blocks and the lower W8x31 needle beams and began pulling the building into position at rate of about a foot per minute. It didn't take much to move it because it was on "wheels" (building rollers).

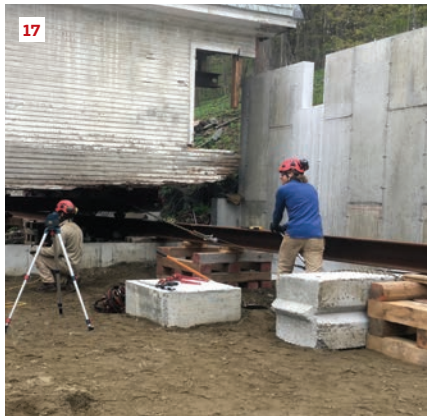
With the I-beam track set and leveled, the building was pulled with come-alongs anchored to the concrete waste-blocks (17). Four 10-ton-rated Hilman rollers, two per track, were used to roll the building in place (18). A turntable on top of the roller allowed for tweaking the roller's direction to keep it aligned on track (19). It took an hour and a half to move the 30,000-pound structure (20). Here, a video still from the author's GoPro camera shows the building nearly placed on its new foundation (21).

Even though we had two come-along setups, one come-along did all the work (17). We used four 10-ton-rated Hilman rollers, two per track, to roll the building in place (18). The rollers come with a turntable on top, which allows for tweaking the roller's direction to keep it aligned with the track. We use a handle tool, which we hitch on the end of the roller to straighten them as needed (you have to keep an eye on them, as there are no guides to keep them

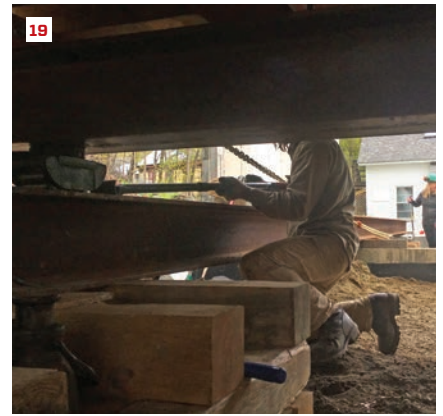
from rolling off the track's top flange) (19). It took an hour and a half to move the building, including time to "jump" the rollers over the track seams (20, 21).

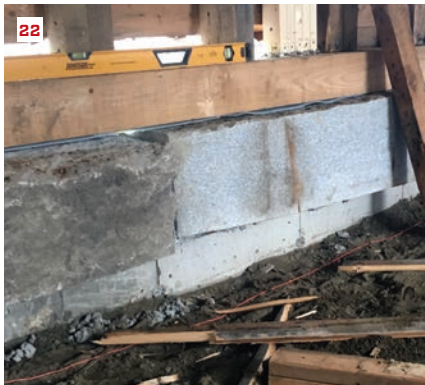
The building was lowered onto new 6x7 sills set on the granite (22). The cribbing towers were lowered one tier at time, the steel rolled out with beam rollers (23). Hydraulic jacks were used for all the lifting (24). A steel plate was inserted during removal of the chimney support beam; a tube steel support was added later (25). The retaining wall beam pockets were blocked in (26). Here, the carriage house is in position, ready for complete restoration (27).

In many ways, lowering the building was the easy part of the job. The squared-up structure lined up with the new foundation nearly perfectly. We lowered the building onto new 6x7 sills set on the granite and toe-screwed the wall studs to the sill with TimberLoks (22).

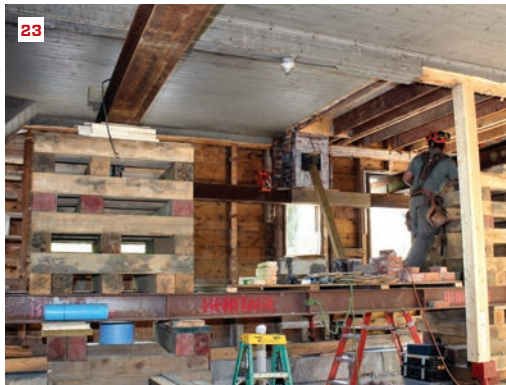
The cribbing towers were lowered one tier at time and the steel was rolled back out (a reverse of their installation) (23). We used eight 22-ton Simplex hydraulic jacks for all our lifting and lowering needs (placed on metal bearing plates and in-line stacked cribbing to transmit the load through the tower) (24).

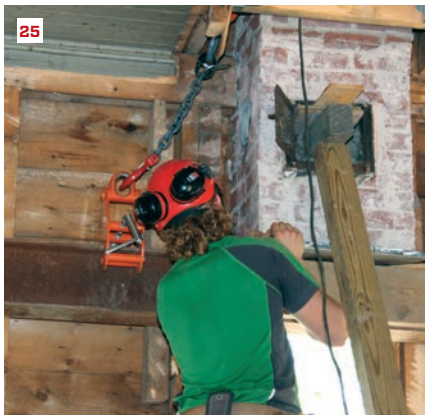
A 3/4-inch-thick steel plate was inserted during removal of the needle beam supporting the chimney; a tube steel support was later welded to the plate for support (25). The retaining-wall beam pockets were blocked in prior to installing the brick veneer (26). With the building in position, it was ready for complete restoration (27).
