# Upgrading a Cable Railing

Coastal conditions call for extra steps to fight corrosion

by Steve Sherritt

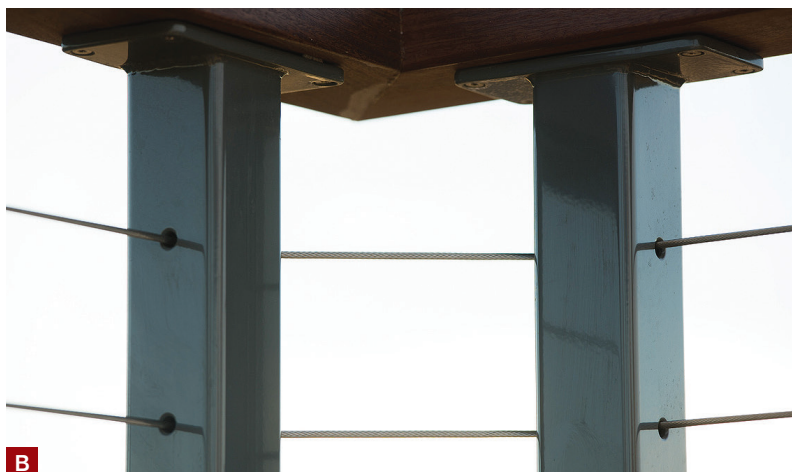
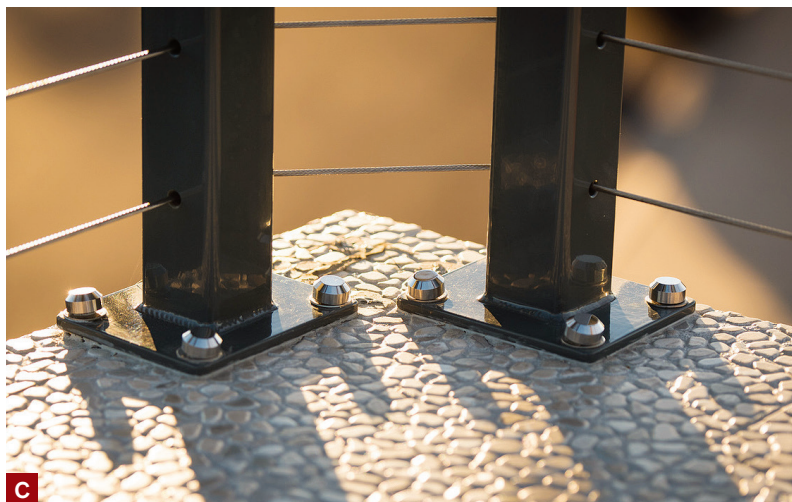
**Figure 3.** Besides being undersized, the original, single-corner posts required a sharp bend in the cable, which prevented proper tensioning (A). The author prefers double corner posts, which offer a more gradual bend for the cable and a more secure corner attachment for the ipe top rail (B). The posts are equidistant and located a minimum of 4 inches from their centers to the corner, which creates a soft, 45-degree cable bend at each post (C).

**Double corner posts.** The fabricators of the original railing used single posts at the corners. To do this, they had to drill holes on two walls of the corner posts and run the cable through the posts at a 45-degree angle. But architectural braid 1x19 stainless cable is considered semi-rigid and cannot bend or move at a tight angle inside a small, 1½-inch square tube. As a result, the cables

became bound at the corner posts, making tensioning impossible and creating extreme tension loads on the corners. Binding at the corners likely contributed to the broken fasteners and standoffs, due to the overloading of certain points on the railings.

We replaced the deck's single corner posts with two posts at each corner (**Figure 3**). Using double corner posts makes it easier to install continuous runs of cable without any binding and offers a cost benefit to clients because it eliminates a number of cable fittings. And mitering top rails at the corners is much easier with two posts because each railing member has its own mounting plate.

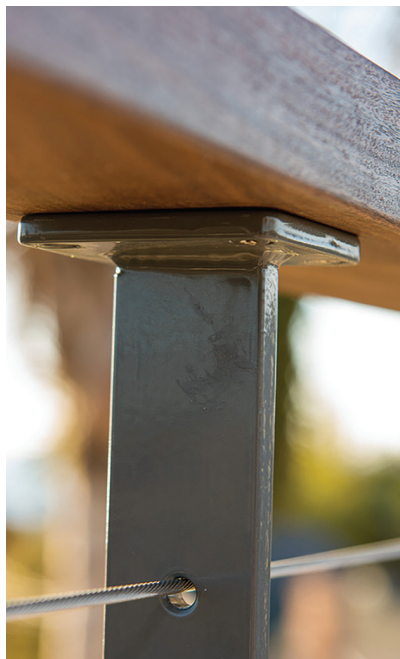
**Figure 4.** By upgrading from a  $\frac{3}{4}$ -inch-thick to a full-2x4 ipe top rail, the author was able to eliminate the metal subrail typically used with aluminum and lighter-gauge stainless steel rail systems.

Because our clients were fond of the hardwood look of the original  $\frac{3}{4}$ -inch-thick ipe top rail, we beefed it up by using stronger, 2x4 stock, which won't warp under tension. The ipe top rail is directly attached to the welded post plate connections via four  $1\frac{1}{4}$ -inch by #10 SS screws with countersunk heads. Because of the strength of the ipe, there was no need for the continuous steel reinforcing subrail often used with aluminum railings (**Figure 4**).

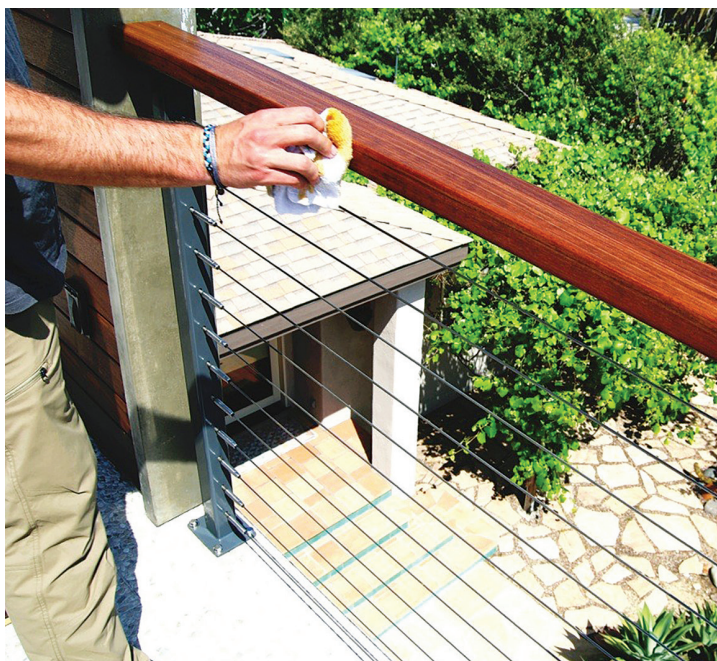
**Figure 7.** Routine cleaning and maintenance with a penetrating oil finish is needed to keep the ipe top rail looking good in a marine environment.

Penofin's hardwood penetrating oil finish (**Figure 7**). We've found that if the wood is kept clean, penetrating oil products can be added as needed (sometimes one to three times a year). Different levels of exposure will require different application rates, but it is a nice brush-on-and-wipe-off product with good longevity.
