BUILDING SCIENCE

Rehab From Above A complex roof gets a building-science makeover

BY JIM BRADLEY

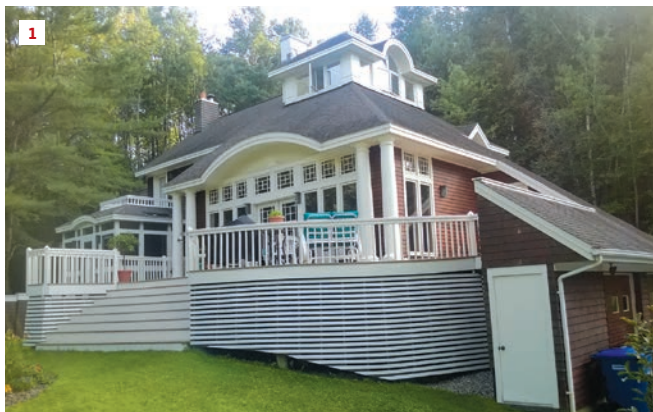
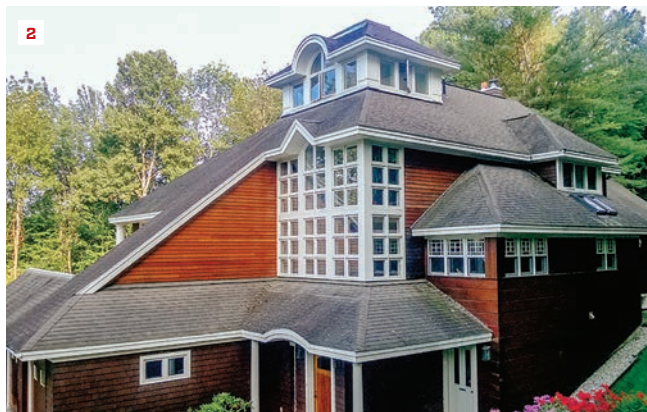
Originally a simple raised ranch, this home had been remodeled with complex architectural details (1, 2), which made adding to the roof's thickness impractical. The shingle roof needed replacement, and there was mold and rot in some areas of roof sheathing (3, 4). Existing fiberglass insulation (5) was compromised by installation gaps and voids, as well as mouse tunnels.

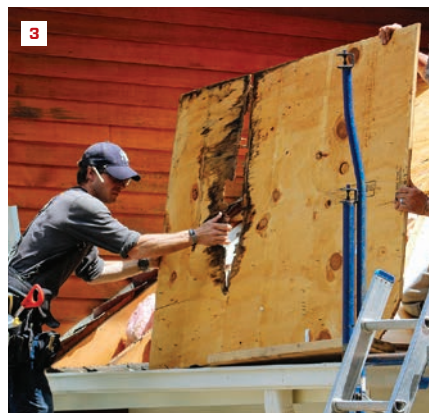
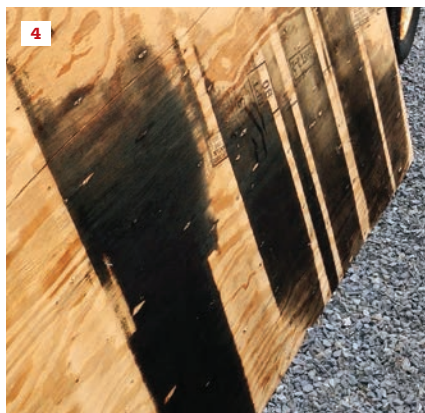
To address the problem of roof runoff soaking the soil near the foundation, we also decided to put large commercial gutters on the roof. When the gutter contractor leaned his ladder against the roof, however, we saw that the sheathing at the roof edge was soft, indicating rot in the roof system. On further inspection, we found more soft spots on the roof. The more we learned, the more the homeowners came to see that their roof needed repair.

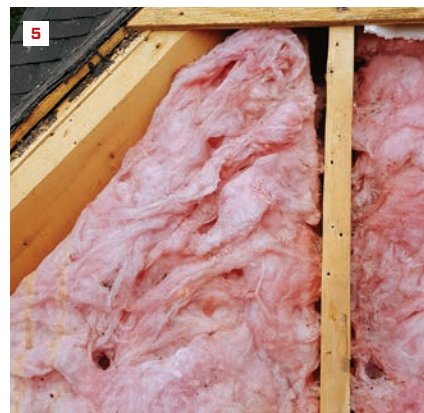
We took apart and reconstructed most of the roof system from the top side. In the photos above, you can see our crew working on one portion of the cathedral roof. Starting at the bottom, they began by removing the existing plywood and stripping out the existing fiberglass insulation. The condition of the insulation varied from place to place—some portions were OK, but in many places, the insulation was dirty and full of mice and bats. The plywood also was in mixed condition; some pieces were sound, but in some rafter bays, there was blackening and deterioration all the way from the eaves to the ridge.

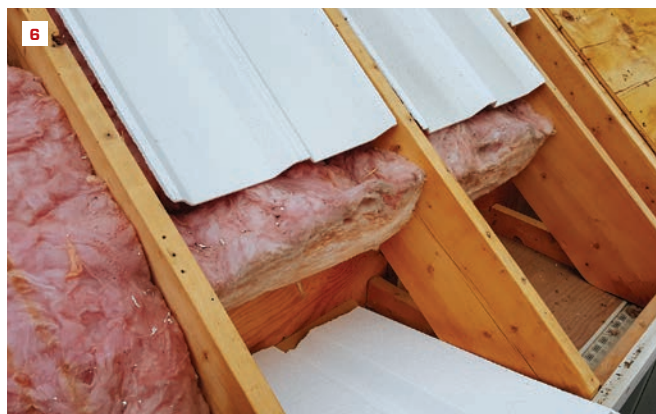
Existing fiberglass batts in the rafter bays were exposed to wind-washing at the eaves (6). Complicated existing framing around the chimney, an older original roof that had been left in place, and the later belvedere addition had created a maze of interconnected air bypasses (7, 8, 9). For this rehab, the existing ceiling (10) was left in place, and the roof upgraded from above.

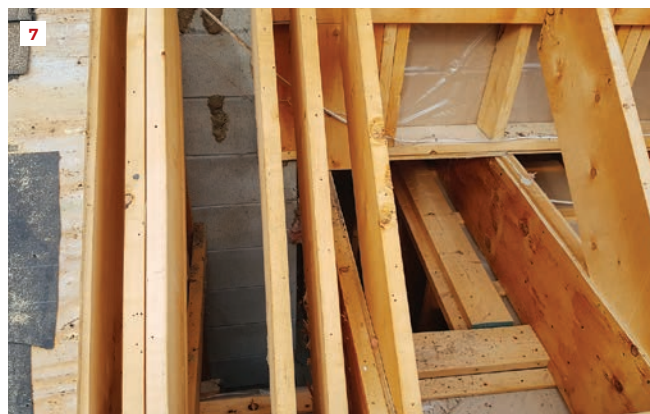
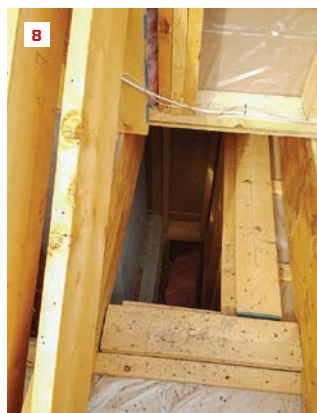
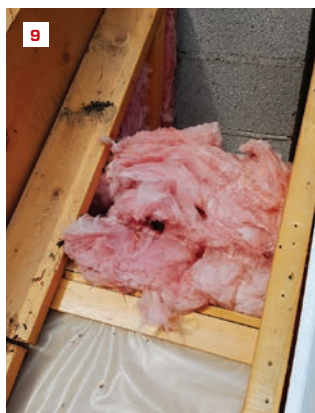
The really big air bypasses were things like the framed chase around the home's masonry chimney. Big enough for a person to crawl through, that chase extended all the way from an unconditioned attic down to lower floors and allowed heat and moisture to flow up into the upper parts of the roof. Also, the floor of the belvedere was unblocked and uninsulated, allowing drafts, and an unin-

We approached the problem of the cold, leaky attic by defining the home's air control layer at the underside of the roof rafters rather than at the attic floor—the same condition that already prevailed in the cathedral-roof portion of the house. In the cathedral-roof areas, however, we could access the insulated cavities only from above, whereas for the small attic portion, we were able to approach from the inside of the house as well. That access allowed us to apply a more sophisticated air and vapor control layer from underneath, using Intello membrane with Tescon tape at the seams, a big improvement over poly.

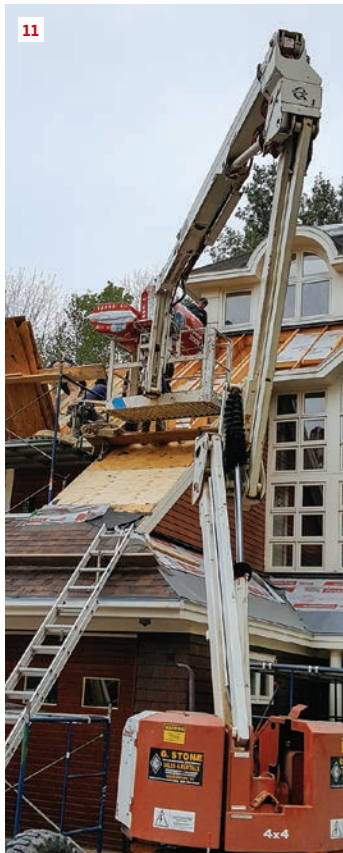
Because the home needed new roofing shingles, and because some sheathing was damaged and needed replacing, the owners decided to repair the system from outside (11). But some spaces were also accessible from inside. A small attic space was insulated from inside (12). That ceiling got a smart vapor-control membrane (13), and the crew sealed a bath fan (14).

Instead, the owners opted for a more workable solution. We would open up the roof, insulate it with Roxul mineral-wool batts, and then create a venting air space within the rafter bays using lauan plywood. We would resheath the roof with new plywood, then apply underlayment and roofing in the conventional way.

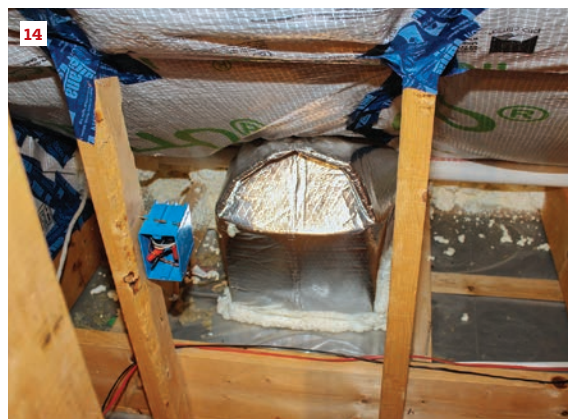
When we assessed this roof system, we found a wide variety of deficiencies in the assembly's air control layer. Some of the air leaks were relatively minor, but many were large, and some were huge. There were small holes in the drywall (made by the owners, who had installed drywall anchors in several places). There were recessed lights in some of the ceilings, which leaked into the roof cavities. Unsealed bath fans also penetrated the ceiling, allowing air leaks.

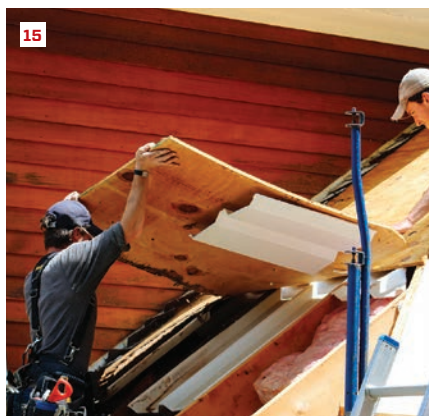
Working from outside, the crew removed the existing sheathing (15), filled gaps between the ceiling and the rafters (16), nailed cleats to the sides of the rafters (17), and insulated the cavities with Roxul mineral wool (18). They protected the insulation with luan plywood (19), also creating an air space to help cool and dry the roof system.

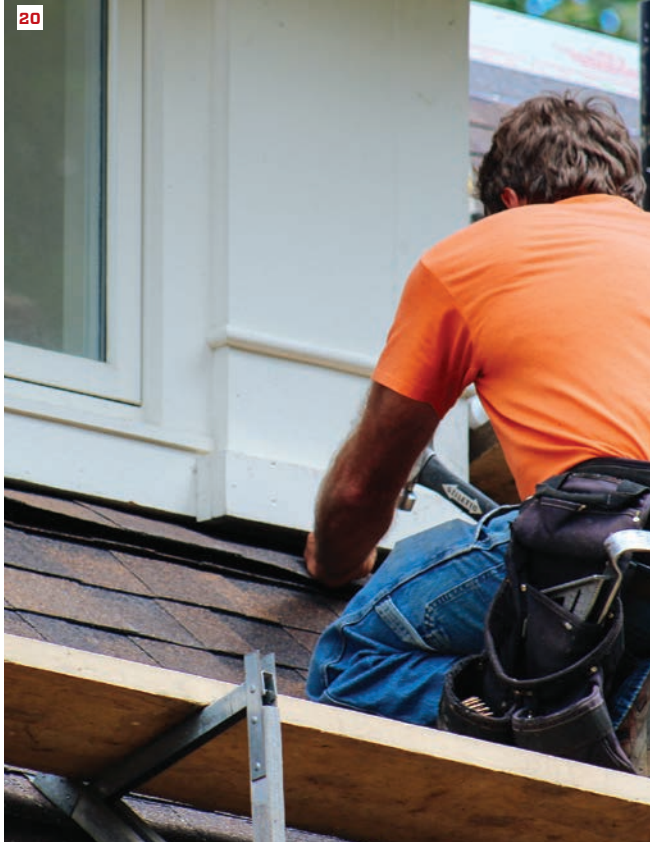
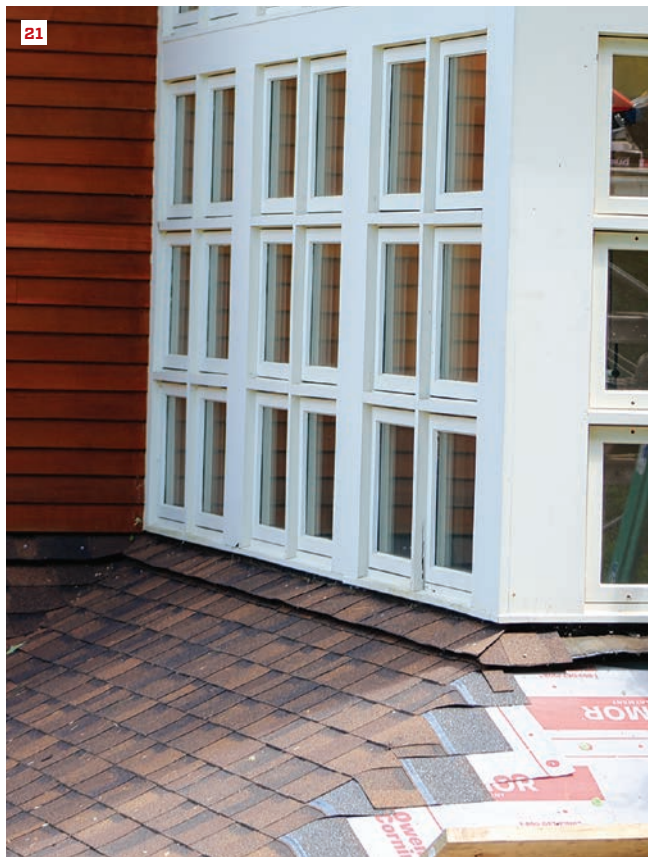
Where roofs abutted walls, the crew installed Cor-A-Vent Roof-2-Wall vent to allow air in the rafter vent channels to exit the system (20, 21). Ridge vents (using Owens Corning VentSure; not shown) were also installed where feasible. The solution chosen allowed the repair to take place without any disruption to the existing windows.

deterrence to rodents and bats. We installed ridge vents, where feasible, and roof-to-wall vents at the top of the rafter runs to allow airflow through the cavities.
