## Fixing the Bonus Room

A room over the garage shouldn't always be a warranty issue

BY MATT BOWERS

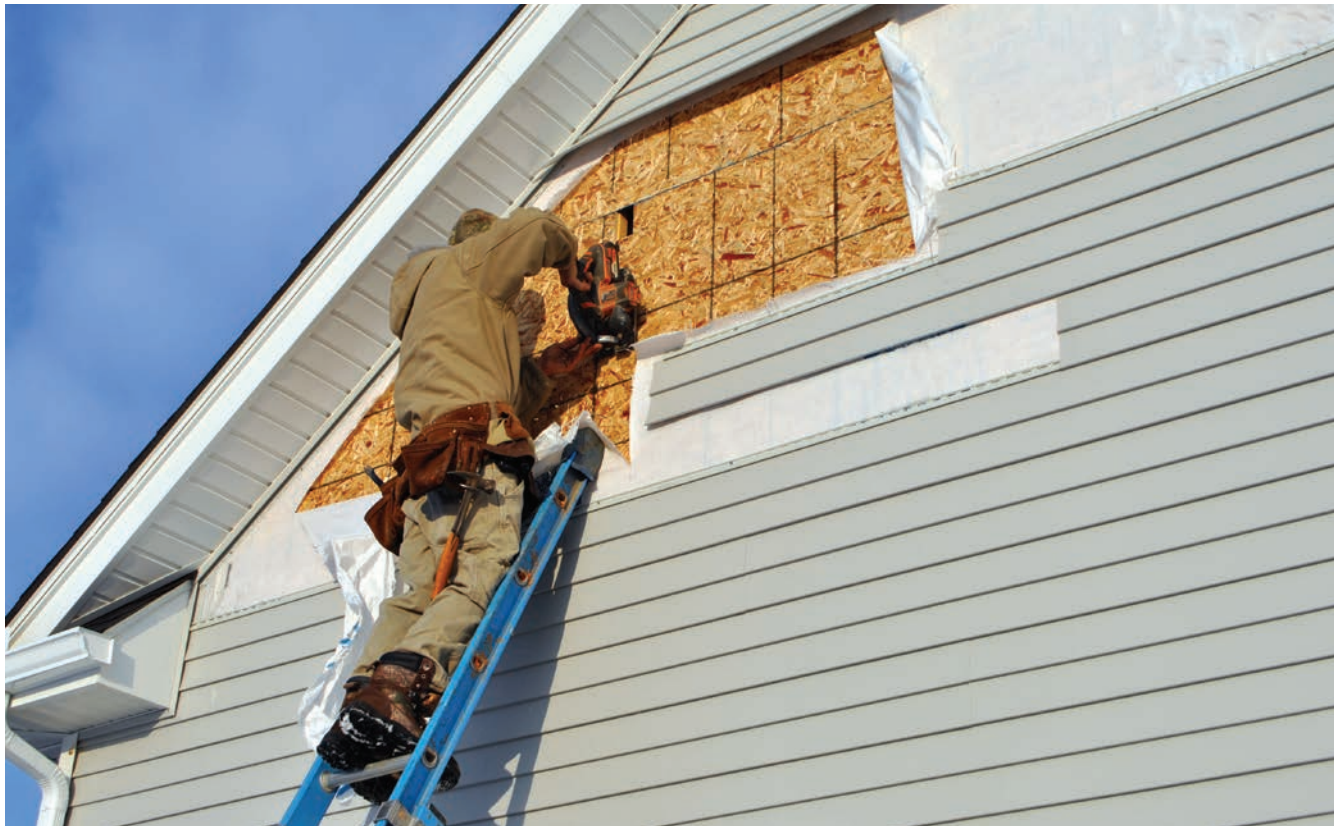
I'm a HERS rater and project manager for Airtight Services, a home-performance contractor in upstate New York. In the photo above, one of our carpenters is cutting open the gable-end wall over a garage on a brand-new house. He's starting one of the jobs that have become part of our bread and butter: an energy upgrade performed as warranty service for a home builder on a cold, leaky "bonus room" over the garage.

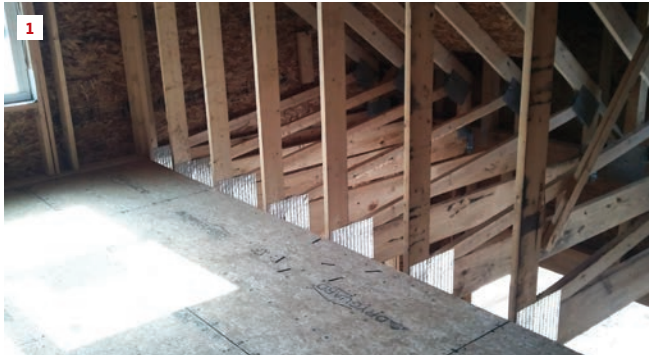
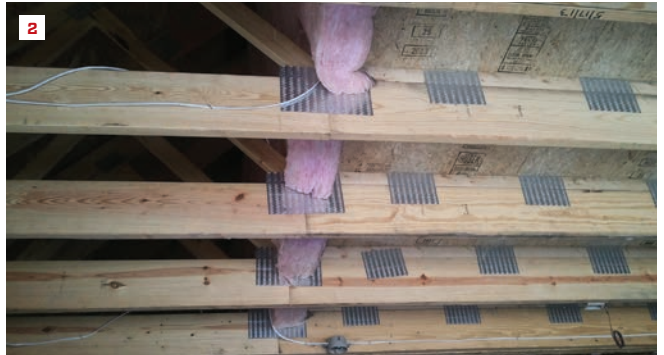
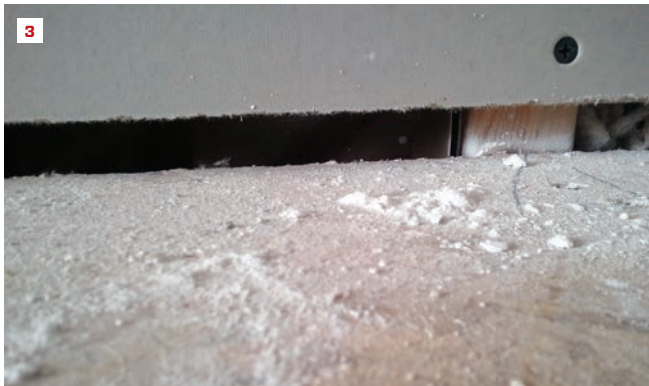
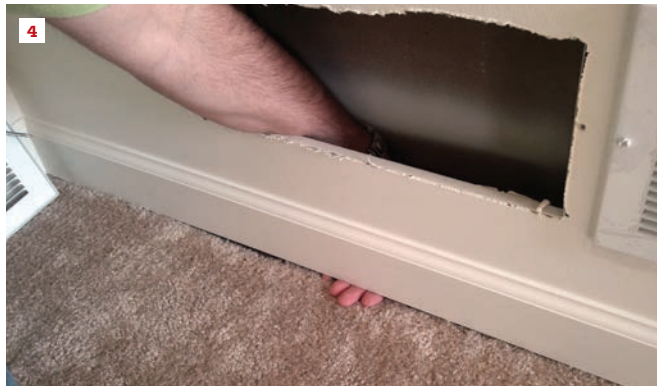
To construct a typical bonus room, the builder first installs OSB subflooring on the truss chord **(1)**, then insulates the vertical sidewall truss webs with kraft-faced fiberglass batts **(2)**, stapling the facing to the sides of the 2x4 webs. Next, the builder applies drywall to the room walls—leaving space below the drywall **(3)** for the carpet installers to attach a tack strip. After carpet and trim are in place, a huge air gap remains at the base of the wall **(4)**, communicating with the cold vented attic.

The photos above show a typical bonus room at various stages of construction. Because the framing is basically a set of trusses, there is no wall plate at the bottom of the wall. As a result, there's a gap—typically a big gap—at the bottom of the wall. This allows air to leak freely into the room from the space behind the wall, which is connected to the outdoors via the roof eave soffit vents.

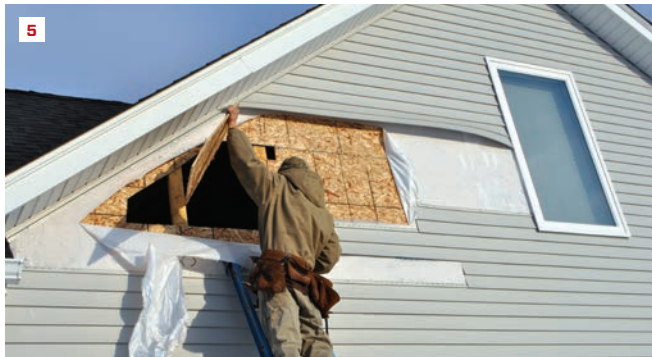
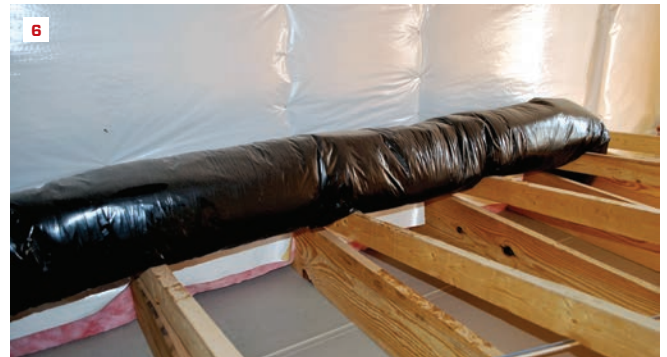
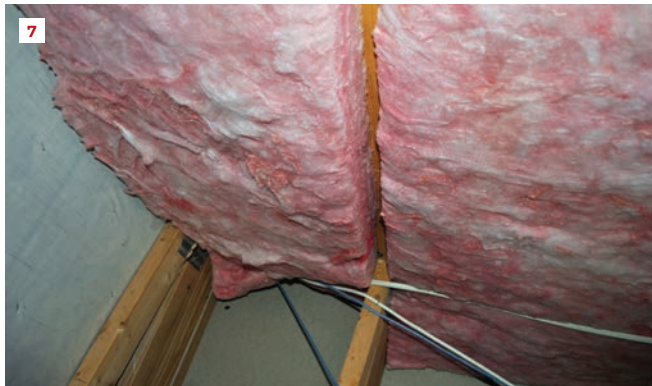
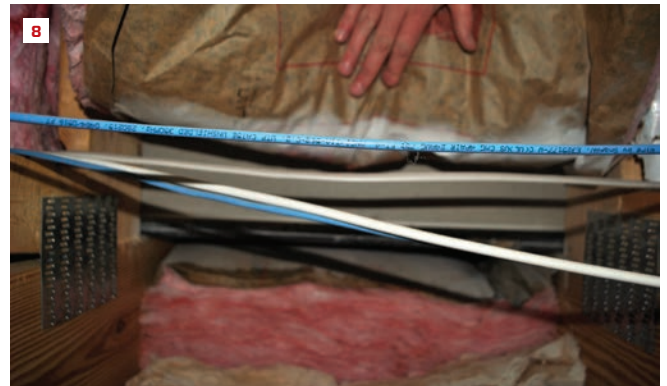
Working from outside, a carpenter cuts into unheated space above the garage next to the bonus room (5). Under the low roof, he finds the back of the bonus-room wall (6), with a plastic air barrier stapled to the wall over the fiberglass insulation (but not sealed at the top or the bottom). With the plastic removed, the R-19 batts bulge out beyond the 2x4 framing (7). Where the wall meets the floor, nothing blocks air from flowing through fiberglass batts installed under the subfloor (8).

What we found in the space behind the bonus-room knee wall in this house is typical (see photos, above). The white plastic air barrier is not sealed at the bottom or the top. With the plastic sheeting removed, the R-19 fiberglass insulation bulges out from the 2x4 wall framing cavities. When I fold back that kraft-faced wall insulation at the bottom, we see the condition under the floor: two insulation batts stuffed up into the truss bays from below, with the lowermost batt's kraft facing stapled to the truss sides to hold the insulation in place. And it's a little hard to see in these photos, but the joint between the subfloor and the drywall is open half an inch, as in photo 3 on the facing page—and there's daylight between the baseboard and the carpet.
