BY SCOTT GUTHRIDGE

## Leaky Basement Windows

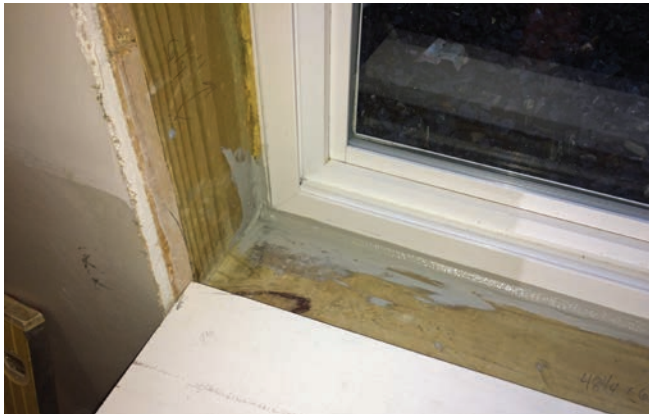
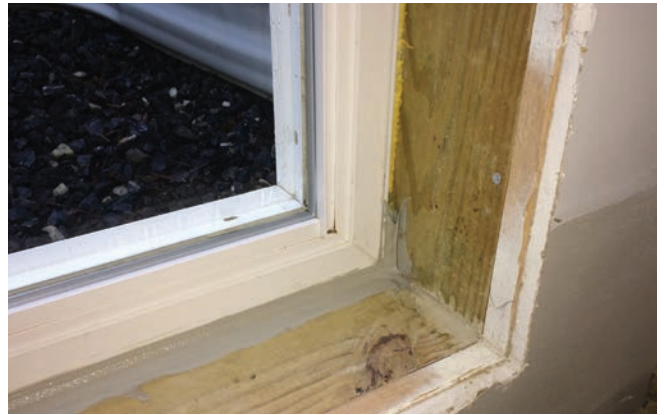
As I looked from inside the home at the wooden framing around the window, I saw what looked like a water stain on the corner. I wondered what had caused it, so I looked outside around the perimeter of the window and found a slight crack in the gray caulk that my crew had originally applied to seal the window.

of the structure, and this is likely true for below-grade applications. But in this case, direct exposure to the elements seemed to have caused the sealant to pull away from the vinyl window and the concrete opening it was placed in.

What had actually happened, to the best of my knowledge, was that the vinyl window itself had small cracks in the corners of the window frame. I took some photos and started documenting the process.

I dried up the water with some rags and went outside, set up the hose to spray the window, and left it running. Then I headed back into the basement to determine where the water was leaking through first. It appeared that the left side was leaking almost

immediately, and eventually the right side started leaking as well.

Short of pulling all the basement windows and using a peel-and-stick to create a drainable sill pan, the expedient fix was to inject a high-quality polyurethane sealant into the gap below and on the sides of the window unit, creating a retrofit sealant pan before installing extension jambs.

I grabbed a new tube of caulk (Vulkem 116 polyurethane sealant, which is very similar to the Superior Wall caulk). While cracked, the existing caulk was still strongly adhered to the concrete. I applied the new sealant over the old and made sure it was bonding well to the concrete wall and the vinyl window.

I certainly did not want to tear out the window and start from scratch, although it crossed my mind. If I had removed the window, I would have been able to place a peel-and-stick membrane under the window, just as I do on all windows in a wood-frame wall. Short of this measure, I decided to create a pan by injecting the same polyurethane sealant that I had used on the outside to fill in the gap around the bottom and sides of the window.

I removed all the spray foam that I had used to air-seal the opening and cleaned it out as well as I could. I then took my caulk gun and shoved the tip as far into the 1/4-inch gap as it would go. I wanted to make sure the entire space was filled with sealant to prevent any water from entering the structure. As the sealant was squeezed into the opening and started oozing out in front, I troweled the sealant along the bottom and up the sides about 3 inches.

After letting the sealant dry for a day, I got out my hose. Again, I set it up to spray the window gently, and I went inside and hoped for the best. This time, there was no evidence of water inside. I let the hose run
