BY ELIOT LOTHROP

## Breaking Down a Silo

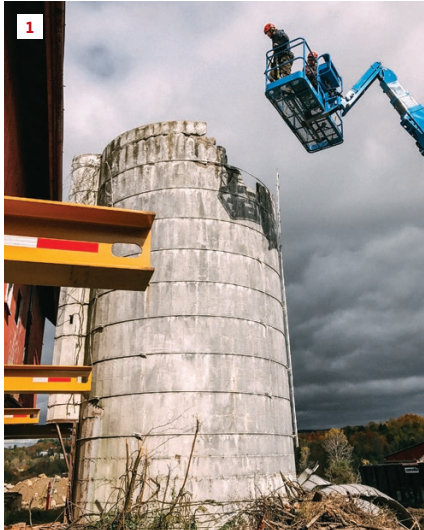
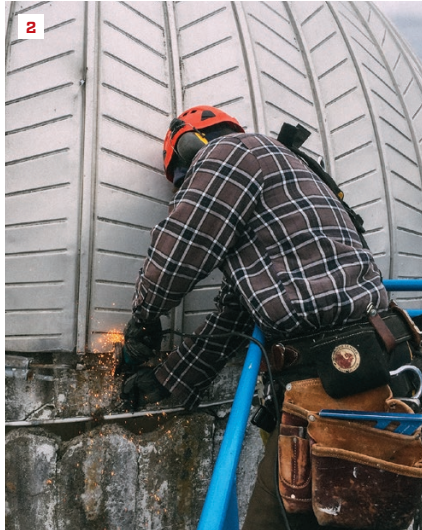
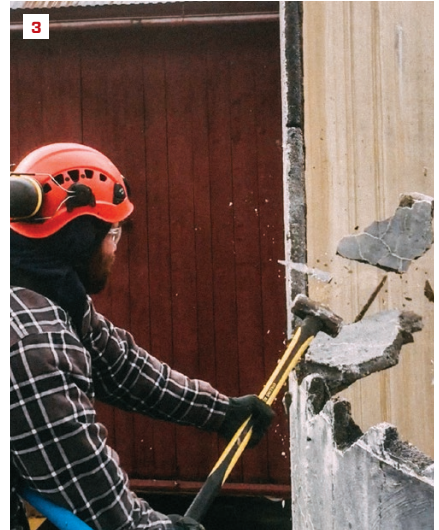
The client's silo, shown in the photos above, was a "concrete stave silo." Roughly 18 feet in diameter and 30 feet tall, it was built with interlocking concrete blocks (or staves) held in place by steel tension rods. The individual blocks were roughly 10 inches wide by 30 inches tall by 2 inches thick and were dry-laid—that is, interlocked together with no mortar. The interior was then skim-coated

Early into the barn repair (we jacked up the whole barn, then replaced the foundation and slab), the owners wanted us to look into the possibility of turning their silo into an observatory. When we inspected it with our lift, we knew within a few minutes that it was too far gone to save. There were numerous fist-sized holes through the block and a large, continuous crack along the top block course, giving the appearance that the top course and domed roof were well on their way to shearing off. With this news, the clients agreed to demo the structure.

Because we had aerial lift equipment that could keep the crew above and out of the way of the silo, we felt that it was safest to remove the silo from the top down **(1)**, in case something went wrong. First, we carefully cut the uppermost steel tension rod from above using a grinder. These rods tend to violently snap when cut, and the lift's steel basket offered protection **(2)**. With the top rod cut, we removed the domed roof. We then cut a few more tension rods and sledgehammered the block debris into the silo **(3)**. Demoing a course or two at a time, we worked our way down the silo to about 12 feet off grade. At that point, our excavation sub was able to safely remove the debris and the silo's concrete pad using his excavator.
