A “Never Worry Again” Insulated Ceiling

BY JEREMY KASSEL

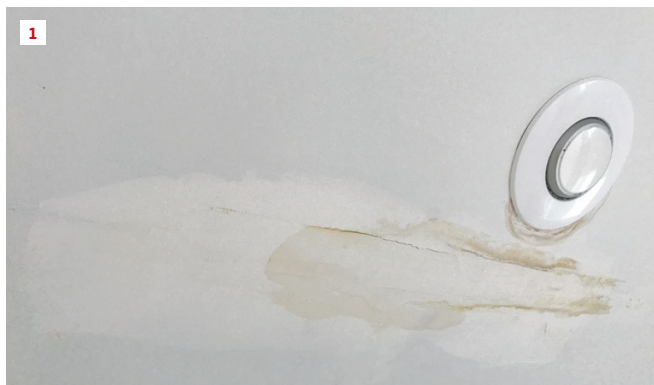
Water stains on the drywall of this cathedral ceiling look like they might have been caused by a roof leak (1). But given the location of the water stains, the author knew this was not a leak, but rather condensation due to poor insulation and air leaks around the recessed light fixtures (2).

When I arrived at the home, I took one look at the ceiling and knew that we weren’t dealing with a roof leak—we were dealing with an air leak. The location of the water staining was just “downhill” of recessed lights, which can be a common source of heat and air loss when installed in a cathedral ceiling.

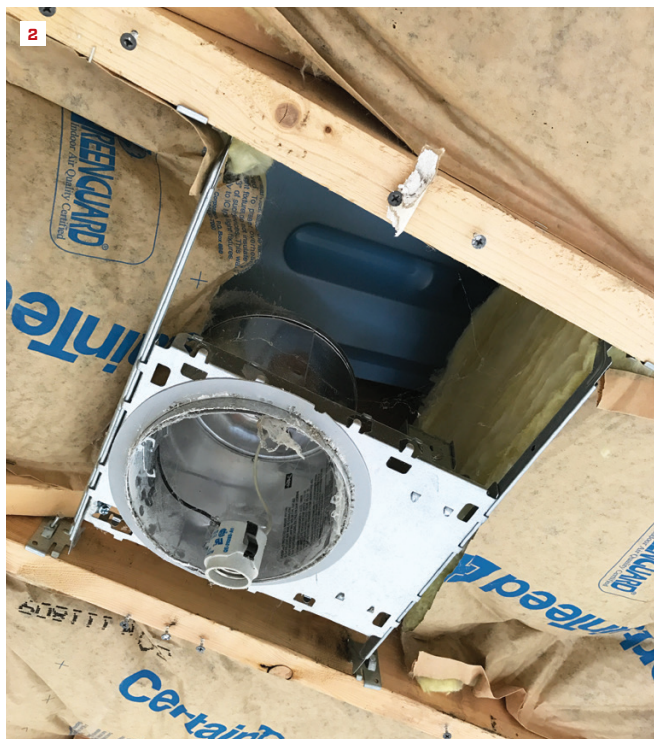
After we began demolition, my worst fears were confirmed. The previous contractor had used no insulation over the tops of the cans, and sloppy fiberglass installation on the sides of the housings, or even none at all. Inadequate insulation around and above the light housings resulted in an appreciable amount of air movement and heat loss. In winter months, this combination of air movement and heat loss resulted in air-transported moisture condensing on the underside of the roof sheathing. At times, there was enough condensation to drip from the

Step 1. All of the existing drywall, fiberglass insulation, and foam insulation baffles were removed from the sloped and flat portions of the ceiling. Upon taking down the drywall ceiling, I confirmed my hypothesis: Sloppy installation of fiberglass (or none at all) was found adjacent to and on top of all the recessed lights.

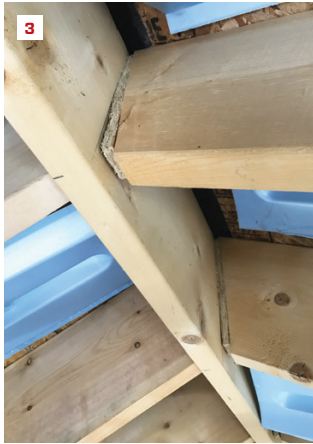
After demolishing the existing ceiling to expose the framing (3), the author reinforced the rafter-to-ridge connection with new joist hangers (4). The owner wanted to replace the high cathedral ceiling with a conventional flat ceiling (5).

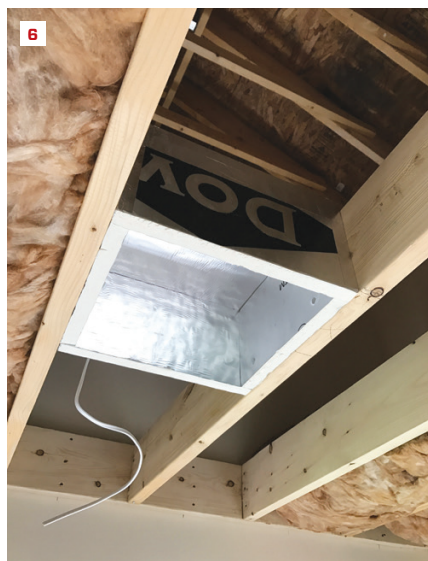
To make it easier to air-seal and insulate the new ceiling, the author assembled light-housing boxes made from foil-faced rigid foam (6). They were tightly taped at all corners and to the continuous layer of rigid foam fastened to the ceiling joists (7). After strapping the ceiling in preparation for drywall, the author sealed all penetrations—including the electrical box for a ceiling fan—with canned foam sealant (8). The new worry-free ceiling is shown at right after the first coat of mud (9).

Step 7. Recessed lights are notorious for heat loss and air loss. To overcome these problems, we built “boxes” out of 1-inch-thick rigid insulation. These boxes were taped and air-sealed on the

Step 8. We installed the light-housing boxes in the locations of our lighting, drilling $\frac{3}{4}$ -inch holes in the center of the top of the boxes to send in our wire drops.
