BY JAKE LEWANDOWSKI

## Repairing Rotted Trusses

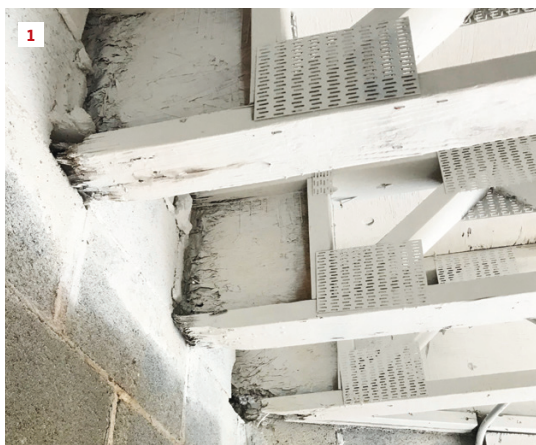
**Damage from a roof leak.** We recently were called in to repair trusses on a townhouse that was built in the mid-1990s. The trusses supported a third-floor deck with a living space below. After seeing water damage on some interior drywall, the clients opened up the wall below the trusses. When they found extensive mold, they removed the rest of the drywall, exposing an adjacent CMU wall with pockets that supported the trusses. The ends of three of the trusses had rotted (1).

Removing water-damaged ceilings and walls revealed three trusses with rotted ends (1). To reinforce them, the author made plywood gussets. He traced the chord pattern onto a blank (2) and made a template to transfer the fastener layout (3, 4). Squash blocks stiffened the ends of the trusses (5).

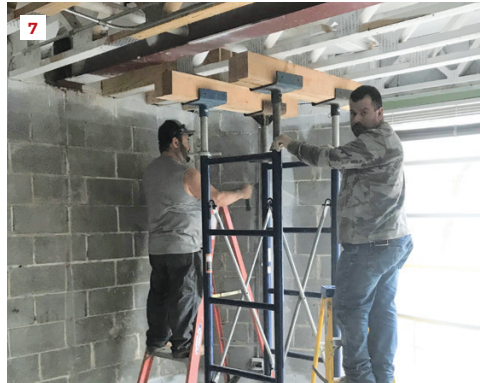
A palm nailer was used to drive the specified fasteners at each location to attach the gussets to the ends of the trusses (6). The crew used screw jacks and beams to lift the trusses to their original height (7), then cut away the rotted wood with a reciprocating saw (8). With an engineer's guidance, the author drew the support-beam elevation (9), plan, and section (10).

Before attaching the gussets, we inserted the 2x4 squash blocks as specified by the engineer (5). We then clamped the gussets to the trusses and drove nails at each fastener location, using a palm nailer (6). With the gussets in place, we spanned across the underside of the trusses with beams and lifted them using a four-point

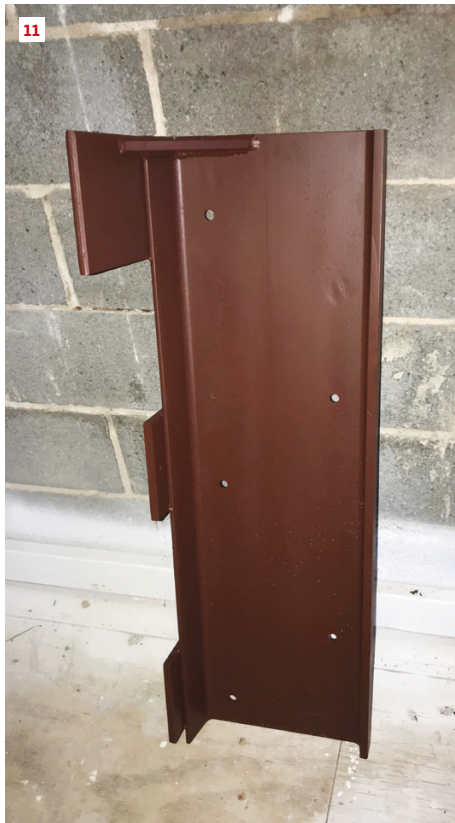
The author's approved drawings guided the fabrication of the support beam (11). With the beam lag-bolted to the trusses, the crew drilled holes for the anchors (12). The anchors were first snugged with an impact driver (13), and then given their final torque with a ratchet wrench (14). The final assembly will be concealed in the wall after the finishes are applied (15).

information, I drew up the beam with the supports, the gussets, and the fastener locations and sent the drawings to the engineer (9, 10). After getting his approval, I gave the drawings to my steel fabricator, and he made up the support beam with the welded support plates (11). The drawings were pretty basic, but doing them gave me control over exactly how the beam would turn out, and it saved me the expense of hiring someone to draw the beam.
