# BUILDING SCIENCE

## Summertime Moisture Problems Troubleshooting condensation in hot, humid weather

BY DOUG HORGAN

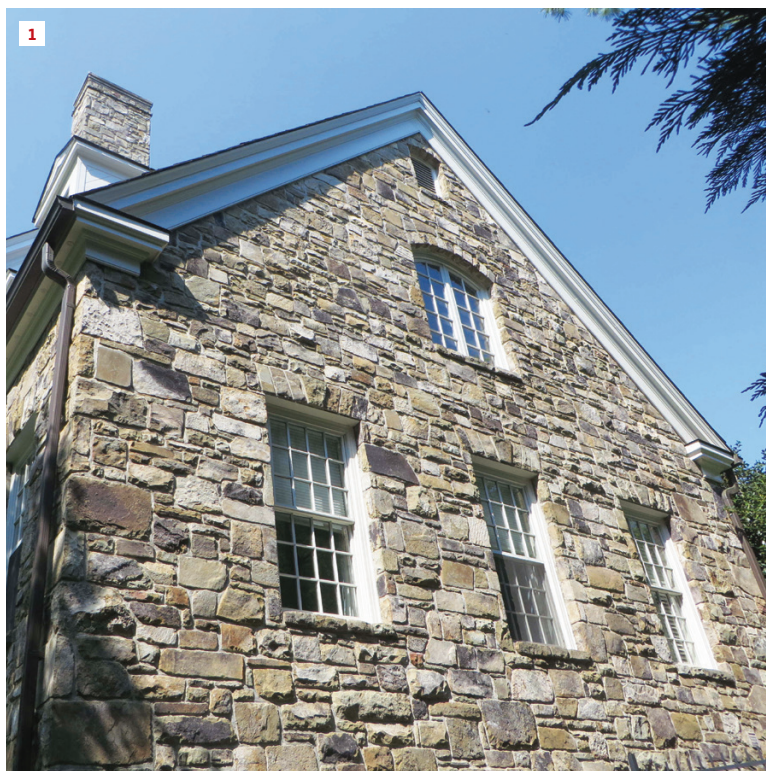
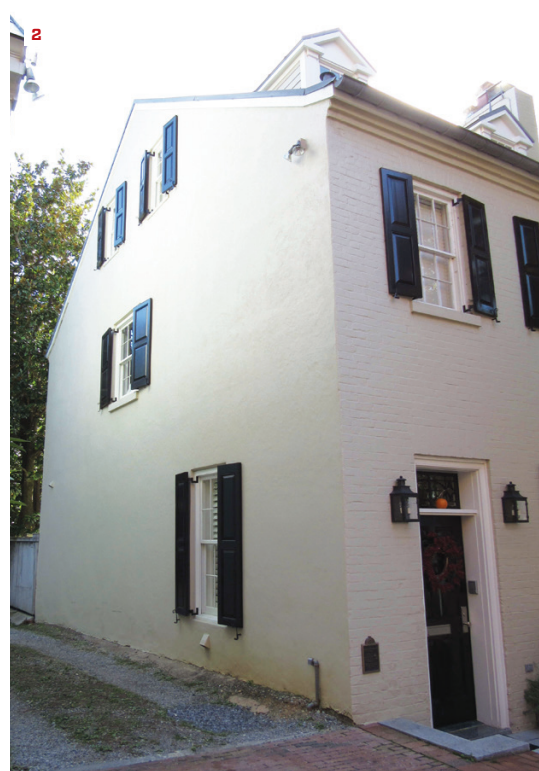
Masonry mass walls like this stone wall (1) and this stucco-covered brick wall (2) can soak up and hold rainwater. When sun strikes these walls, moisture can be driven inward and condense if it is prevented from drying further inward by materials such as poly vapor barriers, vinyl wallpaper, or vapor-impermeable paint (see page 39).

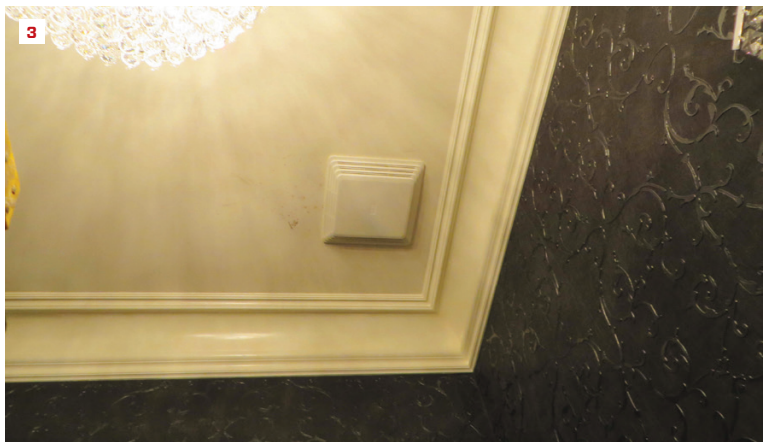
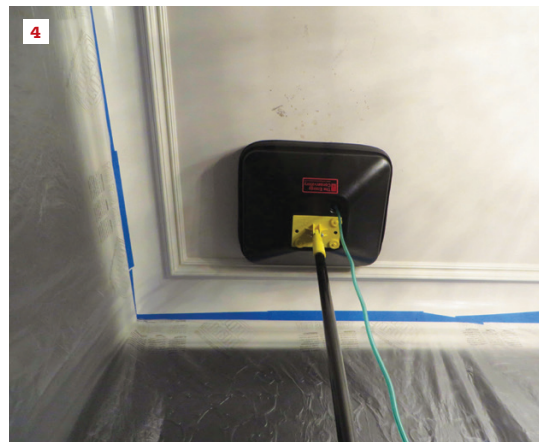
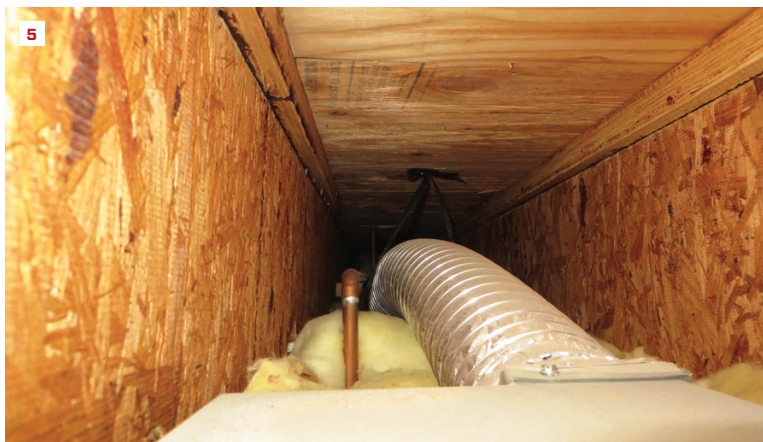
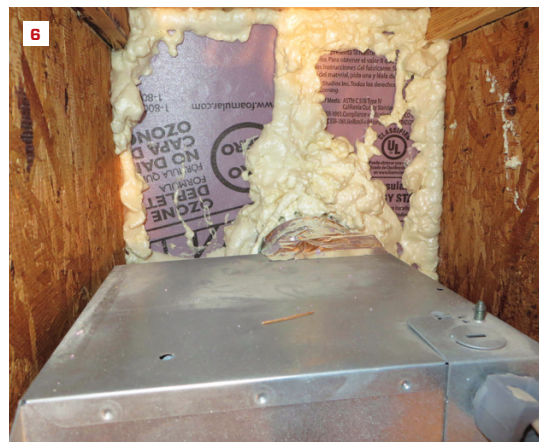
The ceiling near this bath fan (3) had a persistent mildew problem. Diagnostic testing (4) indicated a pressure difference driving moist outdoor air into the room. An open joist bay (5) created a highway for moist air. To fix the problem, the author's crew sealed up the joist bay (6) with rigid foam board and canned foam sealant.

In one case, clients called us to say that their cleaning service had cleaned mildew off the ceiling in the main-level powder room several times, but mildew kept returning. This room was on the middle of three levels and at least 20 feet from the outside walls on the same level. As the formal powder room, it had no shower or bath and was used extremely rarely. The mildew pattern did not

This issue appeared in summer, so there was plenty of available moisture in the outdoor air. The only relatively direct connection to outdoors from this room was via the bath vent fan. We used a pressure gauge to check whether pressure inside the fan was positive relative to the room (so air would move from the fan to the room) and if the room was negative relative to outdoors (so air would be sucked in from outside).

The pressure readings confirmed that both conditions existed, causing air to come in through the fan. Typical bath fan dampers are not airtight; a small amount of air can come through. If you depressurize a bathroom and pull air in through the bath fan duct over days and weeks, a fair amount of moisture can enter.

check the joist bay around the bath fan, and sure enough, the joist bay seemed to connect to the outdoors too.

Our solution was to block off the joist bay with foam board and can foam and add another damper to the bath-fan duct. We first tried a fabric “sock”-style damper, but it didn’t seal well under the low-flow conditions. So we installed a Fantech RSK spring-loaded butterfly backdraft damper, which did a better job.

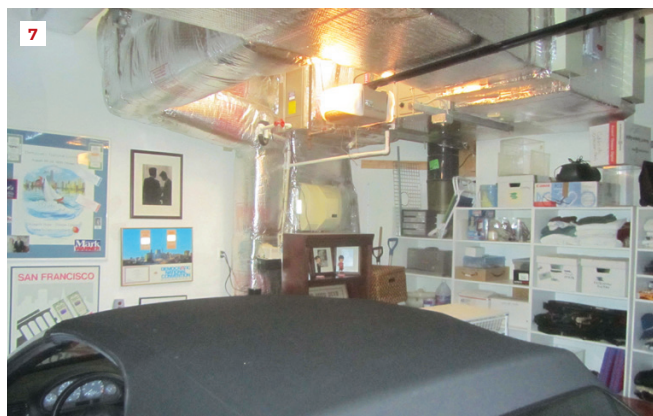
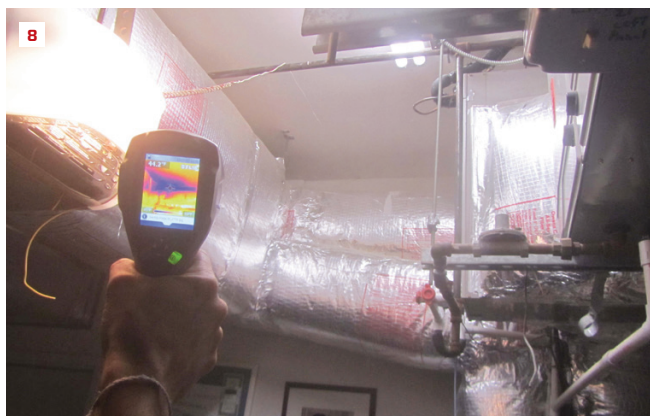
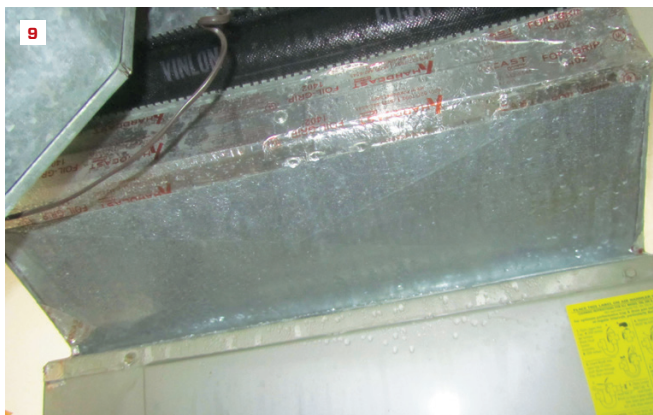
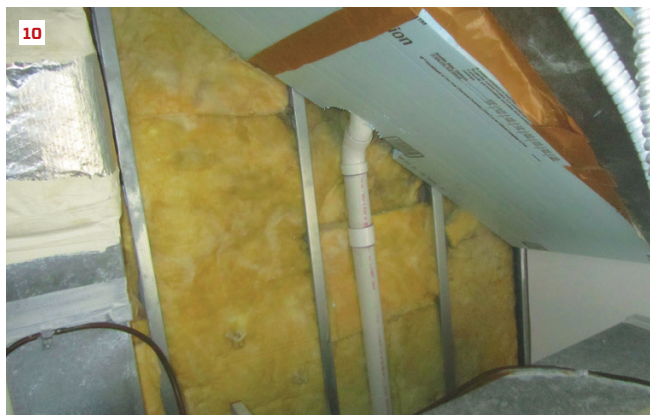
Air-conditioning ductwork in this garage (7) was a setup for moisture condensation. Infrared imaging detected cold spots on the ducts (8). Uninsulated ducts were dripping with condensed moisture (9). Inside the house, someone had tried to address the problem using XPS foam and packaging tape (10).

The house was an unusual five-story townhouse, built in a commercial style with metal framing. The two areas where ducts were covered in drips of condensation were the attic and the garage. (That’s right, they had an HVAC system mounted in the

garage—a risky proposition considering the pollutants.) Condensation forms when a surface is colder than the dew point of the air, so the ducts must have been colder than the dew point of the air in those locations.

Checking the ductwork with a thermal camera, we found that it was cool: in the 40s and 50s. The outdoor dew point in summer in our area is usually above 50°F, and sometimes even above 70°F. If humid air leaks into the house and hits the ductwork, condensation will form, and other than water leaks, air leaks are the most common source of the moisture condensing on ducts.

The thermal camera showed some cold spots worth investigating. In fact, in the photos above, you can see that someone must have recognized the problem in the attic area because they tried to use XPS foam board and what looked like packaging tape to block the air coming in. We used a blower door to depressurize the house, which makes air leaks very easy to find (you can feel the air blowing in from the bad ones, and you can use the thermal camera to find the others). Sure enough, there were some serious

leaks near the attic ducts: The bright yellow areas on the thermal pictures show warm temperatures where the hot summer air is leaking in.

Air leaks like these are easy to fix; in fact, even a homeowner with foam board and packaging tape can do an adequate job if they address the right areas. We use sheet materials, foams, tapes, and sealants that do a better job and last longer, but it's the same idea: Find the leaks and block the airflow with a combination of materials suited to the sizes of the gaps.

The garage was a different story. Garage doors are usually leaky when they're shut, and when they're open, they let in a lot of outdoor air. In this case, we added more insulation around more of the ductwork (there were some bare spots), and we tuned up the weatherstripping on the door as best we could. We also recommended a plug-in dehumidifier for the garage if the condensation continued to be an issue. Needless to say, ductwork and air handlers in garages are a bad idea, and no one should install such a setup in a new construction scenario.

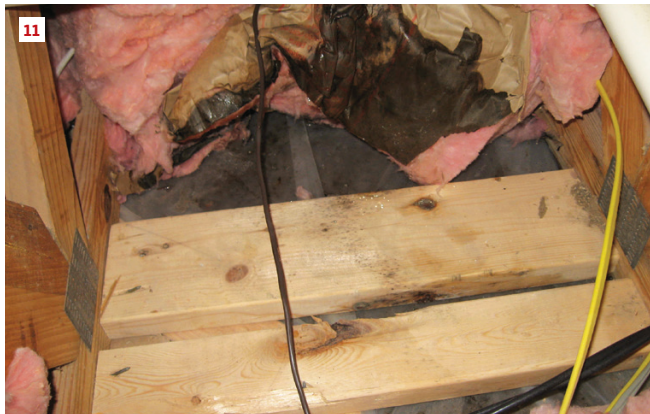
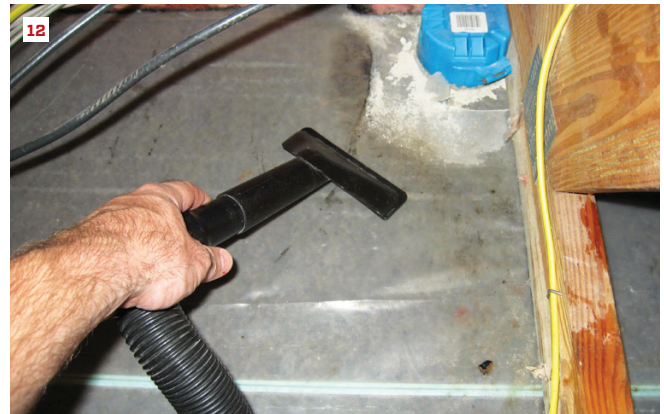
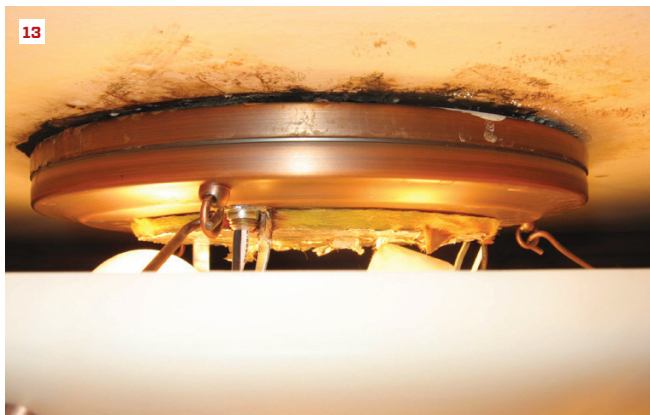
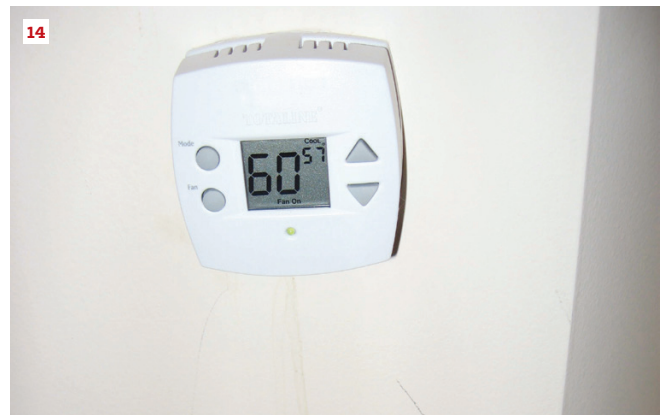
Moisture had soaked insulation above the poly vapor barrier of this wine room (11). The author vacuumed up puddles of water from on top of the poly (12). Bulk water was leaking into the room through a light fixture (13) and around a thermostat (14).

We installed a refrigerated wine room in the middle of a slab-on-grade ranch house. The next summer, the clients called us to report some unusual things: brown drips from the thermostat and around the door, mildew on the ceiling near the light, and an unpleasant smell.

At first, I thought it was condensate leaking from the mini-split cooler head, but on looking more closely, I saw that the water in that area started higher up the wall. "Roof leak," I thought, so I ran up to the hot, humid attic. I found lots of water up there—so much that it was dripping off the batt insulation I moved to see the ceiling. The surrounding wood framing was soaked, and I had to vacuum water off the plastic sheeting we had carefully applied across the wine room ceiling.

since the plastic was on the cool side of the assembly, moisture condensed into liquid on the cold plastic and then couldn't dry anywhere. It just pooled up, then leaked into the walls and the ceiling light.

We applied a layer of closed-cell spray foam over the top of the wine room. This blocks moisture as well as the plastic did, but because of its insulating properties, the attic side of the foam stays close to the attic temperature and never gets cool enough for moisture to accumulate on it. Our standard spec now is for a layer of foam board or spray foam surrounding any wine room.

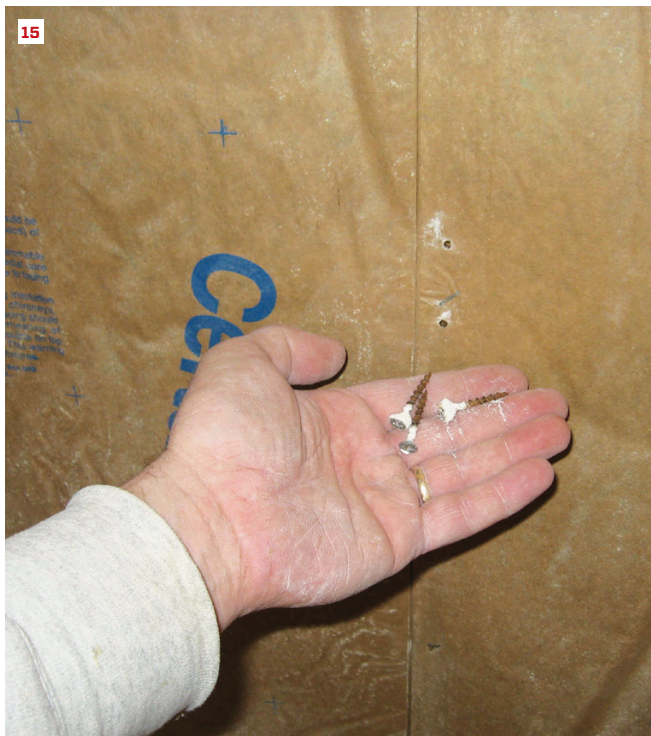
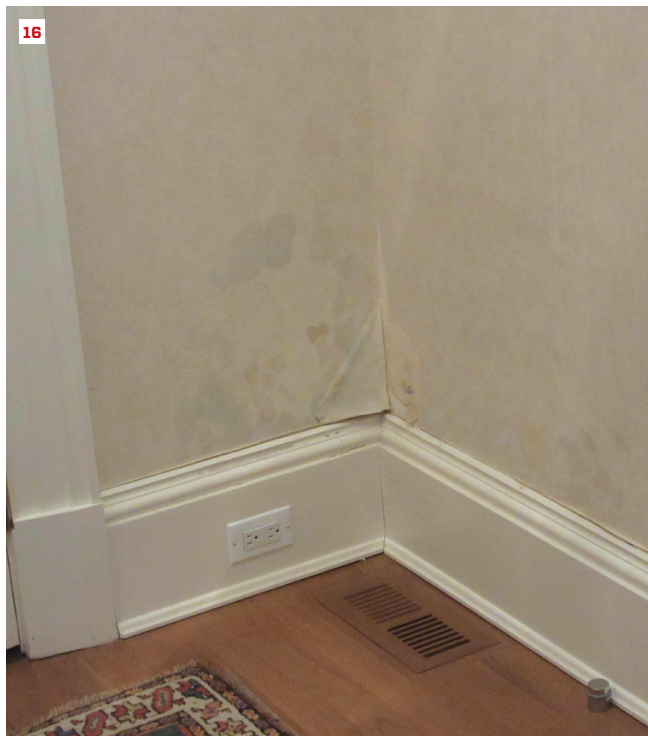
The author has seen more than one case of vapor drive through walls from the outside in. In one case, drywall screws were rusted by condensation (15). In another, mildew formed on the painted walls of the room (16).

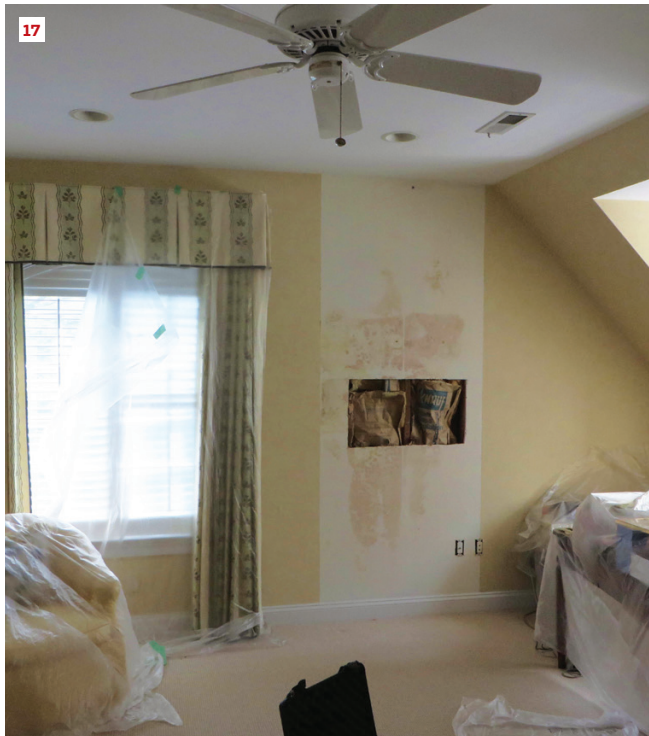
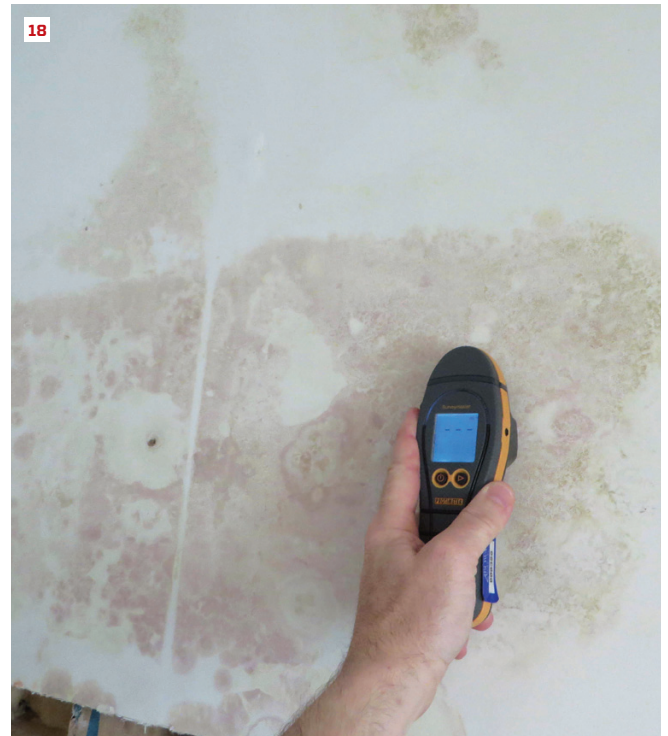
After lots of research, we identified the problem: A combination of rain wetting the stone exterior and sun heating it drove moisture into the walls, where, during air-conditioning season, the moisture condensed on the cold wallpaper. The accumulating moisture could not dry toward the interior.

This wall became damp when moisture was driven in from a stone exterior by sunshine and condensed on the back of the vinyl wallpaper (17). Parts of the wall that were opened up were able to dry to the inside and were quite dry when the author checked them (18). Removing the rest of the vinyl wallpaper addressed the problem satisfactorily.

Sounds familiar, right? Coming into this diagnostic with another option besides "water leak" was pretty helpful. There was an air-conditioner register blowing right on this part of the wall. The parts of the wall that were opened up were quite dry by the time they brought us in, weeks after the vinyl wallpaper had been removed and the wall cut open. Obviously, a lot of drying can happen when there's no wall covering at all and the wall was no longer accumulating moisture from the sun hitting the stone veneer

outside. The clients took our advice to remove the wallpaper, and the wall has been fine since.
