# HOME PERFORMANCE

## Controlling Air Infiltration Lessons learned from blower-door-test failure

BY MATT BOWERS

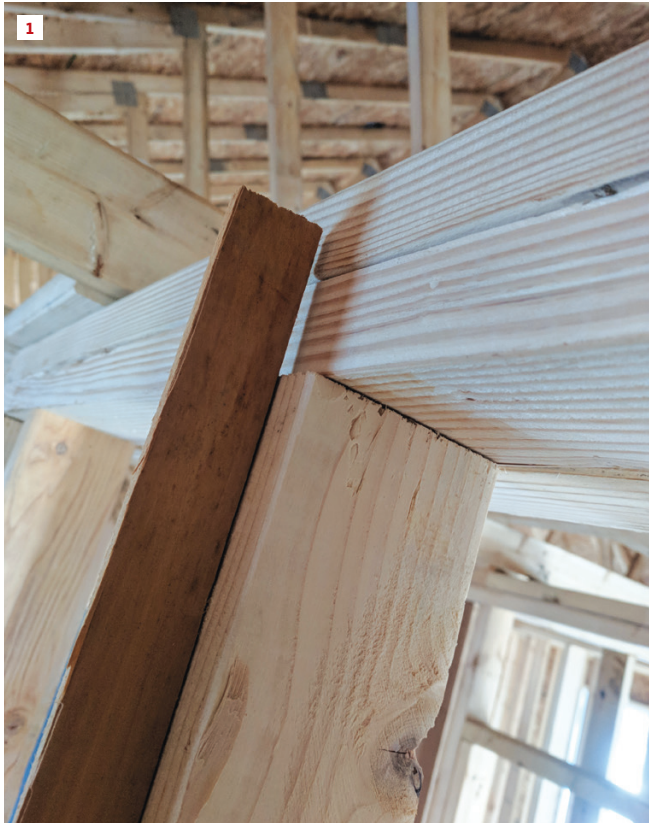
Studs often stand proud of the top plate—here, by a strong  $\frac{1}{8}$  inch (1). This situation will hold the drywall away from the top plate, allowing a pathway for air infiltration from the attic if not addressed. The author seals this joint from the top (2) in a home that failed its code-mandated blower-door test.

The joints between the wall drywall and the top plates—specifically, top plates that are exposed to an attic space, whether they are exterior-wall top plates or interior-partition-wall top plates—are often huge air-leakage areas. When you're framing a wall, if the stud is proud of the top plate by even  $\frac{1}{8}$  inch (1), the wall drywall is pushed far enough off the top plate to create a gap along the top plate that communicates between the wall cavity and the attic. Air from the unconditioned attic moves everywhere from there: I find air infiltration at interior door strikes, at all of the outlets, at switches, and at heating and cooling registers.

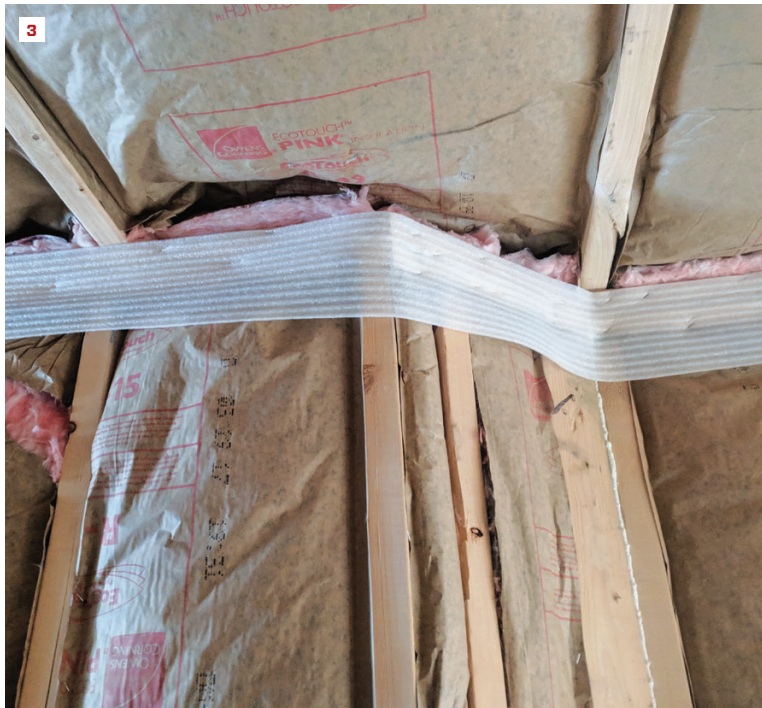
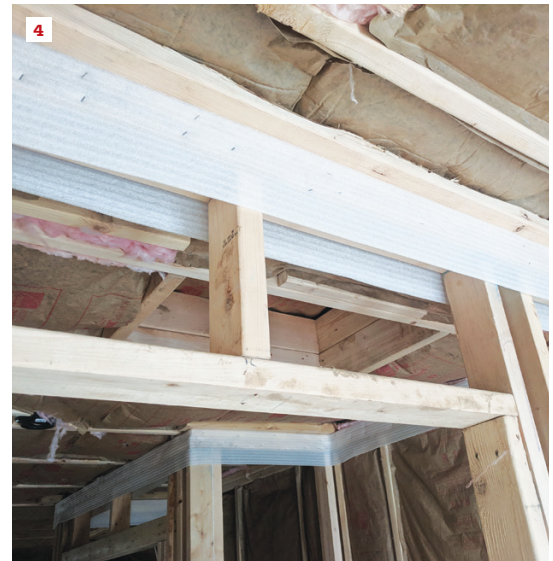
Here, the builder has applied sill-sealer material to the top plates in a home (3, 4). When drywall is installed, the sill sealer will form a gasketed seal and prevent air infiltration at the top of the wall.

instead of as a repair after failing a blower-door test. One solution that I recommend to builders is to use sill-sealer gasket material on their top plates to help cover that void (3, 4). When you roll out this 7-inch or 8-inch sill-seal gasket over the top plate, it makes a nice little gasket that the drywall can seal up to. Habitat for Humanity started doing that in my area and saw a significant improvement. The first house that I ever tested for the organization was at 9 air changes per hour, and now its houses are at about 2.

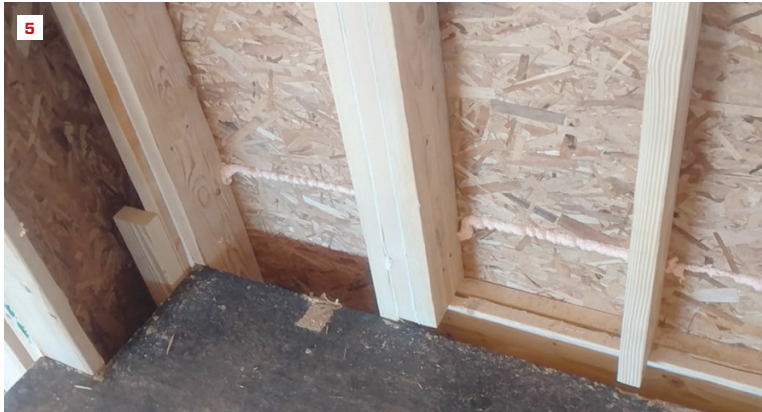
In my market, two-story entry foyers are common, and it's typical to find stairs to the second floor in that room. I frequently find leaks at the stair landing where it connects to the balloon-framed wall (5). The leak occurs where the drywall contacts the landing. If it's a carpeted landing, sealing that joint is as simple as pulling the carpeting back and caulking under the trim (6), and then tucking the carpet back in. If it's a finished hardwood floor, things are a little bit trickier: Sealing the joint requires pulling the trim off to access the joint between the drywall and the floor.

Here, the framing juncture between a stair landing and a balloon-framed wall has no solid blocking where drywall will meet the floor **(5)**. This creates a gap for air leakage. The author pulls back the carpet at a landing in a finished house and seals the joint with gun foam **(6)**. A stair against a garage wall **(7)** creates a highway for likely air infiltration.

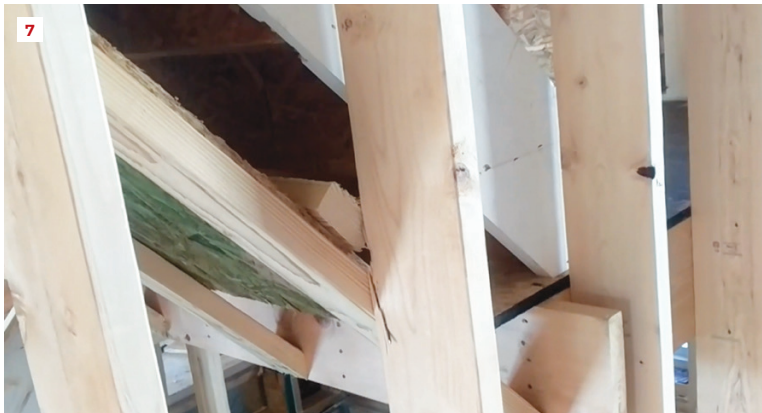
Another trouble spot I see quite often is where a staircase attaches to a wall between a house and the garage (7). In this case, there's usually a false ceiling on the underside of the staircase, and a wide-open air gap between the stairs and the garage wall. If the drywall on the garage side isn't sealed to the slab, which it's

usually not, then air can readily find its way into the garage wall, and then into the underside of the stairs, and then into all sorts of framing cavities in the main house.

To address this air-leakage pathway, I ask the builders I work with to seal the joint between the drywall and the garage slab or the band joist on the garage side of the wall. I also recommend installing an air-barrier material such as rigid foam board over the air gap between the staircase and its false ceiling. This is not a condition that can be easily addressed once the house is finished, so it should be taken care of at the framing stage.

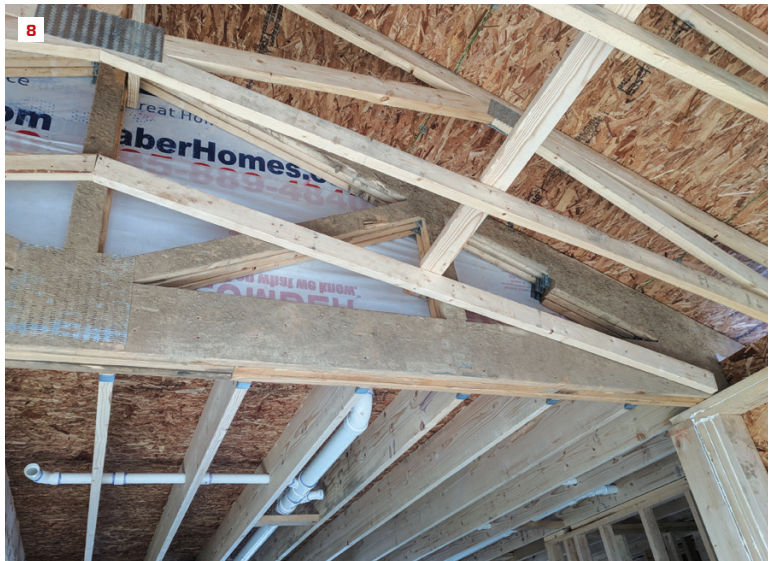
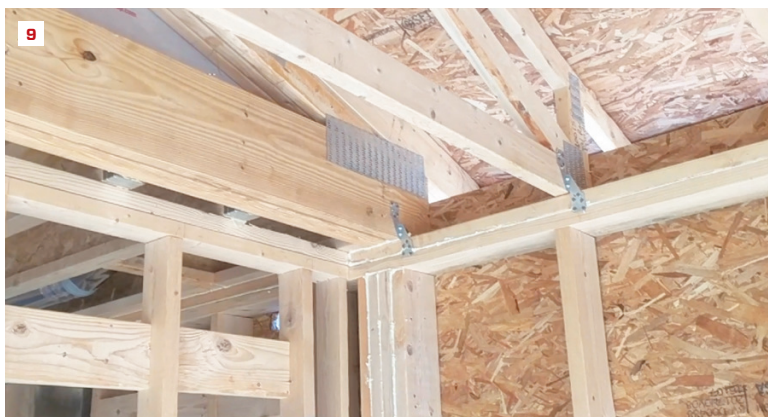
the back of a two-story main house. In the example shown here, a tripled-up girder truss supported the floor framing for the second floor of the main house, with the floor joists hung off of the truss **(8, 9)**. The vented attic of the lower space contacted the wall of the second story and its floor framing—which is also the ceiling framing for the first floor of the main house.

A scissors-truss roof abuts a carrying beam for a floor system (8), as does this flat ceiling truss (9). The leakage pathway is visible when the framing junction is viewed from the other side (10).

The time to address this problem is at the pre-drywall phase. At that point, critical air leak points can be identified and sealed with gun foam. The bottom of the girder truss or laminated beam should

be gasketed as well. I usually recommend that the builder or framer staple sill-seal gasket material on the underside of any place there are hangers supporting the second-story floor joists. This gasketing will seal the joint between the drywall and the beam or girder truss.

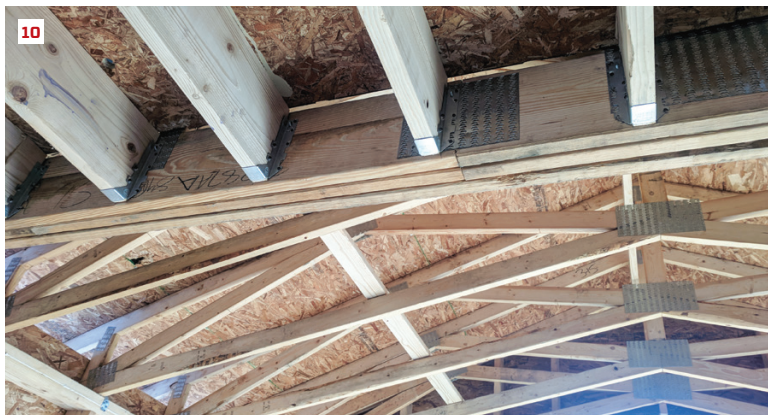
The hangers of the floor joists hold the drywall down from the girder truss, and the second-floor subfloor can't reach all the way out to the edge of the girder truss because the chord members are in the way **(10)**. As a result, a pathway is opened up for unconditioned air in the ventilated lower attic to move into the first-floor ceiling assembly and down into the room through recessed lights—or, depending on the air pressures, for conditioned air to find its way into the attic. This is just about impossible to fix once the house is finished.
