BY KYLE DIAMOND

## Honey Bee Rescue

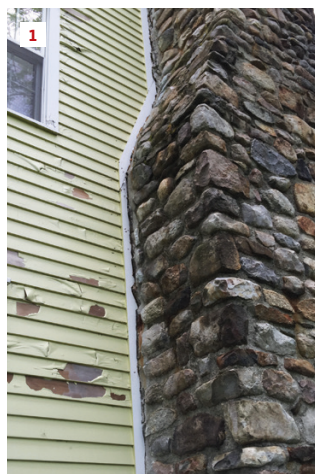
A few years ago, during an initial walk-through for an exterior restoration project, we encountered a large colony of bees nesting in the home's gable-end wall. Wild honey bees were flying in and out of a gap between the stone chimney and abutting vertical trim (1). Infrared imaging taken from outside the house revealed the nest's rough size and location, which was behind the chimney in the vicinity of the second-floor framing (2). The homeowners informed us that the three-story neo-colonial had been rebuilt between a couple of older stone chimneys (on either end of the house) some 30 years ago. We could see that the chimney was pulling slightly away from the wall and that the previous builder did a so-so job scribing the vertical trim to the stone and sealing the joint. This combination allowed the bees easy access into the wall cavity.

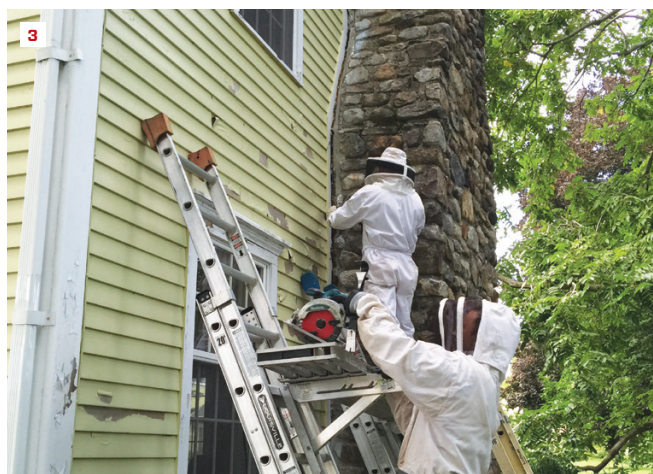
We began by removing the vertical trim covering the bees' entry point (3). This allowed the beekeeper to use his bee vacuum to safely gobble up large amounts of bees. Then, we cut back some of the existing siding and sheathing in an effort to access the nest's wax comb, but hit a road block. Apparently, when the house was rebuilt, the builder made the first-floor ceiling higher and drywalled over an old fireplace located at the old second-floor elevation (the firebox ended up falling between the two floors in the new house). The bees apparently built their nest inside this old firebox, which was inaccessible from the exterior.

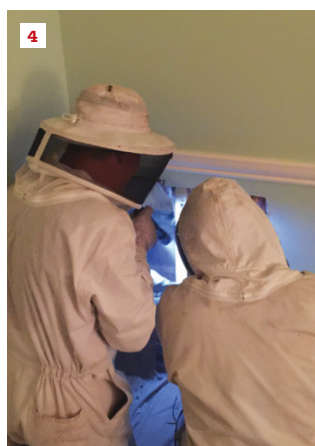
We moved inside and cut out a 3-foot-square hole in the interior wall at the approximate location where we had been working outside (4). We found the bulk of the bees thriving in the abandoned firebox. The beekeeper vacuumed up the remaining bees and removed the honeycomb (5). He took the bees (and about five gallons of honey) and relocated the hive. To prevent bees from returning and keep mice and insects from being attracted to the site, we cleaned the masonry with hot water and bleach to remove any residual honey. Our crew closed up the firebox and repaired the wall, and our painter made it look as good as new. With the relocation successfully completed, we moved on to complete the exterior repairs.
