New Windows for Old Brick Veneer Walls Sealing off the windows when there's no WRB

BY BILL ROBINSON

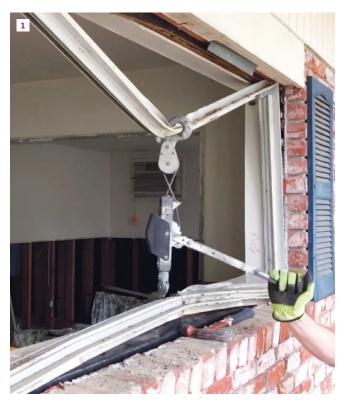
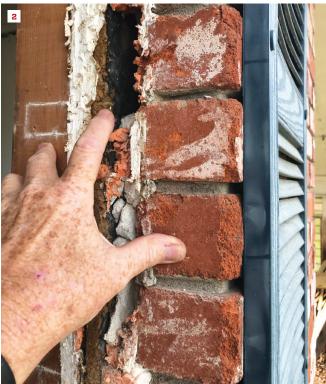
The author identified several existing homes that were gutted and standing empty. The crew pulled existing single-glazed windows from the openings (1). Inspection revealed that, in general, there was no intact drainage plane to be identified behind the existing brick (2), so the decision was made to isolate the replacement windows from the walls.

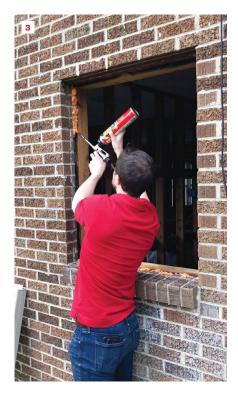
Some openings were prepped by filling the gap between the brick and the wall framing with gun foam (3), and caulking over the rough jambs (4). Site-bent coil stock was used at the head and sill of the openings (5) to direct water out to the face of the exterior.

There were two basic steps involved once the conditions were identified. We needed to fill the gap between the interior face of the brick and the exterior face of the sheathing, then we needed to seal up the opening against water intrusion. We filled the gaps using gun foam or backer rod, then covered the rough-opening jamb area with liquid-applied flashing to create a moisture-resistant cavity to keep water from entering the wall and to isolate the opening. On these perimeter gap details, some form of gap filler (such as backer rod) is necessary to create an effective caulk joint. This prevents three-sided adhesion and creates an hourglass-shaped caulk bead. It's important to have a sealant with high solids content and with good adhesion (meaning it sticks to the substrate) and good cohesion (meaning it sticks to itself).

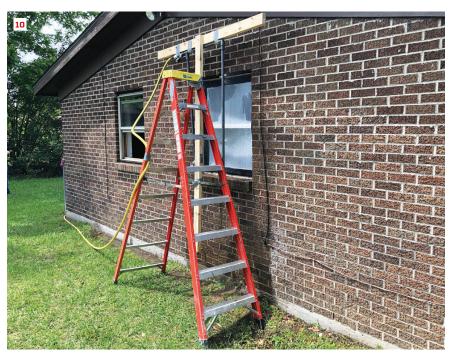
A standard ASTM test rig was set up to apply a constant spray of water to the window opening (10-12). The windows were taped off so that the test would concentrate on the installation method, not on possible leaks in the windows themselves.

Window testing was done by Intertek to the ASTM E 1105 standard. This test looks at the install only, so the window was taped off from the exterior to exclude any flaws in the window itself.

A calibrated spray rack was set up on the exterior, and to the interior, a chamber was established to allow a negative pressure to the test area. The spray rack is calibrated to deliver five gallons per hour of water per square foot of window opening, to simulate a heavy rain. (In passing, the test rack on the exterior did not look like it was putting out the torrential summer rains we get here on the Gulf Coast, although it might represent heavy rain somewhere else.) The variable was the negative pressure on the interior; there were three timed cycles using increasing negative pressure to determine how well the install would withstand defined wind and rain exposures. The test pressures were marked on the interior test film to keep track.
