Exterior Molding Repairs That Last

BY TOM O'BRIEN

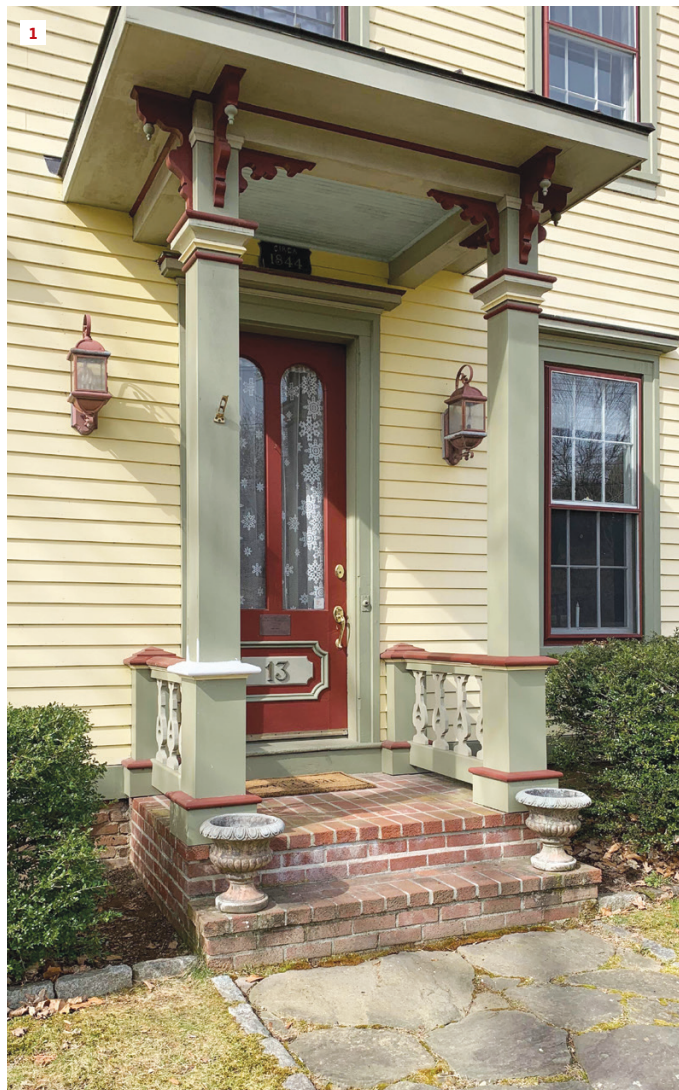
The porch trim on a historic 19th-century Italianate home wraps around the porch column, rather than simply butting up to it. Although beautiful, the design is vulnerable to moisture intrusion, which inevitably led to rot. This prompted the author to use epoxy as part of a long-term solution.

As a case in point, I was recently asked to repair a handrail on the front porch of a 19th century Italianate home in our town’s central historic district (1). A unique feature of this rail was how it wrapped around the porch column, rather than simply butting up to it. Although the design was beautiful, the manner in which it was assembled had left it vulnerable to moisture intrusion; the joint where the rail sections attached to the column was obviously problematic, but it wasn’t until I excavated the damage that I discovered that the bullnose edges were separate pieces, nailed and glued on. With all of those vertical joints solely dependent on caulk or glue to shed water, it’s no surprise that rot eventually found a foothold (2).

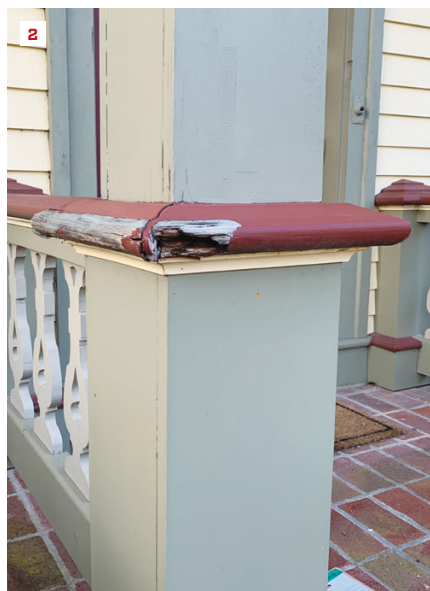
New England's volatile climate took its toll on this porch trim (2). A few severely damaged pieces had to be replaced (3). But those with minor deterioration, such as this column (4), which would have been prohibitively expensive to replace, could be stabilized with borate-based wood preservatives and repaired with epoxy.

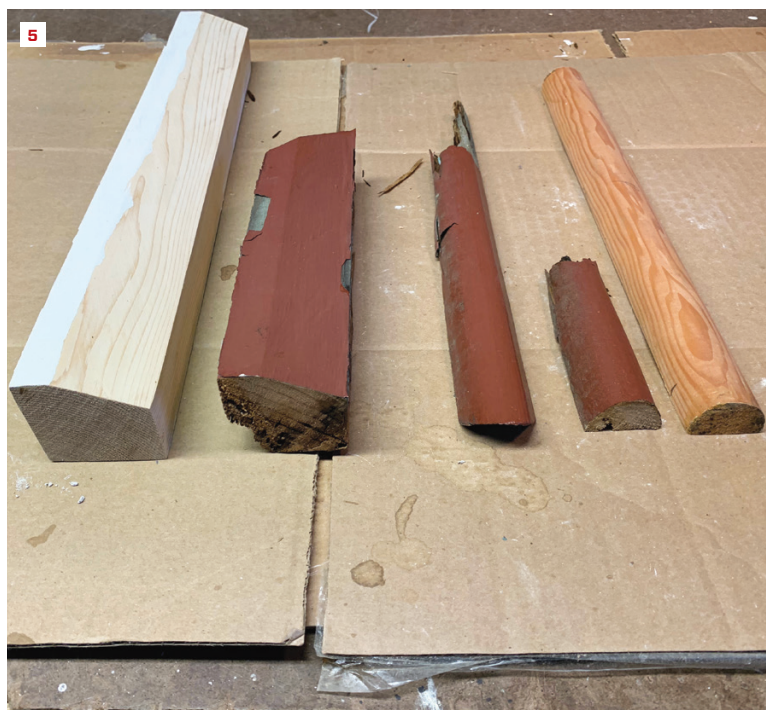
The author cut replacement moldings to size on a table saw, then primed them on their reverse sides (5). As soon as the primer was dry, he immersed the end grain in a borate solution to prevent rot formation (6).

available from a supplier, I've always been able to get there by some combination of portable planer, table saw, router bits, and profile sander. For this project, it turned out that the bullnose was exactly the same shape as a $1\frac{5}{16}$ -inch closet pole, so all I needed was a table saw (5).

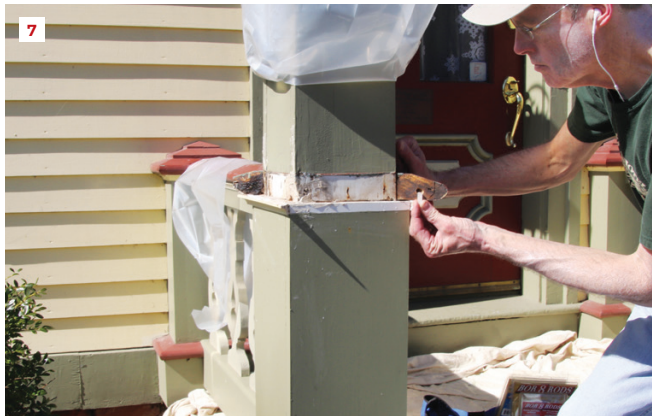
Before the miters are assembled, the author drills a hole and inserts a Bor8Rod that will provide an extra measure of insurance against rot (7).

Back on the jobsite, the old handrail pieces that we decided to save were given a double shot of borates. First, I sprayed the liquid solution on all of their porous (unpainted) surfaces. Then I drilled a $\frac{23}{64}$ -inch hole through the mitered ends and the edges that would be covered by the replacement bullnose, and I inserted a $\frac{1}{3}$ -inch-by-1-inch Bor8Rod into each hole (7). This crystalline tube of boric acid, which is available in a variety of sizes, serves like a time-release capsule that stays dormant unless it gets wet, whereupon it dissolves and kills any rot spores that attempt to gain a foothold.

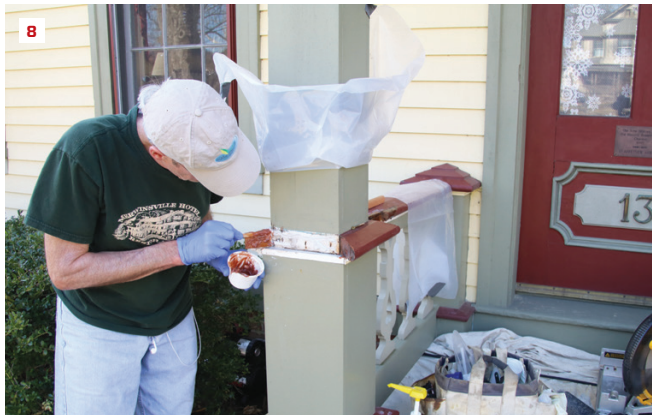
Marine epoxy adhesive ensures that miter joints that are exposed to the elements won't separate (8).

As soon as the wood was saturated with epoxy, I added West System #407 Low-Density Filler to the remaining liquid and stirred enough of it in to create a gap-filling adhesive roughly the consistency of mayonnaise. After spreading a thin layer of this concoction on one side of each joint (8), I assembled the pieces and fastened them with stainless steel air nails. Then I wiped the squeeze-out from each joint and covered the repair with plastic to keep the heat in overnight.

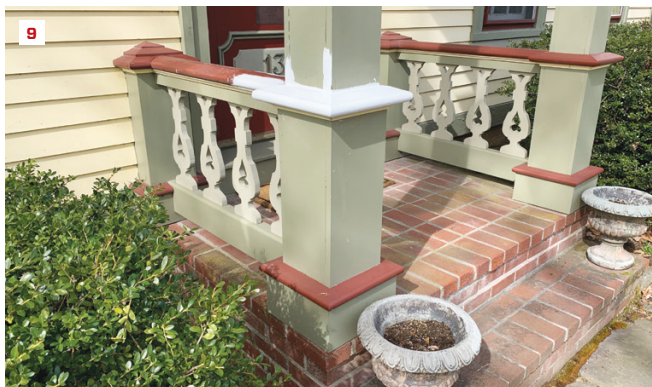
With two coats of paint and an annual inspection, this repair should last indefinitely (9).

The following day, after I sanded the rough spots, all the railing would require from then on was primer, caulk, paint, and (hopefully) an annual inspection (9).
