# STRUCTURE

## Beam-Line Replacement

A streamlined approach to a common structural renovation

BY JAKE LEWANDOWSKI

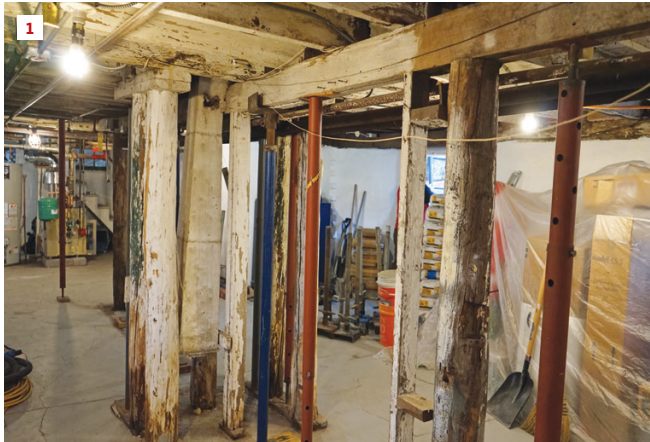
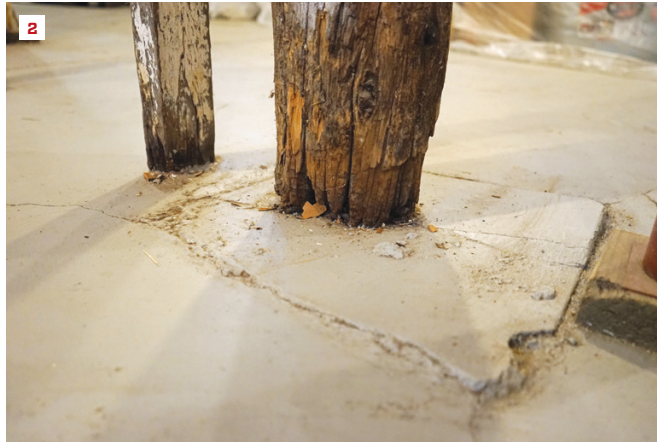
Here's the condition of the existing beam line we found when arriving at the job. This photo (1) shows the original wood posts clustered around the chimney location. Over time, steel "jack posts" (red), which should be considered temporary and do not meet code, had been added. The original posts, showing signs of deterioration from wicking ground moisture (2), were supported on brick footings, over which a thin "rat slab" had been poured at some point to cover the original dirt floor.

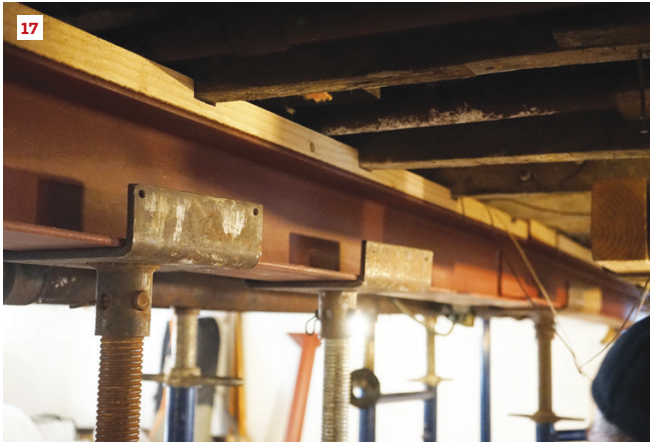
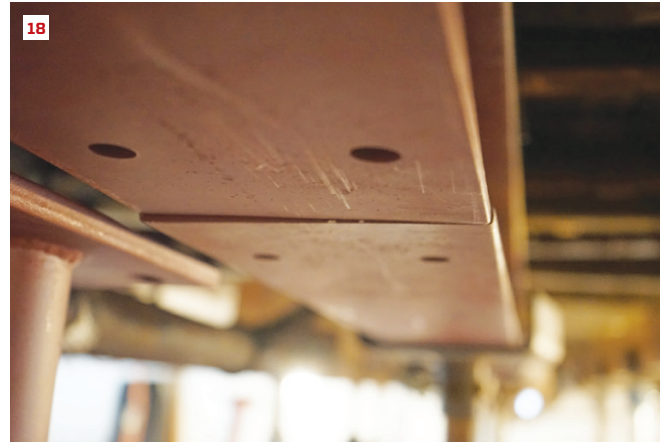
With the mortises cut, the variation in the bottom elevation of the joists was apparent (17). Such variation in joist size is common in older homes. When the house was framed, lumber dimensions varied more than we typically see today, and the carpenters were only concerned with having the tops of the joists at the same height. Once the mortises were cut, the beam sections aligned to within  $\frac{1}{16}$  inch or so; they would be pulled into perfect alignment when the post was bolted in place (18).
