BY FRANK WOESTE AND JOSEPH LOFERSKI

Ledger Strips and the Code

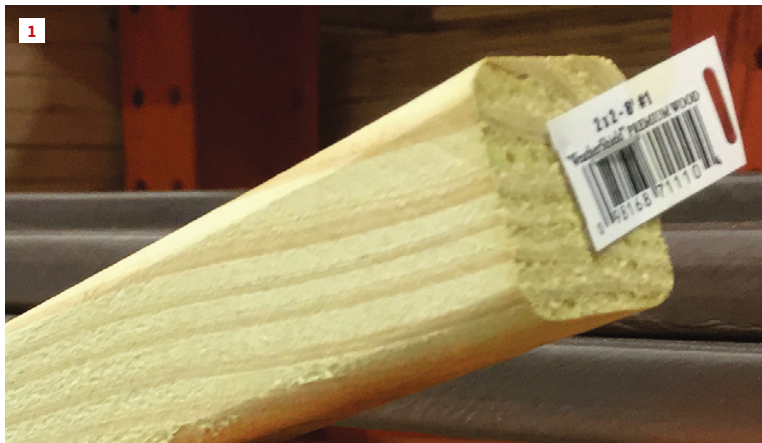
Typical of commercially available stress-rated pressure-treated 2x2 southern pine, this nominal 2x2 purchased at a lumberyard measures 1³/₈ inches by 1³/₈ inches, while the treatment tag reads 1.3125 inches by 1.3125 inches. Neither the measured nor the tag dimensions conform to the nominal dimensions of a 2x2 specified in the 2015 IRC.

We went to our local big-box lumberyard and purchased dimensional PT framing lumber and 2x2x8s for our testing (1). When we measured the cross-section dimensions of the nominal 2x2s with a tape, they averaged 1³/₈ inches by 1³/₈ inches (1.375 by 1.375), while the treatment tags on the ends indicated that the 2x2s measured 1.3125 inches by 1.3125 inches. As such, neither the actual measured dimensions nor the dimensions on the

treatment tag conformed to the requirements in the 2015 IRC, which specifies that a nominal 2x2 measure 51mm by 51mm, or 1½ inches by 1½ inches (2015 IRC R506.2).

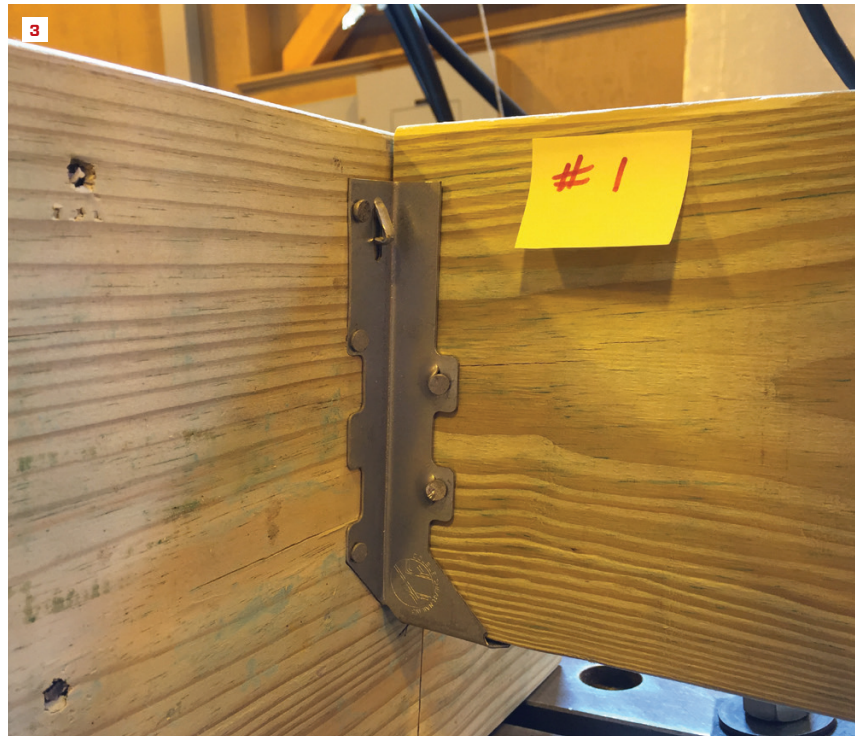
To measure the load capacity and deflection of a 2x2 ledger connection per the 2015 IRC, the authors assembled this laboratory test. On one side of the assembly, a simulated 2x8 joist was supported by a 2x2 ledger strip nailed to a 2x12 with four 10D (3-in. x 0.148-in.) polymer-coated smooth-shank nails (2). On the other end of the assembly, the joist was supported by a Simpson Strong-Tie 316 stainless steel LUS28SS joist hanger and ring-shank 316 stainless steel nails (SSA10DD 3-in. x 0.148-in.) (3). Loads were applied by a hydraulic ram controlled by a uniform downward movement, allowing the load value to peak and then fall off to a much lower value.

Our test assembly consisted of a 2x8 joist fastened to two 2x12s to create two joist-to-framing connections, each sharing 50% of the total applied load from a hydraulic ram. On one end, the joist was supported by a 2x2 ledger nailed to the 2x12. For lateral support, three 10D toenails were installed, with two on one side of the 2x8 joist and one on the other side, per the 2015 IRC. On the other end, the joist was supported by a stainless steel joist hanger. An electronic device—called an LVDT, or linear variable differential transformer—was used to measure the vertical deflection of the end of the simulated 2x8 joist relative to the top of the simulated deck ledger (2, 3).

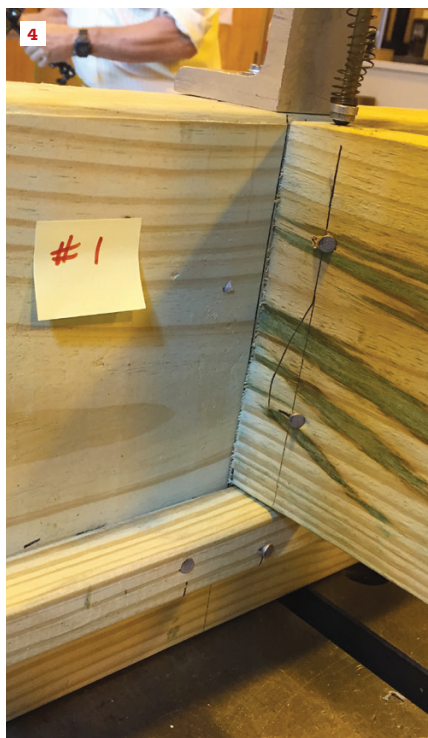
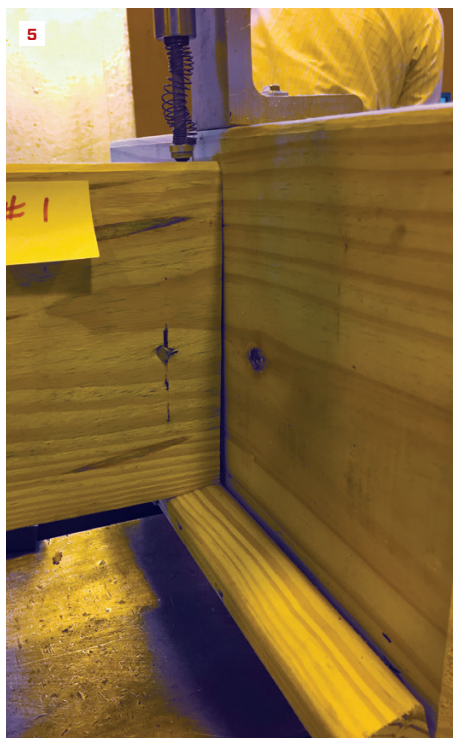
Before the vertical load was applied to the test assembly, the 2x2 ledger strip was snugly attached to the simulated 2x12 deck ledger (4). As the load on the joist increased, substantial rotation of the ledger strip was evident, as indicated by the angle (bottom right in photo) between the 2x2 and the deck ledger (5). As can be seen by the separation between the joist and the ledger after completion of the load test, a supported floor and ledger would have collapsed under a gravity-type loading, such as the load produced by deck occupants (6).

As we applied a load to the test assembly (4–6), we were particularly interested to see the counterclockwise rotation of the 2x2 ledger strip, which created a pronounced "V" between the 2x2 and deck ledger (or support beam). We anticipated that this would happen, due to the fact that the depth of the nailed 2x2 ledger strip was only 1⅜ inches, allowing it to rotate because it wasn't laterally restrained by other rows of nails. A more effective approach would be to support the joists with a much deeper member, such as a 2x6, nailed along both the top and bottom edges.
