## Log Cabin Envelope Makeover

## Building Envelope Makeover

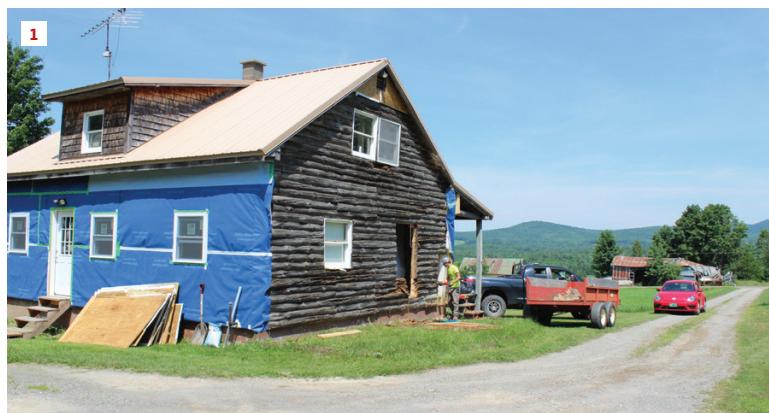
The 40-year-old cabin was built on an exposed site in a region notorious for strong prevailing “Quebec” winds out of the Northwest (1). Rot had penetrated 2 to 3 inches into the 8-inch-wide log walls, with the worst damage at sill locations (2). The log wall was cut into manageable pieces and removed (3).

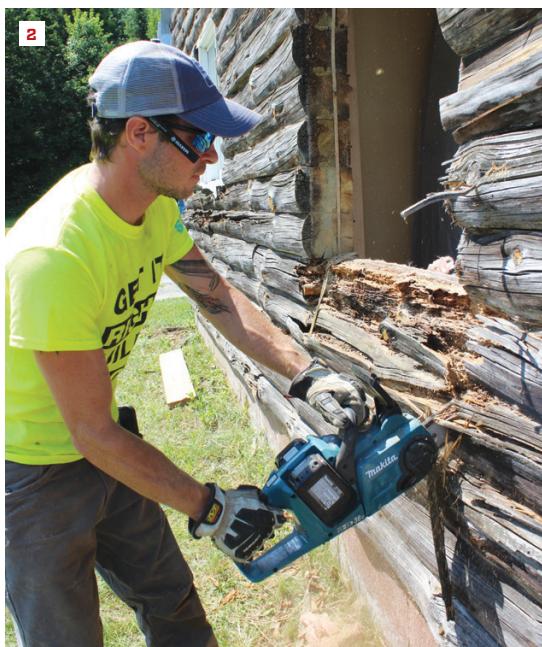
Upon arrival, I could see that the cabin’s exterior had seen better days. Built in the early 1980s by the father, its white pine log walls were severely deteriorated from a combination of years of hard

Northeast weather, the exposed location (the cabin sat in the middle of hundreds of acres of open hayfield), and a lack of regular maintenance with wood sealer. After a long conversation with the father and son, I agreed to take on the gnarly building-envelope retrofit, which encompassed removing the existing log walls, windows, and doors all while working around the homeowner and his indoor cat.

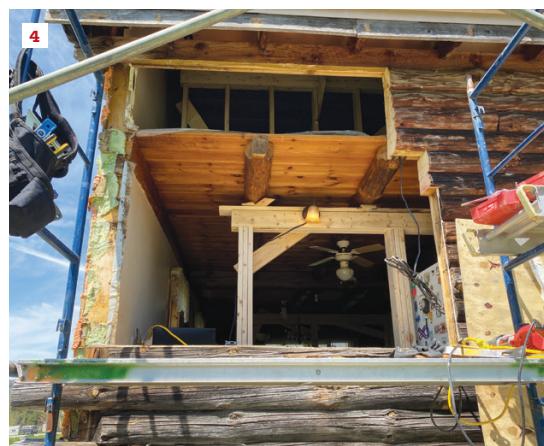
Working piecemeal, alone, the author removed only as much of the log wall as he could replace and seal up in a day (4). The new wall was built from the inside out, starting with a continuous bead of sealant applied to the top of the existing foundation (5). The vapor-control membrane was taped from the foundation up to an existing rough-sawn square top plate (6).

**Working piecemeal, alone.** After the lockdown ended, I installed temporary support walls running the length of the home to support the roof and floor loads. I laid out the framework as well as was possible around homeowner’s living space, then began to remove the rotted log walls in small sections beginning at one end of the rear bearing wall. I worked piecemeal, removing only as much wall as I could replace and seal up in a day.

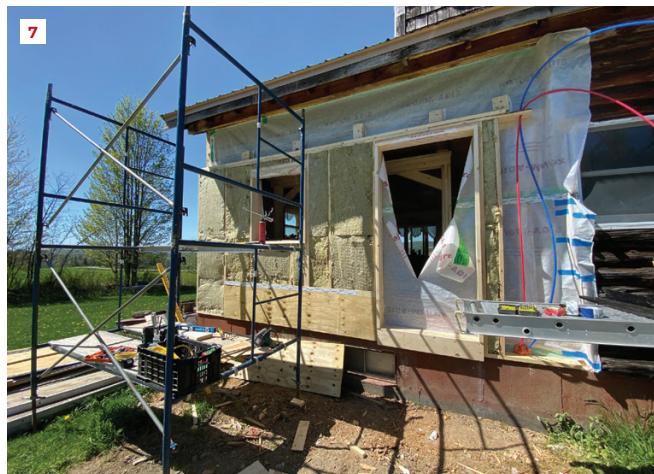
The replacement wall was pieced together from the inside out (7). The author worked his way down the rear wall (8), then the front bearing wall, and finished up with the gable end (9, 10). Although the home was clad with vinyl siding (11) and the exterior “essence” of the log cabin was removed, the main goals were to improve the comfort and longevity of the home.

Next, I pieced together the studwall and infilled the bays with Roxul batts. Then I applied 2-inch foil-faced rigid polyiso, 1/2-inch CDX plywood sheathing, and a WRB membrane. With that wall section sealed up, I moved on to another section of the wall and repeated the process, working my way around the house.
