## Updating a Row House Bathroom

BY ROB CORBO

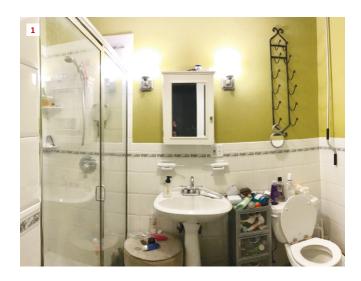
## **Existing Bathroom**

## **Updated Bathroom**

The original 20-year-old bathroom (1) felt dated to the homeowners, who preferred a more contemporary look. Moving the toilet to the opposite wall and installing built-in shelving and a pocket-style entry door maximized the available space in the bathroom's modest footprint.

To strengthen the floor system for the new tile, we sistered new joists onto the existing 2x8 floor framing, straightening and leveling the floor in the process. After the plumber made needed modifications to the underfloor shower and toilet drain lines, we laid down a new plywood subfloor, gluing and screwing the plywood to the framing (see before and after floor plans, left).

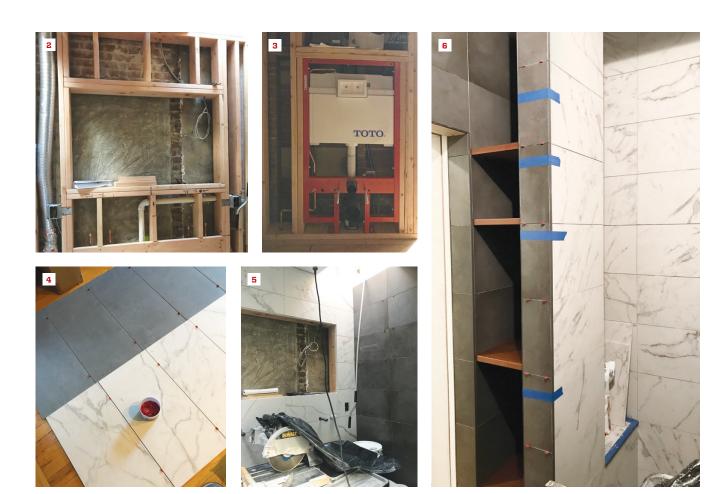
New 2x6 wall framing and solid blocking were needed for the wall-hung vanity and recessed cabinet above (2) and for the toilet's in-wall tank and mounting system (3). The two wall-tile selections were slightly different sizes (4), requiring different-sized grout joints to ensure that they lined up in the corners where they met (5, 6).

The Toto Aquia wall-hung toilet that our clients had selected required 2x6 framing. The unit has an in-wall tank system that requires a minimum 5½ inches of clearance and has a steel support frame with specific rough-opening requirements (3). Because the walls would be clad with large-format porcelain tile, it was critical to use straight framing and install it so that it was perfectly plumb.

a test layout with the two nominally sized 12-by-24-inch tiles, we discovered that they were slightly different heights (4). To accommodate the size difference between the two tiles so they would still be aligned at the corners where they met, he installed the white tile with wider grout joints (5, 6).

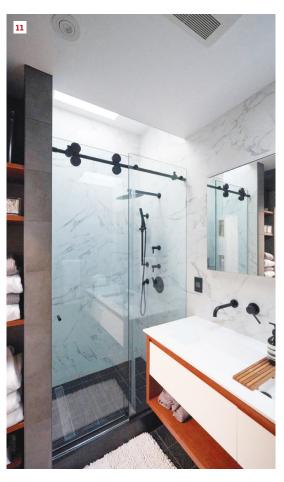
The clients selected all of the finishes and fixtures, including the recessed cabinet (7) and barn door-style shower-door hardware (8). Skylights over the shower and sink (9) make up for the room's lack of windows, while the wall-hung toilet lends the new bathroom a contemporary look (10). The frameless bypass door provides easy access to the shower (11).

**Finishing up.** To prepare for the installation of the room's large recessed medicine cabinet, we had framed a rough opening in the wall and roughed in wiring for its integral lighting. After the tile was grouted, we installed the cabinet (7), along with the wallhung vanity beneath it.

To maximize the small room's volume, our clients opted for a bypass-style shower door sourced from a local supplier, Glasscrafters (8). The shower features a built-in seat topped by a solid black granite slab that matches the stone used to cap the shower curb. Recessed niches above the seat provide plenty of shelf space for shower accessories. We also replaced a pair of skylights, one in the shower, and one over the vanity (9).

Our clients chose the wall-hung toilet because of its contemporary, easy-to-clean style, but it also offers another benefit: It occupies slightly less floor space than a standard toilet, projecting out from the wall only 21 inches, compared with 26 inches or more for a standard toilet. The few extra inches—along with the relatively narrow, 22-inch-deep wall-hung vanity—make a difference in a bathroom that is less than 6 feet wide. This particular model has a dual 1.6/0.9 gallons per flush feature, with controls mounted on a panel above the toilet (10).

To supplement the storage under the vanity, we built a niche next to the entry door. The cherry shelving in the niche matches the vanity (11) and adds a warm touch to the hard surfaces in the room. Pleased, our clients next focused their sights on their second-floor bath.
