## Roof Collapse Averted

A simple framing error almost led to a total building failure

BY DARREN TRACY, P.E.

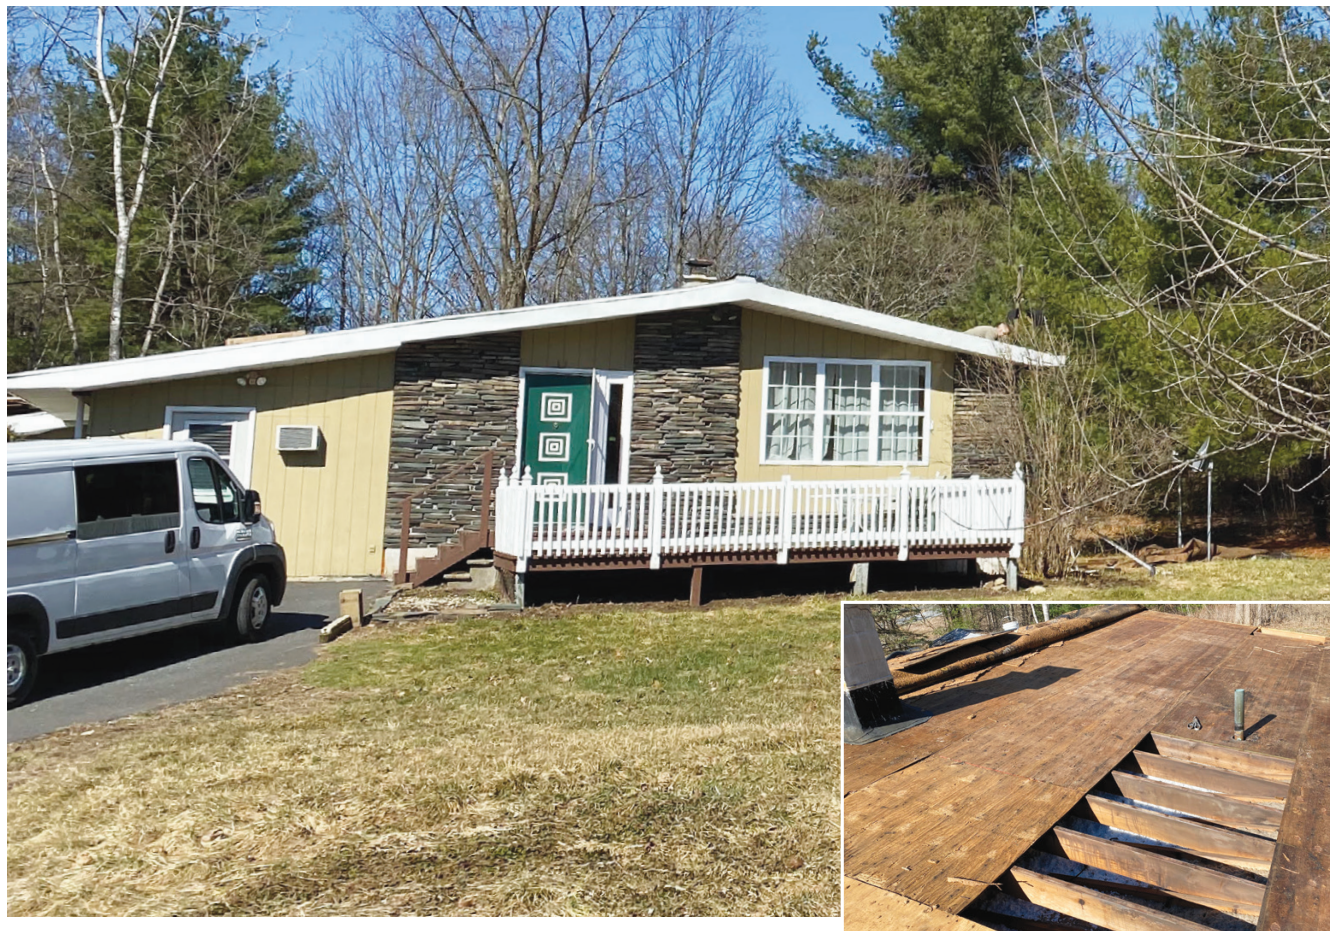
When the old rubber roof membrane and protection board were removed, I noticed undulations in the roof plane. These are visible in the inset photo above. Much of the plywood sheathing was loose and needed refastening as well. No sheathing clips were used when this home was constructed, probably in the 1960s or 70s. I also noticed a slight dip in one part of the ridge. It wasn't significant and a layperson may not have noticed it, but a carpenter tends to notice these things as a natural response to years on the job trying to make items plumb, level, and square.

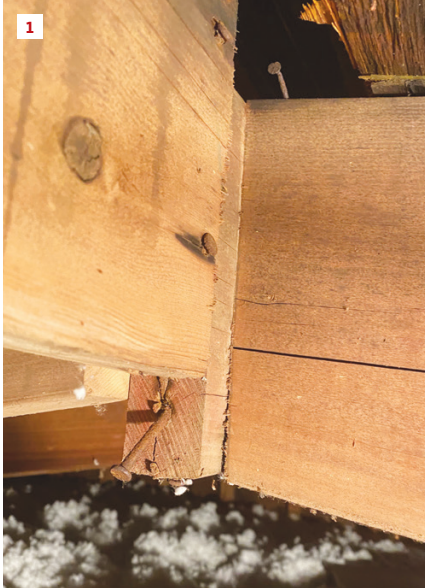
One sign that something was wrong was a slight dip in part of the ridge that was visible from the exterior when the roofing was stripped. Inside the attic, the problem was much more apparent: One ridge board had dropped approximately 1<sup>3</sup>/<sub>4</sub> inches **(1)**. Along the ridge board, some of the rafters had pulled away **(2)**. Remediation began with jacking the ridge board back in place **(3)**.

I decided to take a closer look in the attic, so I got as skinny as I could and shimmied my way into the shallow attic space. It was a good thing that I did! To my astonishment, the ridge board had dropped in some locations, and many of the rafters were pulling away from it.

If photos 1 and 2 (on the previous page) don't get your attention as a builder, engineer, or landlord, nothing will. The roof was in imminent danger of collapse had it been loaded with shingle bundles. Almost certainly, the roof would have collapsed during the upcoming

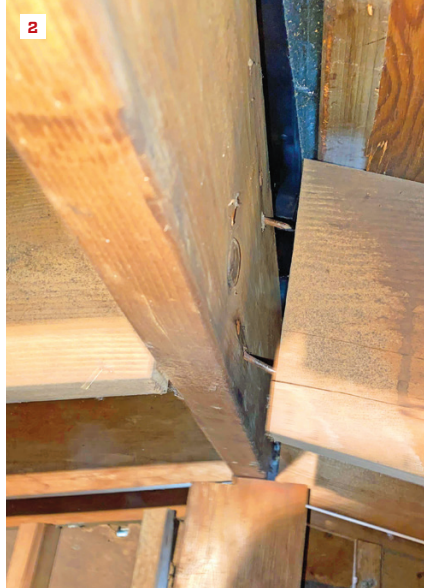
The ridge board dropped and the rafters pulled away because the exterior walls moved outward. The lateral forces induced by the roof load on the exterior walls were greater than the structure could withstand.

Even though the structure has rafter ties (ceiling joists) installed appropriately to resist lateral forces (see “Raising Ceiling Joists,” Jan/19, for more detail about rafter ties), the lateral loads were too great for the structure to withstand. Because a roof with a pitch less than 3:12 provides too much lateral force on the exterior walls, the IRC stipulates that the structure shall be designed as a ridge beam versus a ridge board (R802.4.4).

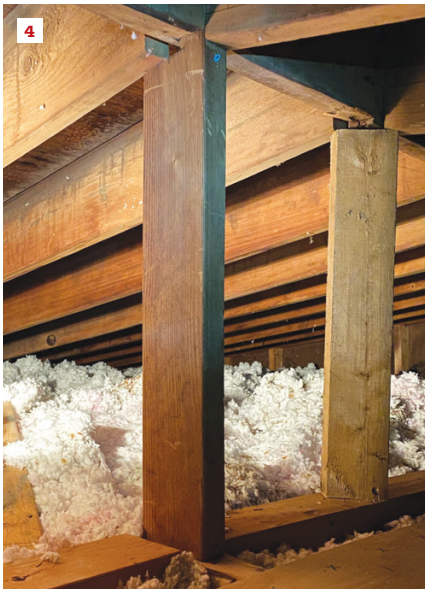
Initially, the author cut temporary support blocks from 2x4s and posted them down to a center bearing wall (in line with the center girder supporting the first floor) **(4)**. The final solution was to build a short wall, starting with top and bottom plates **(5)**, then jacking the top plate up as much as possible to push up any rafters that had dropped down **(6)**, before infilling with short studs.

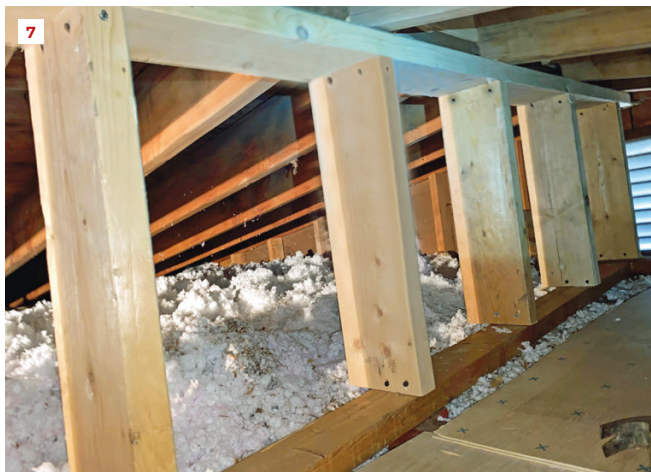
The framed wall that supports the rafters (7) is put together with screws—installing those proved much easier than trying to swing a hammer or use nail guns in the tight attic space. For good measure, the author shimmed any remaining gaps between the rafters and the ridge board (8).

The first-floor partition that supported the new framing was directly above the center beam in the basement. I ran some quick calculations and found that the existing beam and footings were capable of handling the roof load from our newly created load path.

In summary, we converted a ridge-board design to a quasi-ridge-beam design with a framed wall functioning in place of the beam. Although the repairs are not perfect in terms of aesthetics, they are functional and work for me. Had this been a project for a paying customer, I may have made it prettier. With some measure of irony, one of the most dangerous structures this engineer has ever inspected has been his own property. Thankfully, disaster was averted.

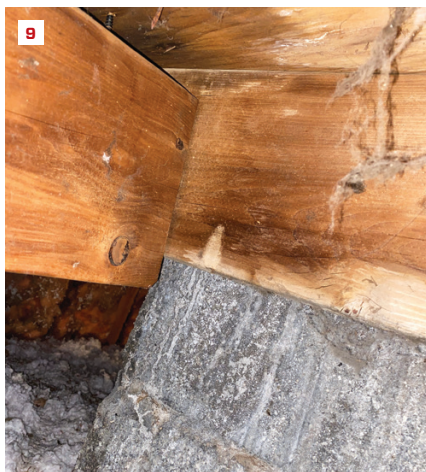
Rafters abutting a header at the block chimney had dropped (9). We jacked those individually (10) and attached the rafters to the header with joist hangers (11).

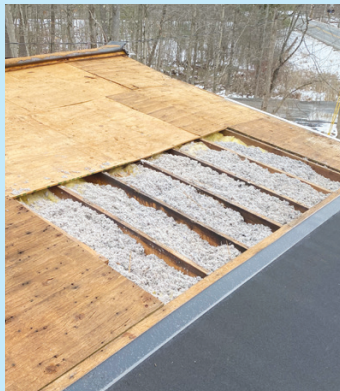
Where sheathing was completely loose and needed to be replaced, we took the opportunity to add cellulose insulation (photo, top left). Note: This end of the house has a cathedral ceiling with insulation between the rafters. It was designed, in fact, with a ridge beam. The exterior walls in this area did not spread.

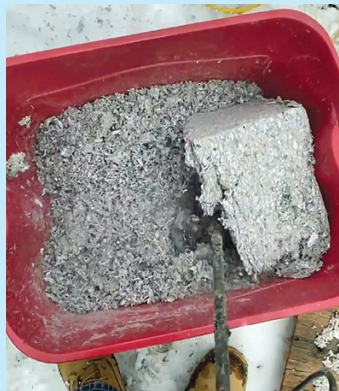
A good way to work with small quantities of bagged cellulose, in lieu of renting a blowing machine, is to place cellulose clumps in a plastic bin. Fluff the cellulose by mixing with a large drill and masonry mixing beater (photo, top right). Transport the fluffed cellulose to the roof in the plastic bin. Have a couple of bins handy so one person can be placing the insulation on the roof while another person mixes. It works great.

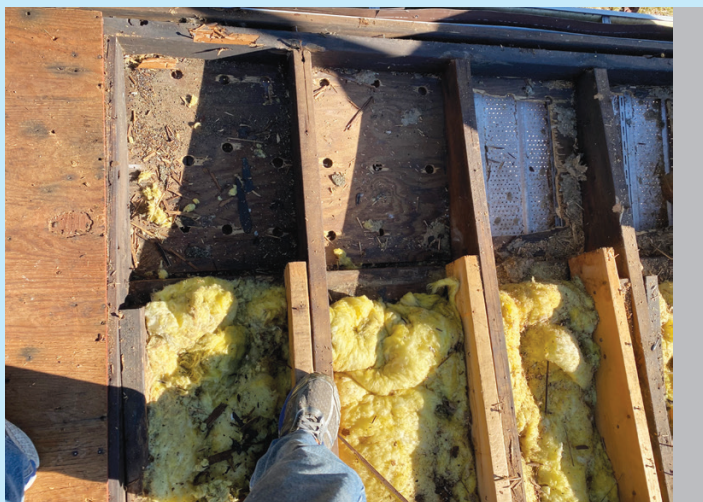
We also increased soffit ventilation where we had access (photo, above). The existing ventilation consisted of 1-inch-diameter holes drilled in the plywood soffit with perforated vinyl soffit below. This was inadequate. For this roof, code requires 1 square foot of ventilation for every 150 square feet of roof area, per IRC R806.2. We proceeded with some chain-saw carpentry and cut large openings in the plywood soffit. —D.T.
