## Slate Roof Restoration

As a long-term solution, slate proved more cost effective than an asphalt reroof

BY T JEFF SPENCER

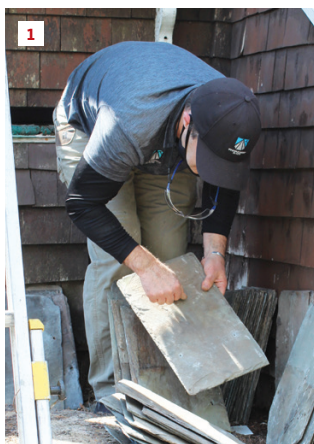
The author “sounds” a slate to make sure it’s intact **(1)**; he rejects 10% to 15% of the salvaged slate he buys. Standard slate tools include (clockwise from top in photo) standard mounted slate cutter; traditional slate hammer; restoration slate hammer; slate ripper; and hand-held slate cutters **(2)**. ANSI-rated Jorestech rock-climbing-style helmets are worn at all times **(3)**.

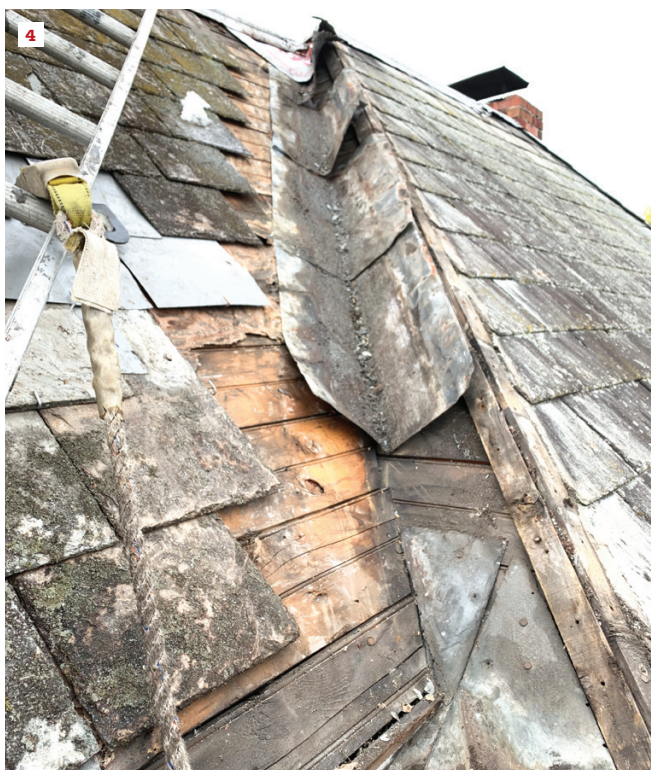
The existing terne metal flashings have done their time and need to be replaced **(4)**. On north-facing roof sections and areas shaded by trees, discoloration from mildew and lichen is common. Roofs can be hand-scrubbed clean with a mildewcide like D/2 Biological Solution ([d2bio.com](http://d2bio.com)).

A typical full-restoration project includes pulling off existing slates to access and replace the worn metal flashings with new ones—typically 20-ounce copper in the valleys and 16-ounce copper everywhere else. We check all the slate on the roof and replace missing, cracked, and disintegrating "shingles." We encounter many bad repairs where the wrong-size slates were used or the slater broke slates when installing replacement pieces. A common mistake we fix is where someone face-nailed a patched-in slate

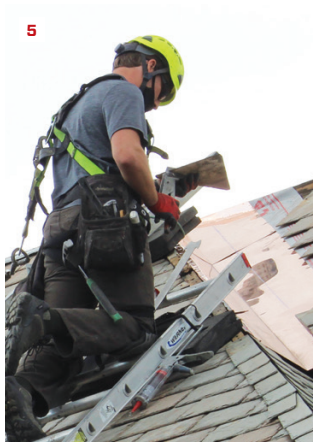
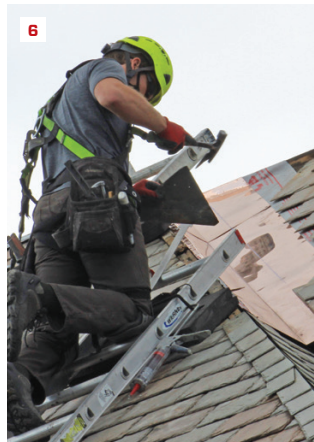
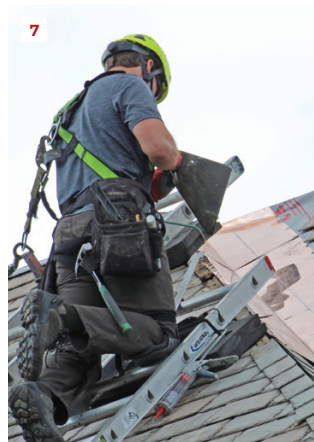
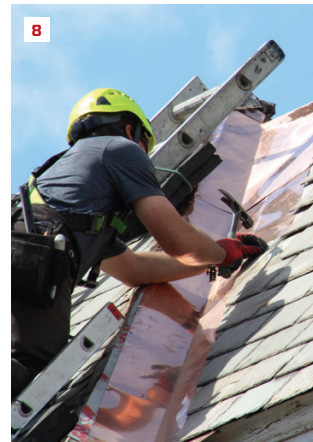
Replacement slate is trimmed along the angled valley line with a hand-held slate cutter (5). A restoration slate hammer (6) is used to punch a nail hole in the trimmed-up replacement slate (7). Nailed into place with the restoration hammer, the slate overlaps the valley flashing 5 inches, leaving 4 inches of exposed copper (8).

with smaller slates. Our rule of thumb is to keep the nail no more than an inch from the edge of the copper flashing—in this case, an 8-inch “no-nail zone” from the center of the valley. We strike a line up the valley representing the 5-inch slate overlap, then begin the time-consuming task of slating the restored valley.

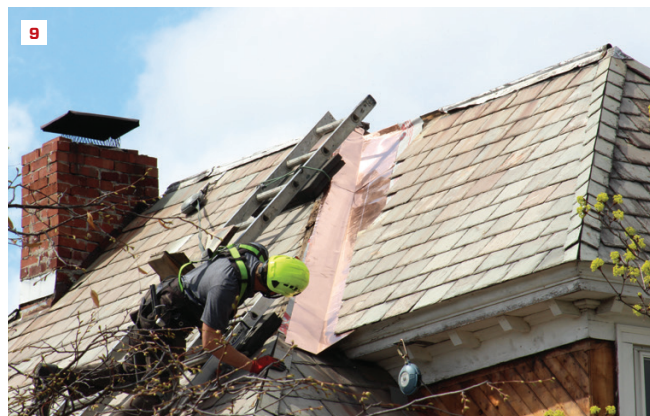
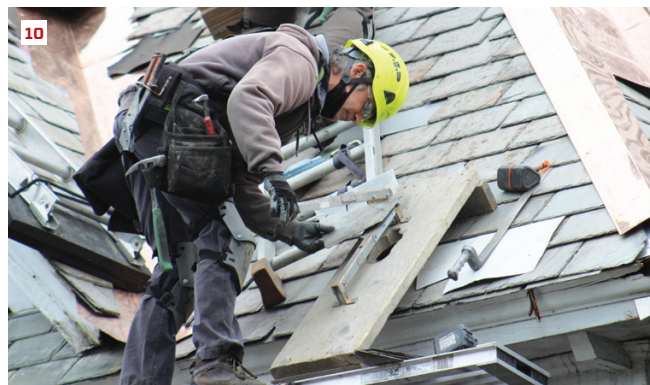
New valley flashing is installed over ice barrier membrane (9). The roof had six valleys, three close to hips. Here, slate is cut from the back with a mounted slate cutter (10).

**Open valleys.** We began this restoration project by pulling slates from the edge of an open valley on the east-facing dormer (the home's hip roof had three dormers with a total of six valleys). What remained of the roof's original rosin paper "underlayment" quickly disintegrated, exposing the board-sheathed roof deck, which was in surprisingly good shape given the condition of the existing slate and flashing. For the new V-shaped valley flashing, we bent lengths of 18-inch-wide sheets of copper with a brake in our shop. (On each side of the valley centerline, we planned for 4 inches of exposed copper and 5 inches under the replacement slates.)

On new-slate installations, we always apply ice barrier membrane in the valleys and at the eaves and integrate roof underlayment with the peel-and-stick. While we feel obliged to install ice barrier membrane on restoration work, it's something we've wrestled with over the years. Joseph C. Jenkins, the author of *The Slate Roof Bible*, advises not to use peel-and-stick membrane on slate roofs because the slate has the potential to stick to the ice barrier membrane, making future repairs difficult. We have installed felt paper between the peel-and-stick and the metal flashing on past projects for this reason. But here we used Titanium PSU30—an ice barrier membrane with a slip-resistant surface (owenscorning.com). We ran a 30-inch-wide strip up the valley, tucking it under the staggered pattern of the existing slate. We then installed the new V-shaped valley flashing and fastened the edges with stainless steel roofing nails.

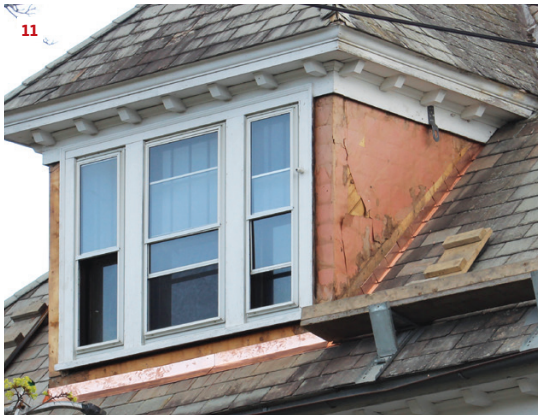
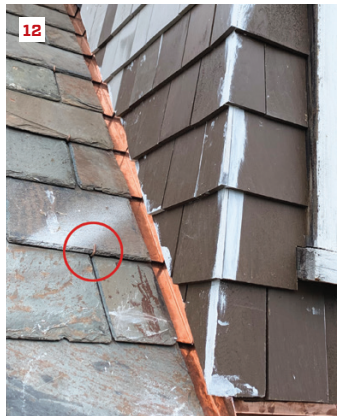
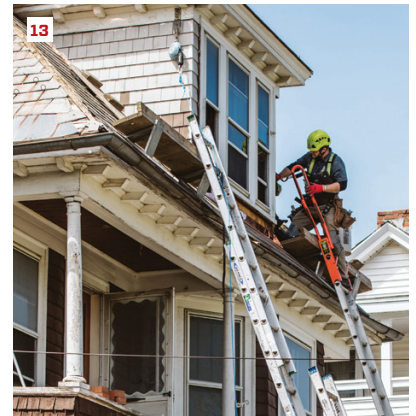
The shingled walls of the hip roof's dormers are stripped to make way for new step and apron flashing (11). Copper slate hooks (shown here in red circle) secure replacement slates along the roof-to-wall perimeter (12). A 15-lb. felt building paper weather-resistive barrier was installed, then the slate crew shingled the sidewalls (13).

Some carpentry is usually involved in restoration work. Repairing damaged trim and roof decking is commonplace, as well as re-siding dormer walls to install new step and apron flashing.

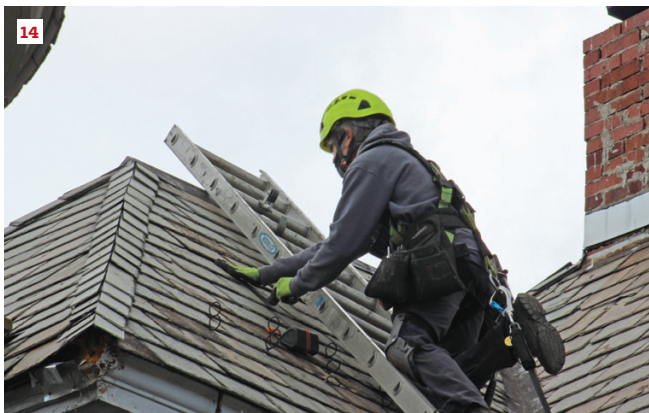
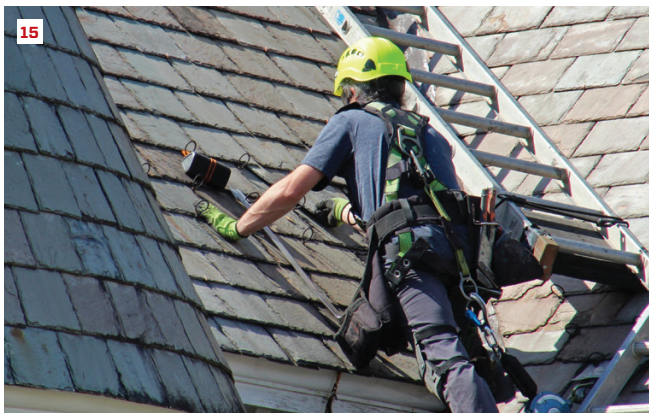
A crew member slides a ripper under a slate to help slide the slate out (14). A salvaged replacement slate is slid into place and later secured with a slate hook (15).

**Replacing damaged slate.** We remove a damaged slate by first sliding the flat end of the ripper under the slate and pushing it up until the hooked end is above the nail. We pull it sideways and down to hook the nail in the notch of the ripper, and with a few hammer taps downward on the ripper’s handle, the nail loosens. Most slates are fastened with two nails, so we repeat for the other nail. We slide the ripper back under the slate, press down on the top of the slate with our free hand—sandwiching the slate between our hand and the tool—and pull down on the ripper to slide the slate out. We then slide a salvaged replacement slate in its place.

There are two ways to fasten a replacement slate. One way is to punch a nail hole in the new slate between the edges of the slates above, midway up the joint. We slightly pry apart the overlaying slates above, just enough to drive the new nail between them. Unlike other materials, slate has to be nailed loosely; it is important to leave the head of the nail just flush with the face of the slate, so that the slate “hangs” on the nail. If the slate is nailed too tightly, it will break under the stress. If the nail sits too high, it can poke through or break the slate that lies on top of it. We cut a 4-inch-wide piece of copper or aluminum coil stock to make a “bib” long enough to reach the top of the new slate and cover the nail by approximately 2 inches. Before sliding the flashing into place, we bend the top up and the bottom down a little bit, creating a slight “S” shape to help it pass over the nail and stay in place.

Our preferred method to replace damaged slate is to use slate hooks instead of nails. That way, we don’t have to punch nail holes and risk breaking slates or worry about bibs sliding out over time. We drive the pointed end of the hook into the roof deck, leaving

the crook of the hook in line with the bottom of the replacement slate. The replacement slate is pushed into place over the hook, then pulled down to rest on it. (For more on slate replacement, see “Repairing Slate Roofs,” Dec/03.)

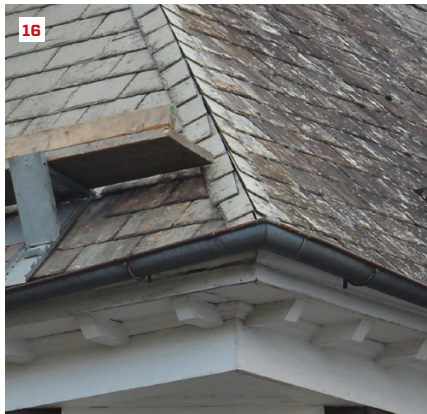
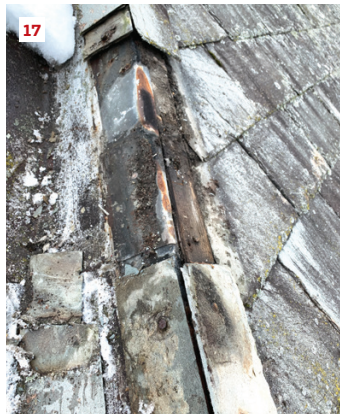
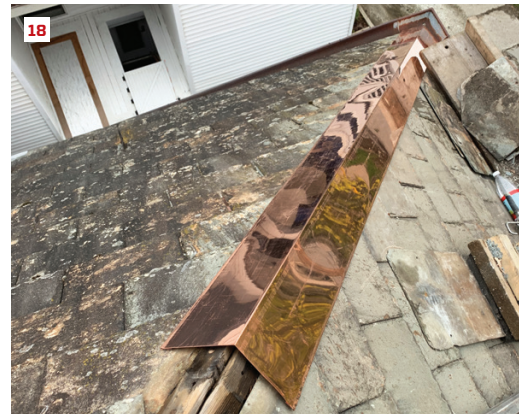
It used to be common to install “mitered” cap slate at hips (and ridges) without step flashing, but it tends to spread apart over time (16). The “mitered” slate wasn’t cut at 45 degrees, but at 90 degrees, and was joined at the sharp edges of the back surface. A cost-effective solution is to remove the existing hip (and ridge) slate (17) and install new copper cap flashing (18).

**Hips and ridges.** If the roof had an Achilles’ heel, it might be the detailing of the slate hips and ridges. During the height of slate’s use as a roofing material, it was common to install “mitered” slate at hips and ridges without step flashing; I believe the thinking back then was that any water that happened to find its way into the unfinished attic would eventually dry out. Mitered cap slate tends to spread apart over time and open up to the elements.

Rebuilding slate hips and ridges with step flashing tends to be expensive and time-consuming. To help lower the costs, we removed the existing hip and ridge slate and installed copper cap flashing (bent from a 12-inch-wide strip of 16-ounce copper and hemmed ¾ inch at the edges). We secured the flashing with stainless-steel gasketed screws driven through the slate below and into the deck and hip framing.

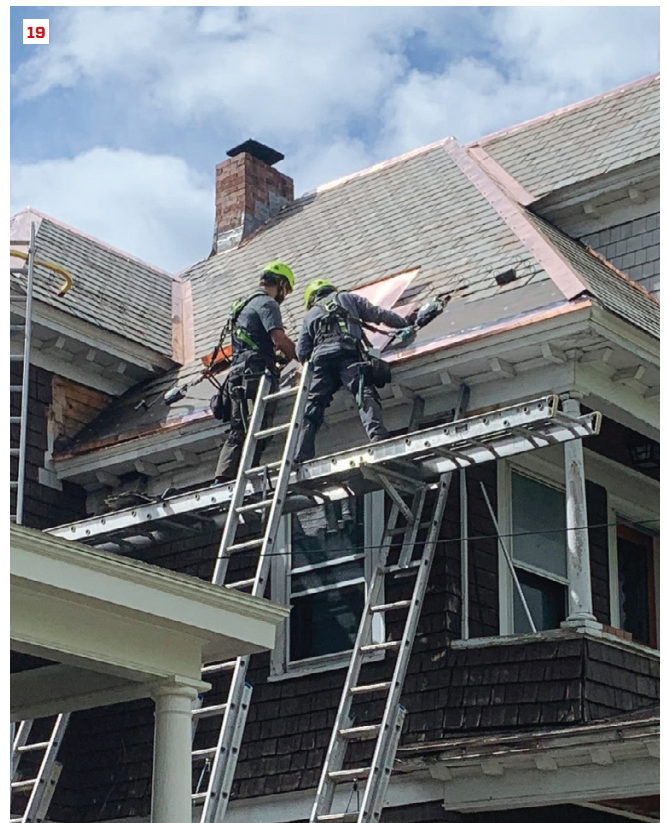
Galvanized-steel snow belt is replaced with copper panels along roof eaves (19). Ice barrier membrane is installed on the deck, then a layer of felt paper to thwart the replacement slates from potentially sticking to the membrane.

**Snow belt and snow guards.** On homes of this vintage, snow belts were often retrofit on roofs to address ice damming. Along the south-facing eaves on this project, we replaced a poorly installed, rusting galvanized-steel snow belt with copper. We first applied ice barrier membrane, then a layer of felt paper to thwart the replacement slates from potentially sticking to it. We fabricated the copper snow-belt panels in the shop, then installed them on site, joining the seams together with rubber mallets and hand seamers. On the north side of the roof, we installed Alpine SnowGuards’ PD10 pad-style snow guards ([alpinenowguards.com](http://alpinenowguards.com)) to keep snow and ice from falling into the neighbor’s driveway.

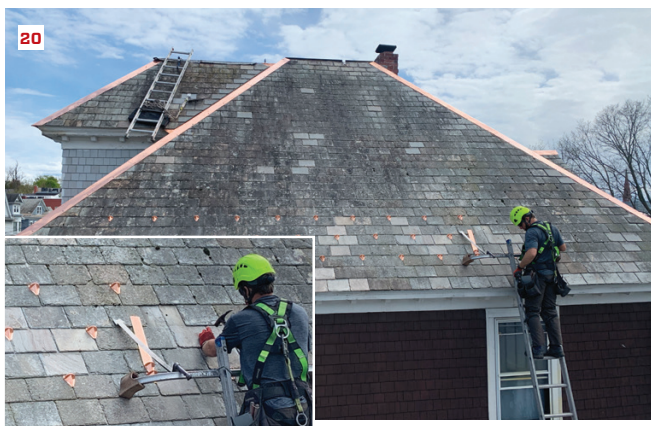
Copper snow guards (inset photo) applied on the north side of the roof will help keep ice from falling into the neighbor's driveway below (20).

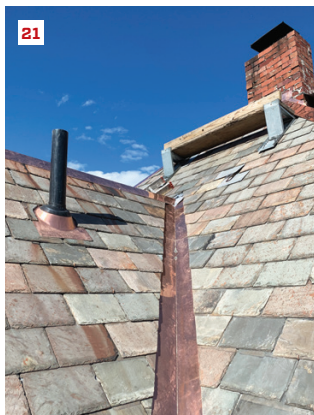
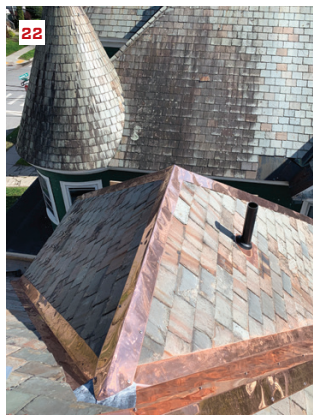
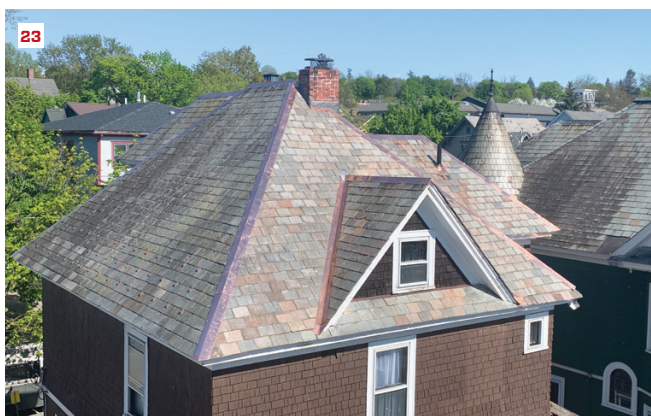
Salvaged semi-weathering green-gray slate blends into the existing slate on a finished open valley (21), dormer (22), and north- and west-facing sections of roof (23). Seventy-five percent of the existing slates were left intact.
