# Retrofitting a Rooftop Deck to a Stucco Home

Removing an attic gave this California home more outdoor living space and better ocean views

by Edmund Bourke

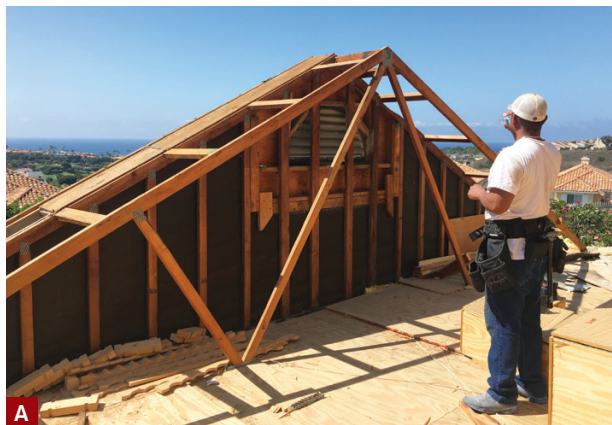
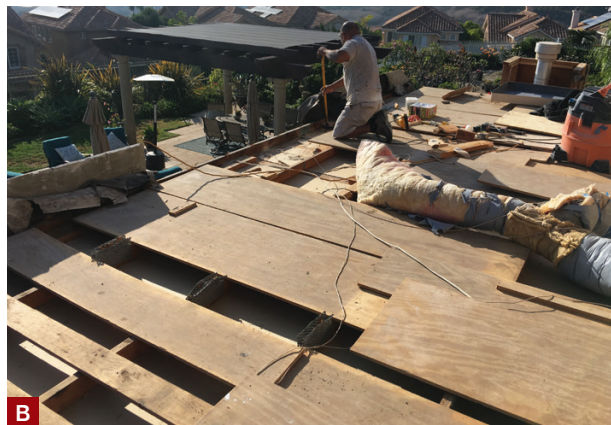
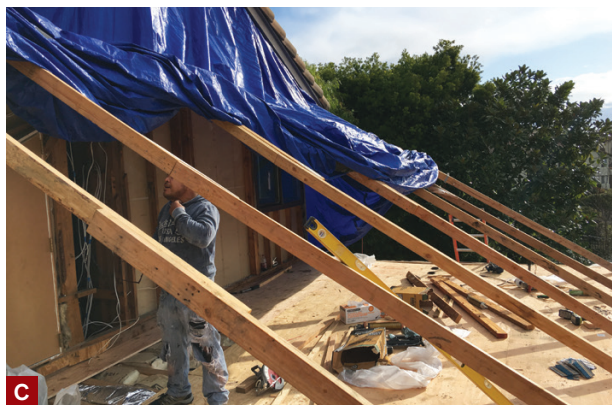
**Figure 1.** With most of the truss roof dismantled except for the gable end, the Pacific Ocean begins to come into view (A). Workers dismantled the roof trusses from the top down, removing the bottom chords last in order to leave the ceiling drywall intact (B). Before hanging new 9¼-inch PSL ceiling joists, workers ripped V-shaped tapers along their top edge so that the flat-framed deck would slope toward drains installed in the center of the deck rather than toward the outside edge. While waiting for the waterproof deck membrane to be installed, workers tented the area with tarps to protect the living space below (C).

companions—a pair of large Labrador retrievers—to remain in the house during construction (**Figure 1**).

We left the bottom chords intact as we started disassembling the roof trusses, leaving the drywall ceiling fastened to the chords and the back of the drywall exposed. Then, as we removed what was left of the trusses, we were careful to minimize damage to the drywall. Though we had to pull the fasteners out through the back of the drywall, the process left the paper face fairly intact, which made patching the ceiling later on easier.

Then we stripped away the stucco finish from the wall to expose the framing so that we could fasten a 9¼-inch PSL ledger to the house with structural screws. We also installed a PSL rim joist on top of the existing wall plate, then hung 9¼-inch PSL ceiling joists from the ledger and rim joist 16 inches on-center,

This rooftop deck was designed to drain to the center rather than along the outside edge. So before hanging the joists, we ripped V-shaped tapers along their top edges from both ends toward the middle so that the roof sheathing would slope away both from the house and from the edge of the deck toward the center. With a slope of ¼ inch per foot, these tapers still left plenty of material—about 7 inches—in the middle of the joists to support roof loads on the 14-foot-wide deck.

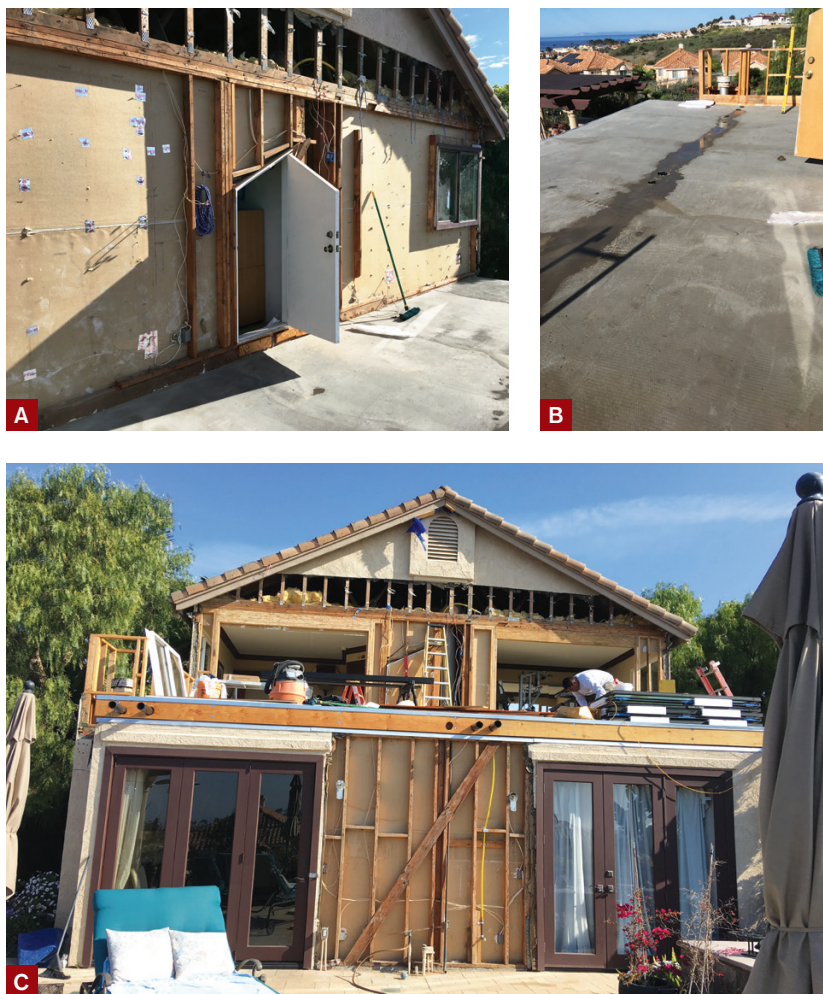
**Figure 2.** The roof deck was finished with a three-coat stucco finish over diamond lath stapled to the sheathing, followed by a Silcor liquid-applied waterproofing membrane system (A). Water drains through three pairs of roof drains oriented along the centerline of the deck (B). Once the new deck was watertight, workers reframed the wall to install two new bi-fold doors to match the doors on the first floor (C).

Originally, the designer had determined that three 3-inch-diameter drains—one in the center and one at each end—would provide the necessary capacity to handle water flowing off the deck. We decided to play it safe and doubled up the drainage capacity by installing two drain lines instead of just one at each location, in case of a heavy rain event or a drain blockage from debris. The drains exit through the rim joist and empty into a gutter.

bodies when we installed the sheathing, and subcontracted the roof deck waterproofing to another company. Those workers taped the joints in the sheathing, applied a primer/sealer, and flashed around the perimeter of the deck. Next, they stapled diamond lath to the sheathing and applied a three-coat stucco finish (**Figure 2**).

To waterproof the deck, the crew rolled on Silcor 575 liquid-applied polyurethane waterproofing membrane (th.gcpat.com)

over the stucco finish. Then they applied a rolled-on coat of Silcor Top Coat 80 finish, followed by a sprayed-on texture coat. Later, the deck surface was spray-painted to match the finishes on the rest of the house.

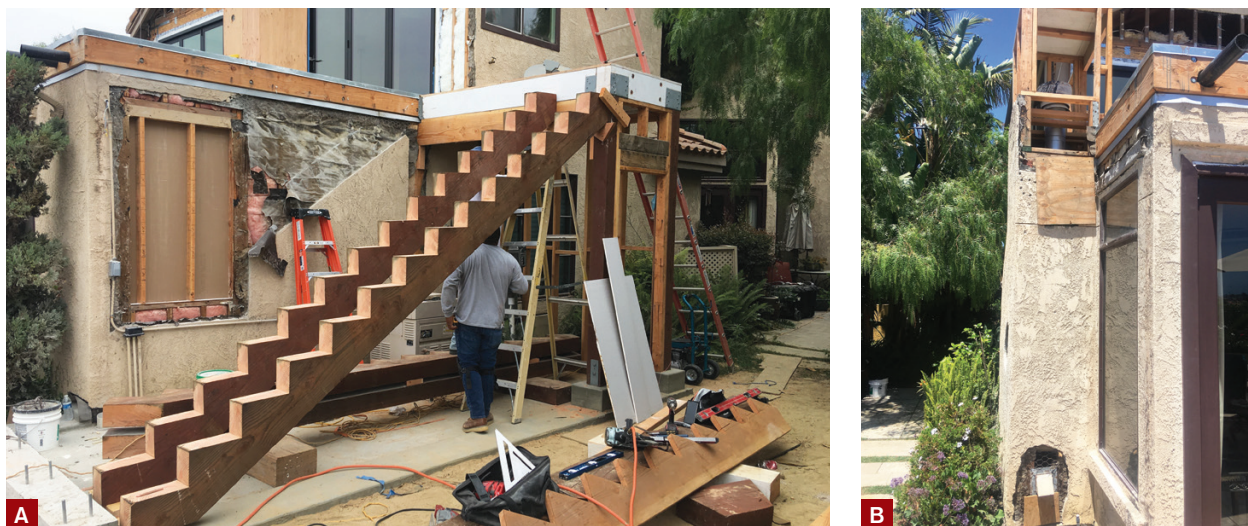
**Figure 3.** To seismically reinforce the stairs, workers connected a grade beam at the lower landing to the moment-framed upper landing with stringers cut from 4x14 treated Douglas fir beams (A). The chimney was reconfigured to make room for a new direct-vent gas fireplace for the rooftop deck and reframed as a low privacy wall (B).

To make room for a new direct-vent gas fireplace for the rooftop deck, we reconfigured an existing chimney chase, which contained the vent for a gas fireplace in the living room. Instead of being oriented vertically, the new chase is framed as a low wall, providing the deck with a little bit of visual separation from the neighbors.

The original plans called for a spiral staircase for access from the ground level to the upper deck, but the city building department asked for a more robust, seismically reinforced design. Our solution was to install a grade beam at the lower landing as well as a pier foundation for the upper landing, frame the landing like a moment frame, and connect the lower and upper landings with stringers cut from four 4x14 treated Douglas fir beams. After we installed plywood treads and risers, the stairs received the same stucco and Silcor finish as the roof deck, creating a dry space for storage underneath (**Figure 3**).

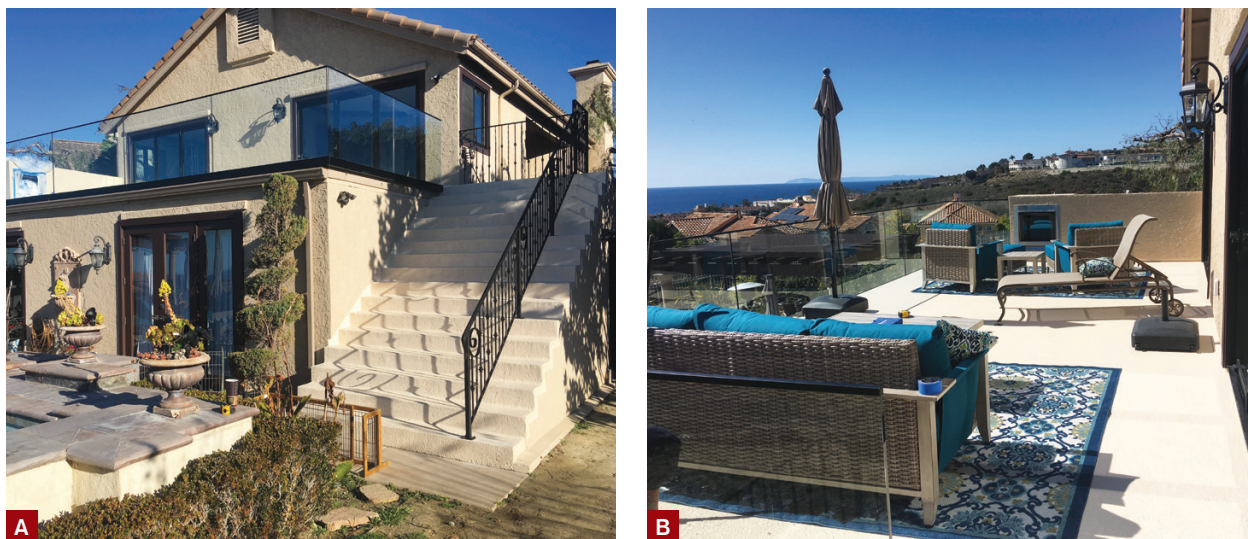
**Figure 4.** The stairs received the same stucco and Silcor finish as the roof deck, followed by a fire-retardant paint, creating a dry, nonflammable space for storage underneath (A). The stairs were fitted with a wrought iron railing, while the deck's custom-fabricated glass-panel guard system preserves the views of the Pacific Ocean (B).

Because the home is located in an area that the city of Dana Point has designated a Very High Fire Hazard Severity Zone (VHFHSZ), certain construction elements applied to the project. While a retrofitted sprinkler system wasn't required, the deck surface had to qualify as an ignition-resistant or noncombustible

material per SFM Standard 12-7A-4 and 12-7A-5 in the California Building Code. We supplemented the three-coat stucco walking surface and new stucco wall surfaces with a fire-retardant paint (**Figure 4**).

To avoid obscuring the ocean views in any way, we installed a custom-fabricated glass-panel guardrail system, which is

supported by fascia-mounted brackets. On the stairs, we installed a custom-fabricated wrought iron railing to match the home's existing gates and fences. Lastly, we installed the new direct-vent fireplace. ♦
