New Life for an Old Porch

by Alex Bartlett

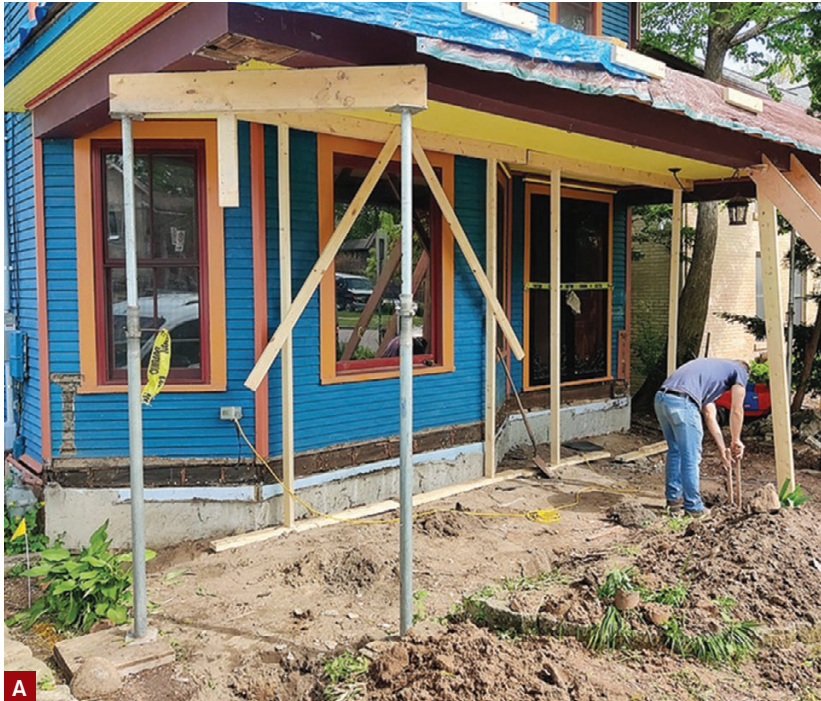
In the Third Lake Ridge Historic District in Madison, Wisc., front porches are a prominent architectural feature of many of the homes, which were built between the 1850s and the 1920s. This particular Victorian-style home dates to 1899, and the porch (like many in this neighborhood) suffered from shallow footings, rotten floor boards, and roof leaks. My employer, TDS Custom Construction, a 30+ year-old design/build firm located a few blocks away from the district, was hired to restore the porch as well as design and build a single-car garage for the property that would stylistically complement the original house.

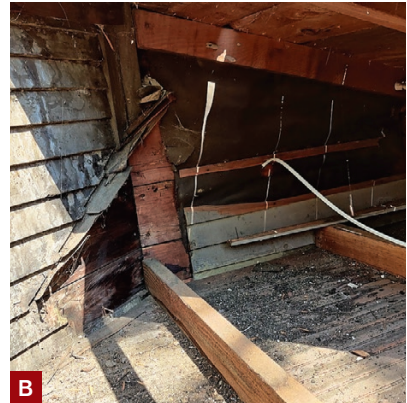
After shoring up the porch roof with temporary supports (A), workers removed the old porch. In addition to inadequate footings, the porch's roof system had been simply toenailed to the wall sheathing and was pulling away (B). After digging and pouring new footings (C), the crew installed new porch framing, with the joists oriented parallel to the house (D).

We started by temporarily posting under each corner of the sagging roof using screw jacks to try and level it (A). The porch was nearly 2 inches out of level from left to right, and one of our biggest concerns was the connection to the house as we began to jack the corner up to level the roofline. To help with any stress or settling that might occur because of this, we built a temporary shoring wall under the roof right against the house. Next, we removed a few sections of skip sheathing near the peak of the porch roof to see how it was fastened to the

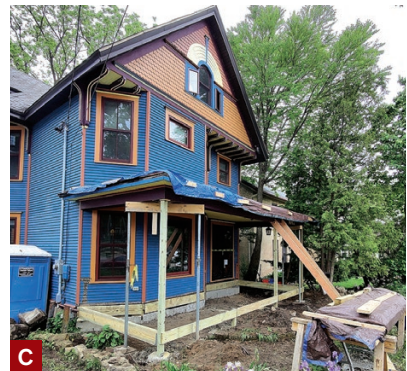
house and discovered that the roof rafters and ceiling joists were only toenailed to the existing siding with 10d nails (the porch wasn't original to the house). As the porch framing settled, the rafters had pulled away from the house (B).

We corrected this by adding a ledger screwed directly into the stud wall, and then refastening the rafters to this ledger after we jacked the roof up. The ceiling joists were still well-fastened to the rafters, so we simply added a few 4-inch-long structural screws to reinforce those connections. Then we posted the rafters to the ceiling joists, which were supported by our temporary wall below.

We had to cut back the rafters so they were no longer nailed to the house and wouldn't pinch as we jacked the roof up. With the roof system shored up and everything cut back, we were able to easily use the screw jacks to lift the roof to level. We then cut the rafters back further so we could slide a 2x6 ledger in. We screwed the ledger into the studs and screwed the rafters to it.

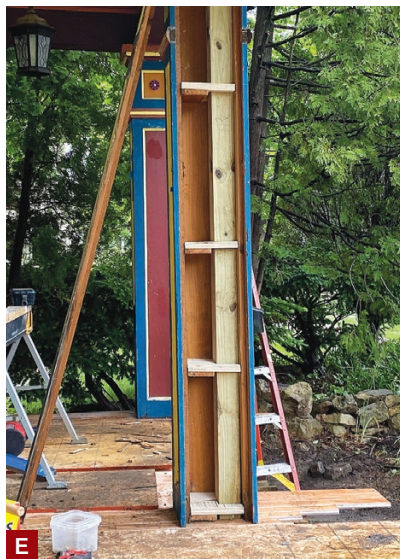
The crew installed blocking around the new pressure treated posts supporting the roof, then reinstalled the porch's original columns and colorful balustrade (E). The project included a new garage, designed and finished to fit with the character of the house (F).

When we reinstalled the columns after completing the porch flooring, we added a lot of blocking so that when we reinstalled the railings, we would have plenty of meat to grab (E). We tried to predrill and use screws in inconspicuous locations (the undersides of the top and bottoms, toe screws through the sides facing the house, and so on). We then filled the holes with wood epoxy, sanded once more, and primed everything.
