BY JIM BRADLEY AND CHRIS WEST

## Air-Sealing Framing

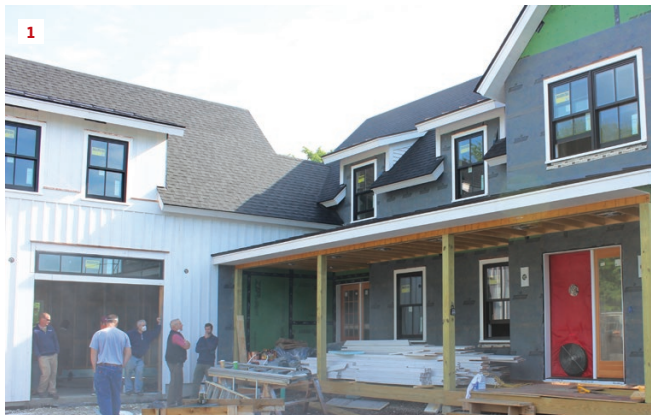
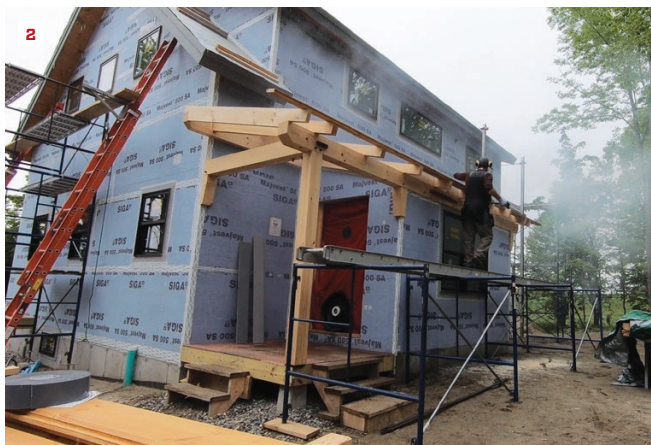
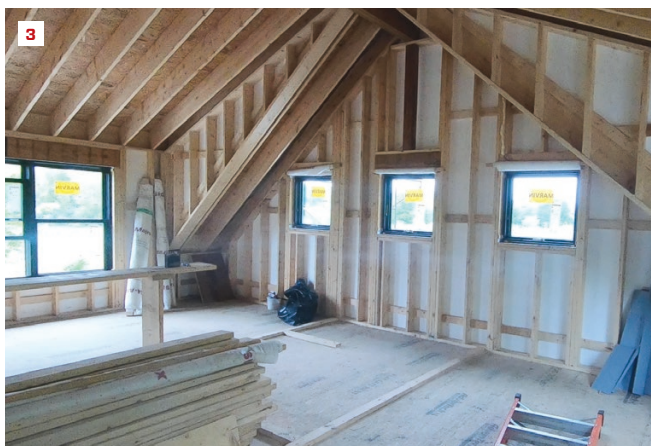
Air-sealing homes has much improved over the past 15 to 20 years. Here, the authors test a well-built Vermont home with a complex roof for air leaks using theatrical fog (1). The home’s multiple dormers proved to be well sealed by the builder’s conscientious crew (dormers are notoriously leaky spots). This modern take on a Cape has shed dormers front and back (2). The home’s thermal shell (2-inch EPS with taped seams sandwiched between the sheathing and 2x6 studs) was airtight, though some small leaks were discovered at the shed dormer framing and sealed before the wall assembly was completed (3).

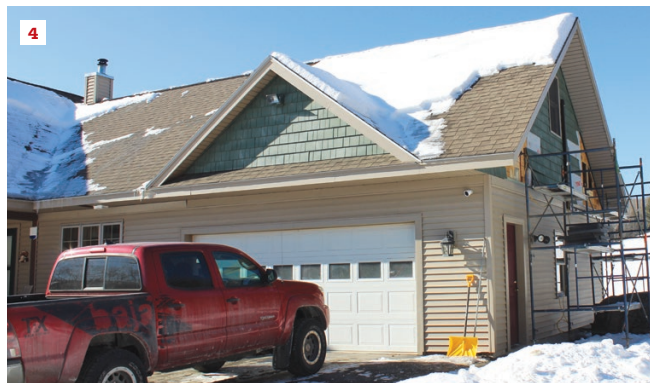
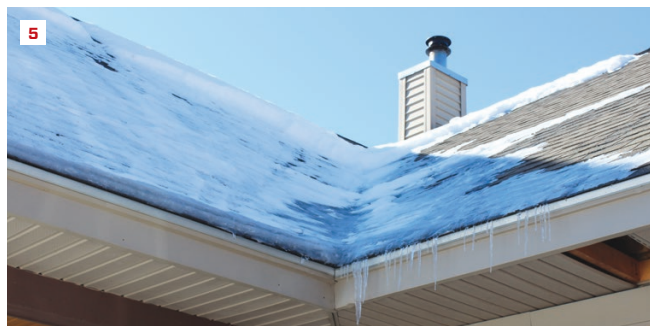
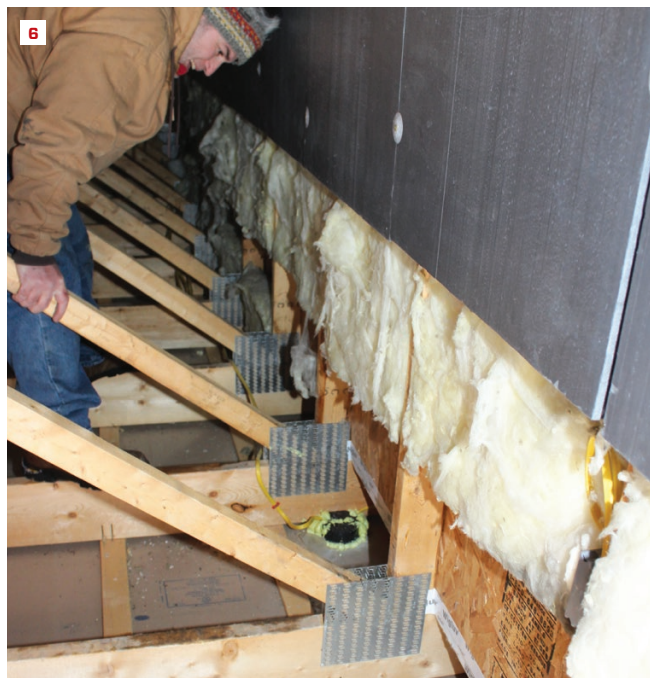
This circa-2006 L-shaped Cape with a bonus room above the garage had a history of ice damming, not only in the valley but also around the entire perimeter of the garage roof (4, 5). Heat loss from an exposed flue located in the transitional framing area where the roofs intersect (outside the existing thermal envelope) contributed to the ice damming, along with air leaks from the heated garage below the bonus room. Working around the attic trusses, batt insulation was removed above the strapped ceiling drywall in order to air-seal ceiling penetrations, while the bonus room knee walls were air-sealed from the back with XPS foam (6). Cellulose insulation will later be blown in under the bonus-room floor and between the trusses.

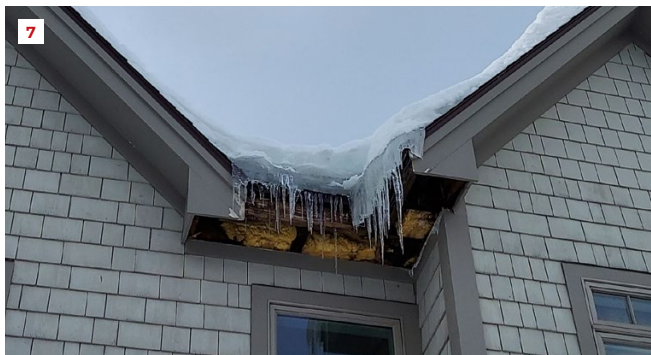
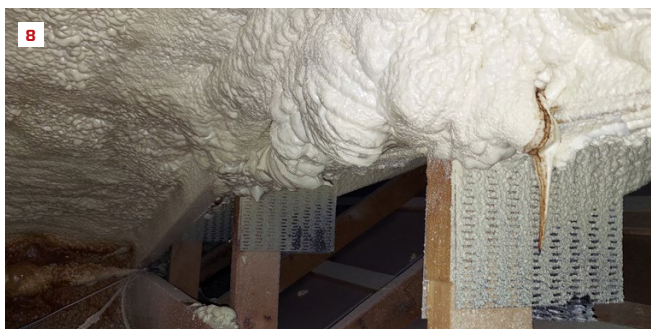
Spray foam was applied to the underside of the decking with no ventilation channel on this northern Vermont home built in 2008, to create a hot roof (7). Here, “tea-staining” leaking from above indicates where moisture transported by warm air flowing through cracks between the foam and the framing has condensed on the roof sheathing (8).

**The spray foam “solution.”** One way builders often try to create effective thermal and air control layers on a complex roof is with closed-cell spray foam in the rafter bays. But we’ve found in our area of Vermont (climate zones 5 and 6, with 60-pound snow loads) that this solution doesn’t work well. Even when the foam is properly mixed and applied, the framing members shrink, especially in attics where the installers are not spraying over the edges of the rafters or encapsulating the truss chords. In these cases, gaps between the spray foam and the wood framing can leak air. The problem isn’t with the foam itself, and applying a thicker layer of foam (filling deeper cavities with more) won’t alleviate the problem in colder climate zones.

And once warm indoor air meets up with the layers of roof sheathing and nonpermeable roofing underlayment, it becomes trapped in a “vapor sandwich.” In our opinion, the solution is to install a roof ventilation channel in each rafter bay before spraying the bays with foam. When properly connected to soffit and ridge vents, this ventilation channel will allow any assembly moisture that escapes through small cracks in the framing to safely vent outside.

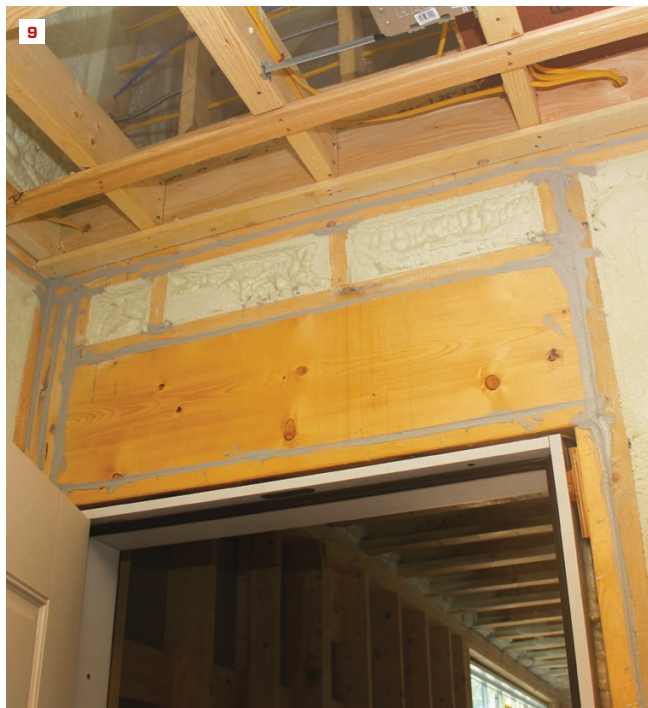
Above, the door header, jack, and king framing of an attached, unheated garage has been air-sealed with a quality sealant (9). Seemingly small, unsealed gaps between framing members become significant pathways when depressurization happens in the home via appliances such as dryers and range hoods.

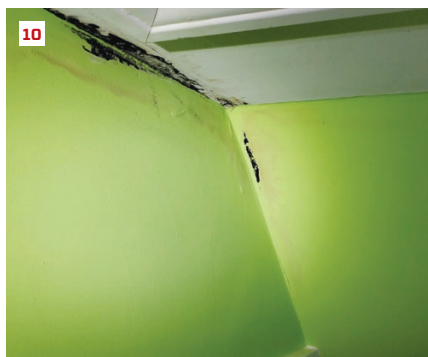
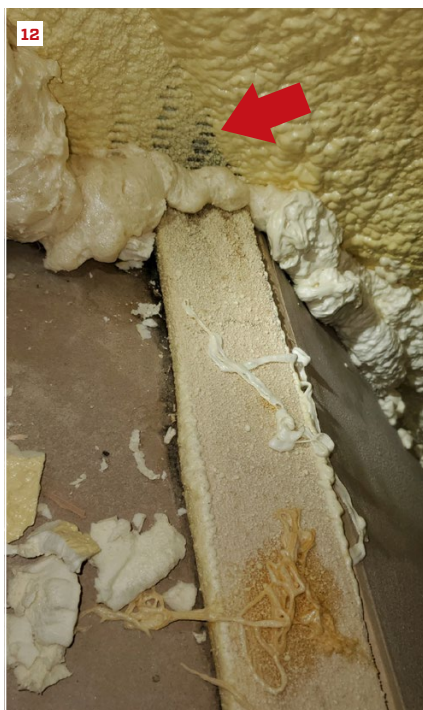
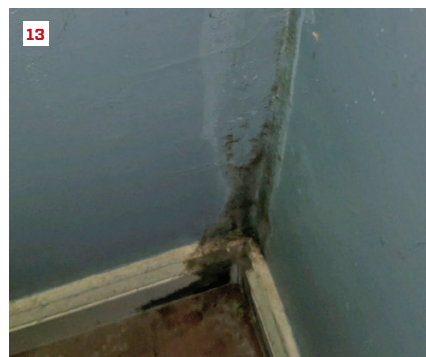
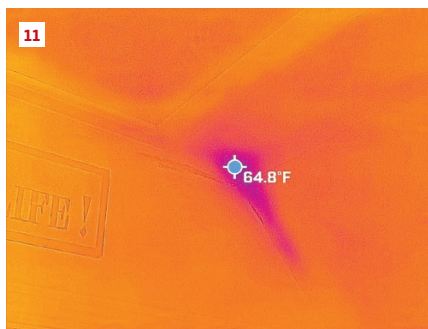
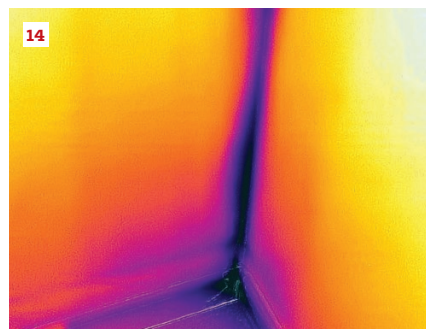
Mold appeared on the ceiling of a marriage wall between the addition (circa 2012, insulated with spray foam) and the main home (10). An infrared image (11) zeroed in on the foaming “miss” of a exposed truss plate abutting the unheated attic space of the old house (12). Lower on the same marriage wall of this otherwise fairly tight house, a gap in the framing occurred because of shrinkage of the framing member. The airflow led to condensation and mold (13, 14). Initially, closed-cell spray foam was thought to solve most air-sealing problems, but the authors believe that sealants (such as caulking, membranes, and air-sealing tapes) and a better understanding of ventilation are needed to avoid condensation problems in cold climates.

**Marriage walls.** When an addition has been built onto an existing house, we often see problems where the framing for the addition is fastened to the existing sidewall. The problem isn’t with the framing cavity, which typically is well-insulated; it’s with the joint itself, which seems insignificant until air flowing through that joint and up into the attic space of the existing house starts to create moisture problems. Typically, the attic is above the home’s thermal boundary, and any indoor air that leaks into this space is likely to condense on any cool surfaces, creating big problems.
