## Rescuing a Round-Top Window

BY EMANUEL SILVA

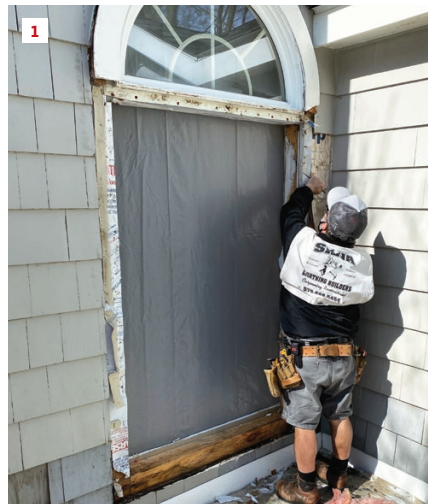
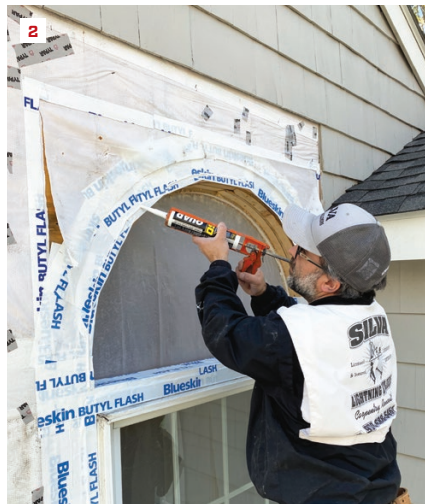
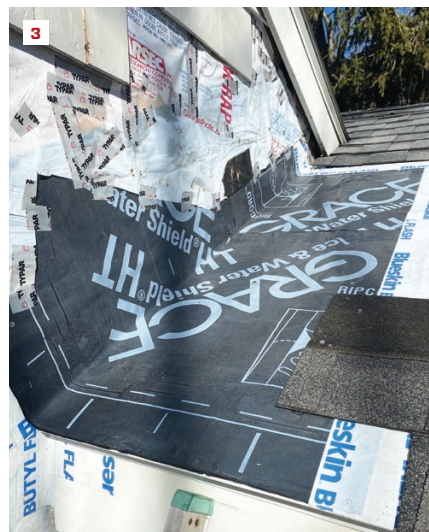
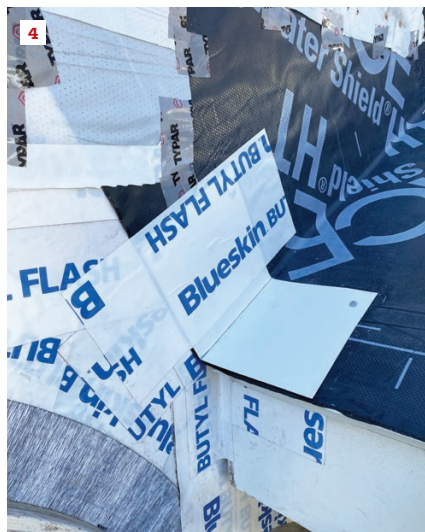
Water draining off the roof directly above the round-top window had penetrated behind the window casing, thanks in part to damage done to the water resistive barrier (WRB) during a previous repair (1). The author removed the upper and lower windows, repaired the damage, and carefully reflashed the opening before reinstalling the windows (2). The repair included removing roof shingles and siding and installing new peel-and-stick membranes on the roof deck and wall (3) in preparation for a new diverter flashing above the window (4).

**Framing fix.** A rooftop deck built when the window was first installed, as part of the same renovation project, made access a lot easier than working off ladders and staging. I started by removing the trim, which is when I discovered the problems with the underlying WRB. The only way to repair the WRB and properly flash the opening was to remove both the upper round-top window and the lower double-hung, along with the cedar shingle siding around the opening.

After removing the flashing and replacing the rot-damaged sill, I added a length of beveled siding to the rough opening for positive drainage. Next, I flashed the sill with DuPont FlexWrap NF, lapping it over the Henry Blueskin Butyl Flash self-adhering flashing tape that I had applied underneath the opening. Then I patched holes and tears in the WRB and completed wrapping the upper and lower openings with additional Blueskin flashing.

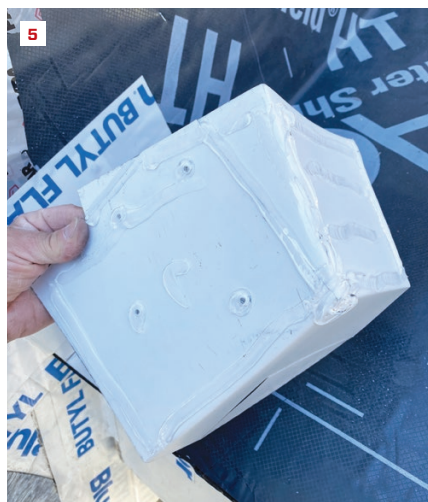
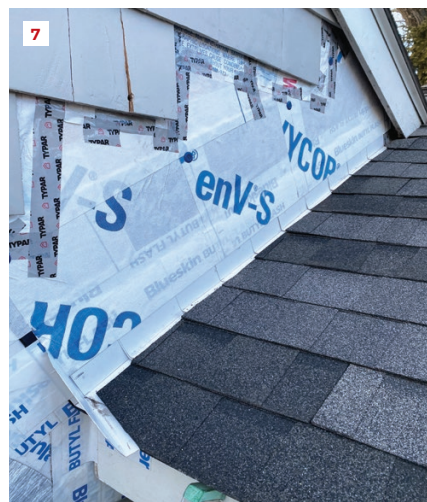
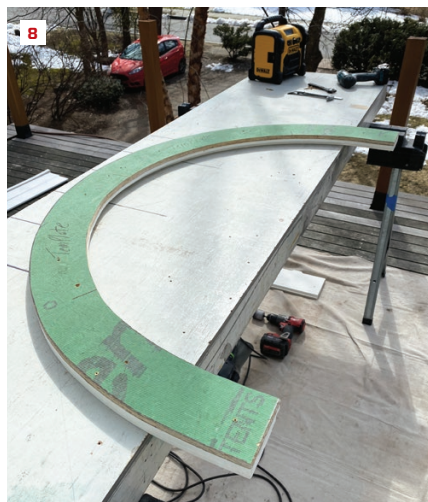
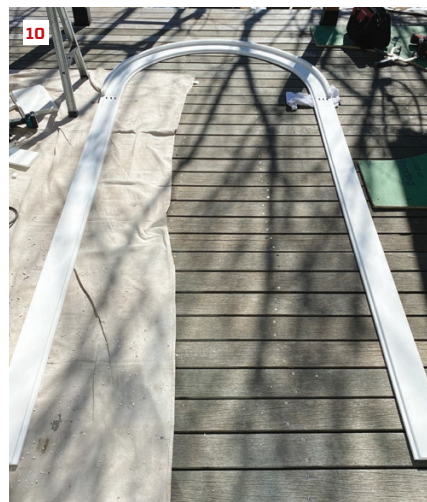
Fabricated from aluminum coil stock (5), the kickout diverter flashing was installed at the bottom of the roof-to-wall intersection (6). The author then reinstalled the roof shingles with new step flashing that he taped to the WRB (7). He used a plywood template (8) to cut the curved PVC window trim with a router and rabbet the inside edge so that the trim fit over the window cladding (9). The kerfed piece added to the back of the curved tracing was needed for sealing the window casing to the wall sheathing. The author assembled the trim as a single unit with pocket screws and PVC glue (10).

From 8-inch-wide painted aluminum coil stock, I had fabricated new step flashing and the kickout diverter. After cutting and folding the diverter into the desired shape in an origami-like process, I riveted the folds together and sealed up the joints with clear silicone sealant.

I installed the kickout over a half-width of step flashing, which I had taped to the wall. Another half-width of step flashing installed over the kickout locks it in place. Then I installed a full step flashing over this assembly, taping the step flashing to the Grace membrane on the roof and wall and sealing up the roofing nail

heads with silicone. I installed the remaining step flashings conventionally as I resingled the roof, leaving a  $\frac{3}{4}$ -inch gap between the edges of the shingles and the upturned legs of the step flashings for good drainage and taping the step flashing to the WRB with Blueskin tape.

**Fabricating the trim.** I made a cardboard pattern of the round-top window and used it to trace the window's outline onto a length of Zip sheathing. Using a compass set to the  $4\frac{1}{2}$ -inch width of the trim and following the arc of the traced outline, I then scribed the trim's outside radius onto the sheathing. I carefully cut to the lines

I used this template as a guide to cut out the round-top trim from two layers of 3/4-inch-thick PVC sheet stock that I had glued together with PVC cement. First, I traced the template outline onto the PVC stock and rough-cut to the lines with a jigsaw. Then I screwed the template down and used a flush trim bit in a router to trim the PVC to finished size. Because I wanted the trim to overlap the vinyl window frame, I used the router to cut a 1/2-by-1/2-inch rabbet around the inside edge of the trim piece.

Even though the trim piece was a full 1 1/2 inches thick, I still had to build it out with another curved length of 1-by-3/4-inch PVC applied to the back outside edge, like a back band in reverse. I couldn't bend this piece without breaking it or putting it into a bending oven (which I don't have), so I kerfed the inside edge with 5/8-inch-deep cuts spaced every 3/4 inch. This allowed the shim to flex evenly around the curved edge of the trim as I fastened it in place with PVC glue and 1 1/2-inch-long GRK trim screws.

Before installing the trim, I added straight legs to the assembly so that the trim would cover both the upper and lower windows. I joined the legs to the curved portion with pocket screws and PVC glue, then drilled pilot holes for the 3 1/8-inch trim screws that I would use to fasten the trim to the wall, first drilling 1/4-inch-diameter plug holes that I would later fill with PVC plugs. After installation, I filled the gaps between the trim and the wall, and the trim and the window frame, with a generous bead of OSI Quad Max sealant.

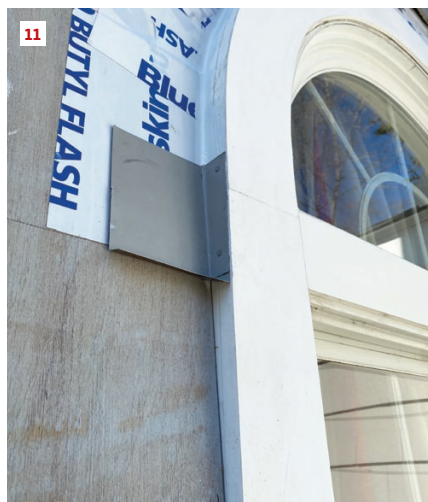
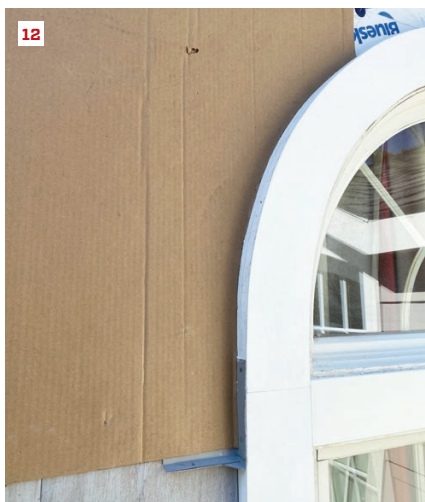
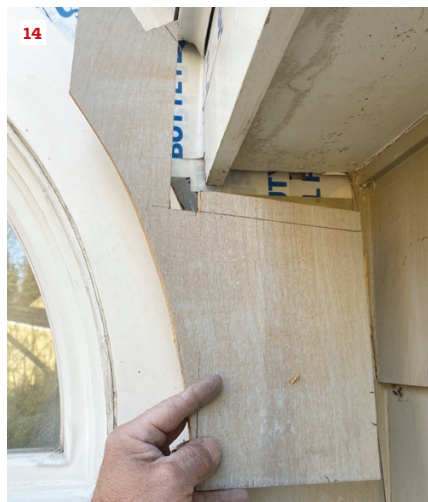
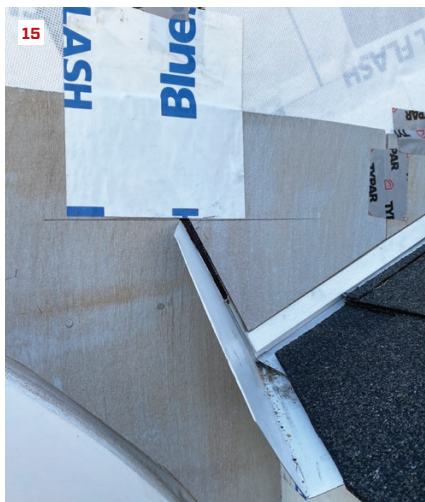
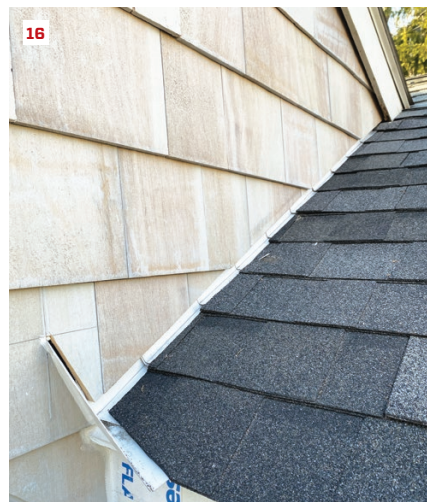
The author also installed diverter flashings on both sides of the window casing to prevent water from flowing off the top and into the gaps between the trim and siding (11). A cardboard template sped up shingle installation around the round-top window (12), as did taping small, cut shingles together to form a larger unit (13). Careful layout was needed to fit the shingles around the kickout flashing (14, 15). The author placed a temporary spacer on the step flashing prior to installing the siding shingles to ensure a consistent gap for drainage (16).

**Shingle installation.** Because I believed that water running off the round-top portion of the window and down the sides of the window casing caused a lot of the damage inside the wall, I folded up custom kickout flashings and applied them to the window casing while reinstalling the cedar shingle siding. To make installation easier around the curved portion of the window, I made reverse window patterns out of cardboard that I could use to mark the curved portions of the shingles on either side of the window.

When installing cedar shingles around curved or complex shapes, I find it helpful to join multiple shingles in a course together with flashing tape, which helps keep the smaller cut pieces properly oriented and spaced. The main thing is to stay level, plumb, and square as you shingle up from the row below, take accurate measurements, and scribe as much as you can around or along odd shapes, such as the diverter flashings that I installed on this project.

Along the roof-to-wall intersection, I installed the shingles butting up against a 3/4-inch-wide temporary spacer to create a consistent gap. Where possible, I caulked around locations water might penetrate between the shingles and other trim, such as around the kickout flashing at the eaves. I use sealant only where I know it will be hidden by an overlying shingle, and when I know that the sealant won't trap water.

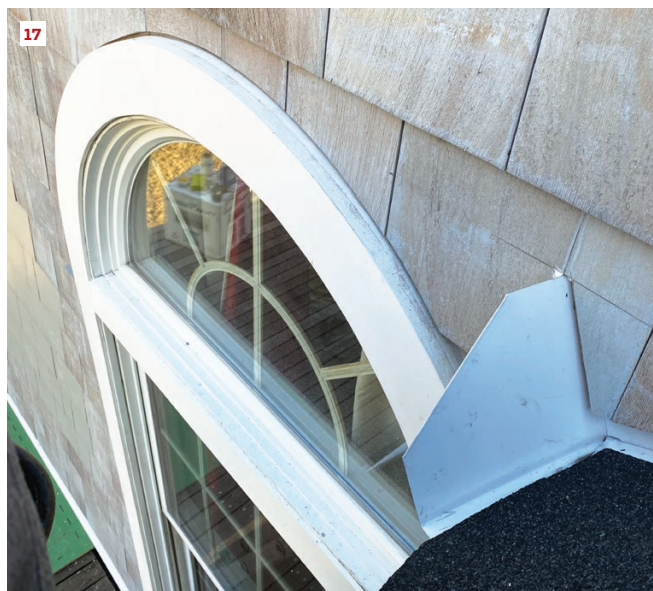
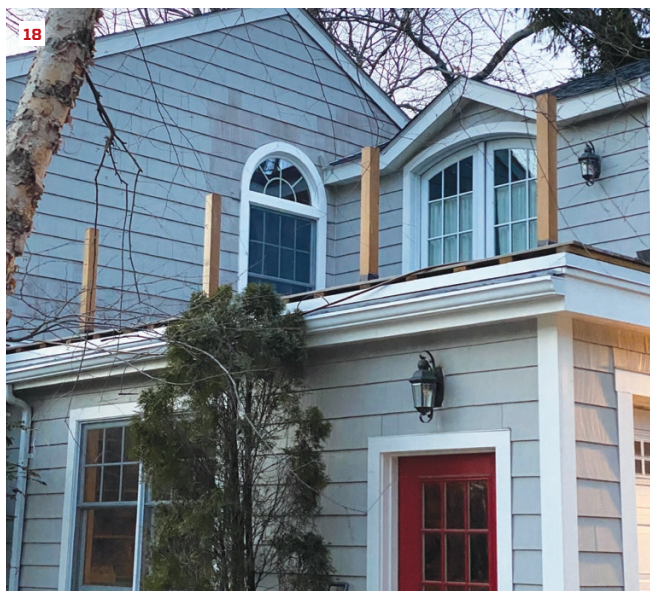
Installed during a previous remodeling job in a gable wall with virtually no roof overhang above to protect it and positioned beneath a lower roof that drains directly onto it, this round-top window provided a perfect entry point for rainwater. But the author's efforts to correctly flash the window and divert water away from it as much as possible have proven effective, with no leakage reported by the homeowners after more than two years (17, 18).
