FOUNDATIONS

Blind-Side Waterproofing Pre-applied waterproofing and concrete liner walls help rescue a hillside structure

BY DOUG HORGAN

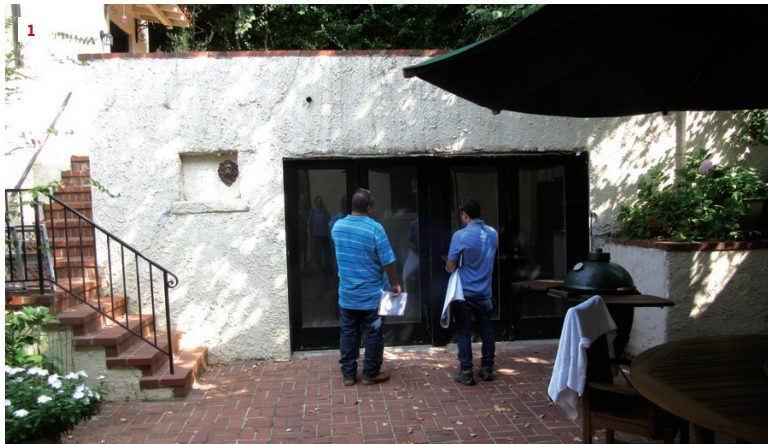
The interior of the building was in poor condition, and we stripped the drywall as part of the planned renovation. In addition to revealing an impressive termite situation, we found large cracks in the 12-inch-thick, reinforced block wall, which made it seem that the building was being pushed down the hill. (The top of the front wall was pushed out significantly as if the upper slab had been pushed down the hill a few inches and had broken the stucco on the front).

The front façade of the attached masonry structure built into the hill is shown prior to the project, its stucco cladding cracked (1). The top of the front wall was pushed outward roughly 2 inches by an underlying slab—seen here during the demolition of the upper patio (2)—which had slowly slid downhill over the years.

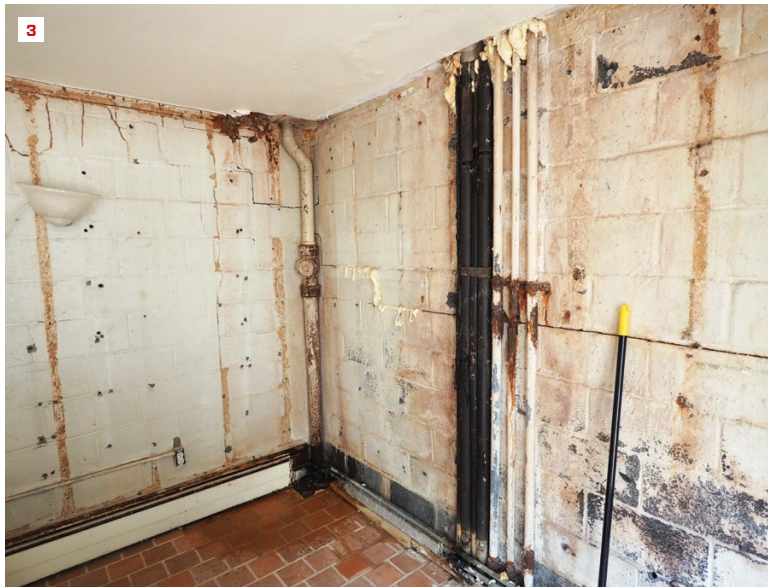
With termite-damaged framing and moldy drywall removed, cracked and leaky block retaining walls were revealed in the interior. Rusted-out electrical conduit and HVAC line sets were also sources of leaking (3).

Liner walls and deadmen. It was time to bring in an engineer, who prescribed new, heavily reinforced concrete walls poured interior of the existing block walls, tied into grade beams and retention structures in the hill above the building. The purpose of the new "liner" walls, as he referred to them, was to take over the structural functions of the existing block wall. These new 6-inch-thick walls were tied into the upper patio's slab with rebar dowels through holes cored into the slab and, at the bottom, doweled into the block wall's existing footing. All in and cured, it was a very solid system.

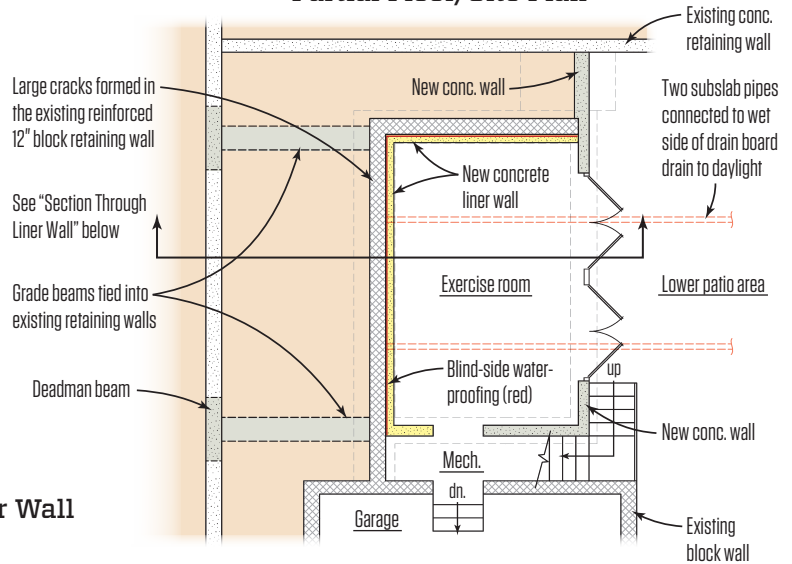
Partial Floor/Site Plan

Our project was to fix a masonry building built up against a hill. The attached structure housed an exercise room on the main level, which was accessed through the garage and small mechanical space. The doors of the exercise room opened onto the lower patio area, while a set of exterior stairs led to an apartment and upper patio area on the second-floor level. On the uphill side, the room's right and back walls were below ground level, with the back wall extending up another 3 feet to retain dirt on the hill above it (see plan and section details on page 40).

To hold back the weight of the soil and keep the liner walls from being pulled down the slope, the engineer designed two grade beams tied into deadman beams and the liner side walls. The two 4-foot-long deadmen were formed under an existing concrete retaining wall located farther up the hill in order to hold the deadmen in place to prevent their overturning.

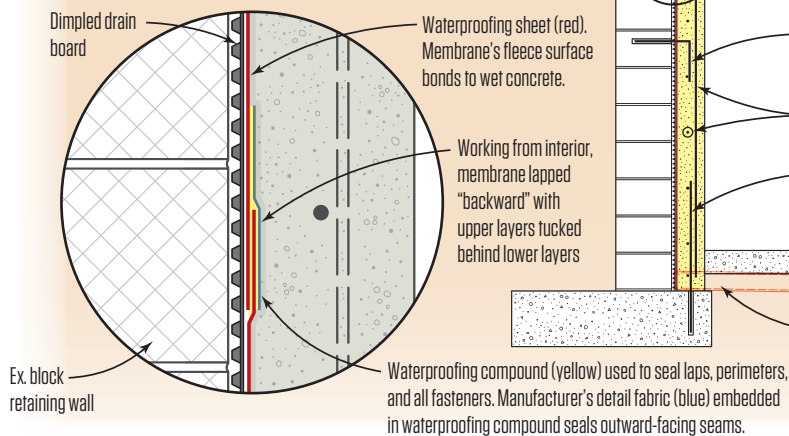
Waterproofing Detail

There are two primary layers to the system we used: drain board and waterproofing sheet.

We used the same drain board we use on many projects, a dimpled sheet of heavy, semi-rigid plastic that creates a space for water to easily move down through. We faced the dimple side out in this case, toward the block walls, making a $\frac{3}{8}$ -inch space at the face of the CMU. The Mel-Drain dimple sheet is available with or without a filter fabric facing, and for this application, we opted to use it unfaced (we use the fabric version only when dirt will be against it, as on the outside of the walls, but in this application, it was sandwiched between two masonry walls).

The second layer is the special sheet waterproofing material, designed to adhere firmly to the concrete we poured up against it. We lapped and sealed it as it ran up the wall, again lapping "backward" with upper layers tucked behind lower layers, directing water out toward the block side of the future poured wall.

We again used powder-actuated fasteners to attach it temporarily and used the manufacturer's trowel-on Hydralastic 836 detail material to seal all the fasteners, laps, and perimeter. The Precon waterproofing we used has a fleece skin that wet concrete will bond with, so once we poured the walls up against the sheets, the temporary fasteners were no longer important for holding the waterproofing in place.

To seal the outward-facing seams, we embedded a strip of the manufacturer's detail fabric in the Hydralastic 836 waterproofing compound; this nonwoven, geotextile fabric helped to create a water- and vapor-proof barrier to resist moisture penetration through end laps.

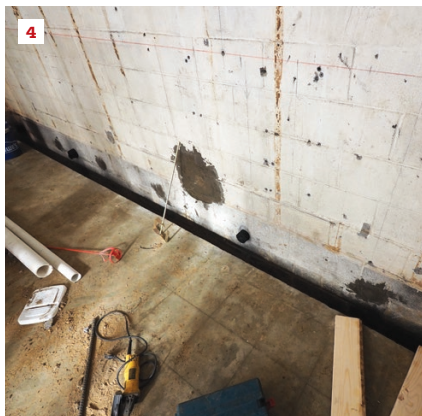
At the slab-to-wall juncture, the existing slab was saw-cut in order to lock in the bottom of the new heavily-reinforced concrete "liner" wall (4). The cut edge also allows room to drain the wet side of the drain board to daylight via two sub-slab PVC drainpipes (see section illustration, facing page).

Blind-side drainage. Our last task was to connect the drainpipes we installed through the wall to an acceptable outlet for any water that comes down the wall. We had left the existing floor slab in place; it made for easier working compared with gravel or mud, and, in fact, we attached the wall formwork to it. Following the plan created by the engineer, we channeled across the slab in two places, exposing the two 3-inch PVC pipes we had cast into the wall. These connected the wet side of the drain board to the below-slab gravel area; we tied new pipes to them to run out the front side of the building and out to the surface as the grade drops off.

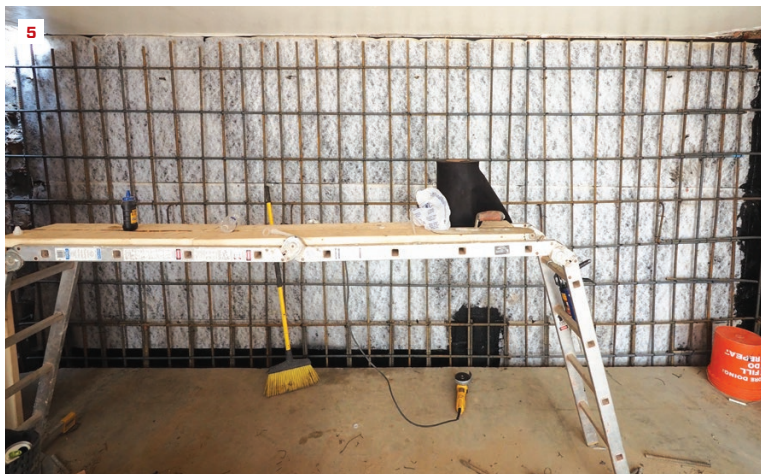
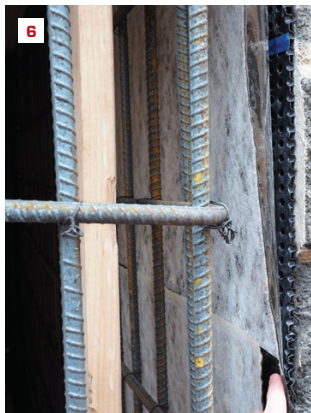
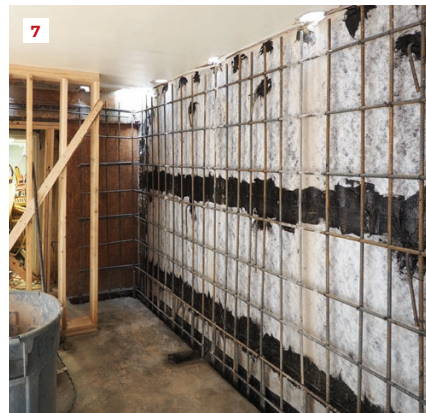
From the interior, the dimpled drain board is installed first, then the waterproofing sheet. All seam laps, perimeter edges, and fasteners through the waterproofing membrane are sealed with a waterproofing compound. The rebar grid is then installed, tied into the upper patio's slab with rebar dowels through holes cored into the slab, and, at the bottom, doweled into the block wall's existing footing (5-7).

Installation is a little confusing because unlike when we waterproof on the outside, overlaps tuck the upper material behind the lower—the opposite of what we're used to. The material was pinned in place with powder-actuated fasteners. At the bottom, we placed two PVC drainpipes from the rear drainage space, through the future poured wall. We connected drains later for water to move out of the building to daylight.

Concrete "liner" wall. For the 6-inch-thick concrete liner wall, we installed the required rebar in front of the waterproofing, then formwork inboard of that.

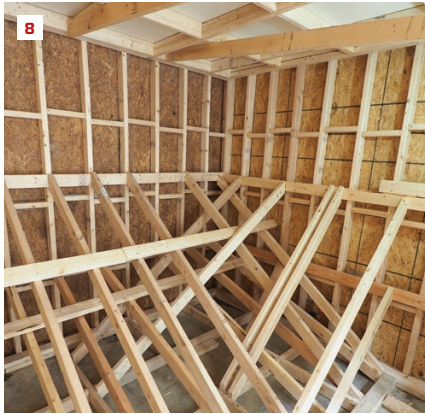
Due to the nonstandard wall height, custom single-sided formwork was built on site (8). The liner walls are poured through cored access holes through the upper patio slab using a 3-inch hose with pea-stone gravel mix to facilitate flow in the rebar-filled cavities (9).

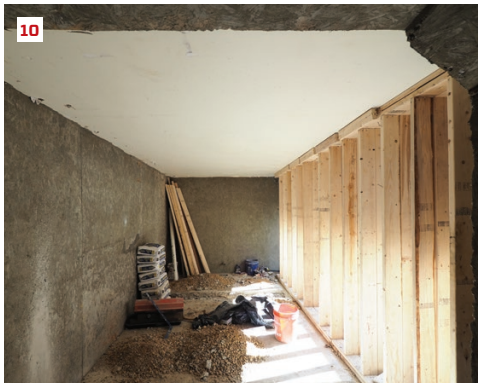
With the forms stripped, the interior space is ready to be fitted out (10). For the stairs to work correctly at the upper patio, a new landing was poured; the existing slab was cut away to fit in the additional riser (11).

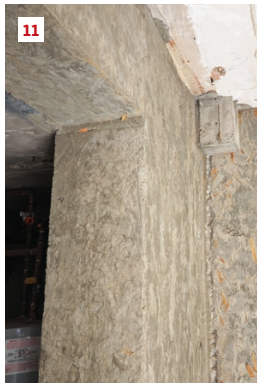
The masonry walls and ceiling were furred out with steel studs to run wiring and lighting, while the front wall was framed out with 2-by stock to more easily frame the rough openings for the arch-top doors (12).

Additional concrete work. The structure's downhill "front" wall was also in poor shape. In addition, the clients wanted to change the style of exterior doors from sliders to a set of arch-top double doors, so we removed all the concrete block on the fourth side of the structure. We poured a reinforced concrete knee wall on top of the upper patio slab to support a new brick-veneer parapet and poured a reinforced concrete beam below the slab to square up the opening. (The door's arch-top rough openings were later framed out with 2-by stock and a stucco finish was applied to the front façade).

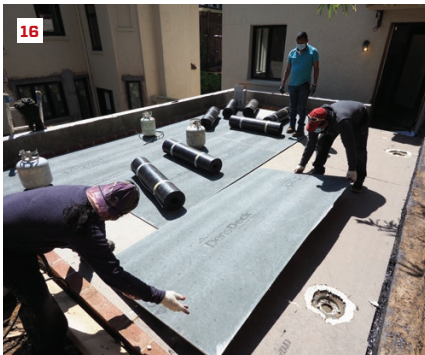
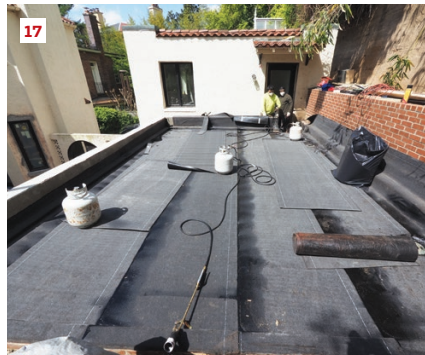
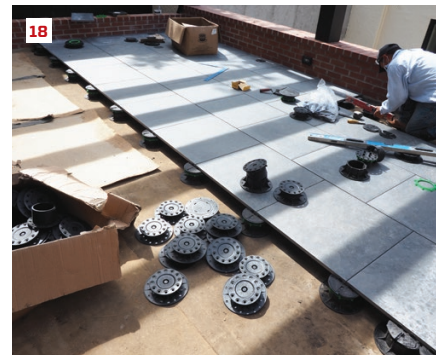
Over a slope-kit of polyiso foam that makes a 1/4-inch-per-foot slope, the crew installs gypsum roof underlayment in the roof drain area (16). The previous roof was asphalt; a torch-down roof system is installed to avoid any compatibility issues with asphalt and single-ply systems (17). New patio tile is installed on adjustable-height pedestals over a protection board (18).

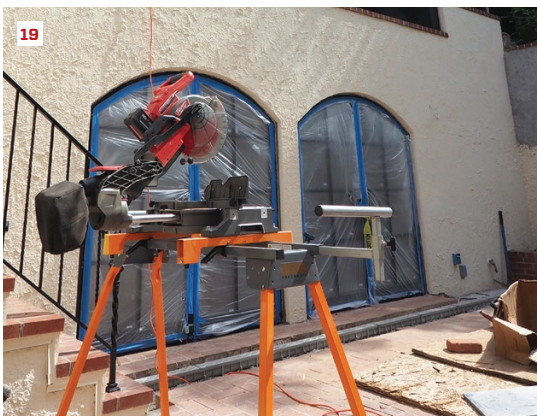
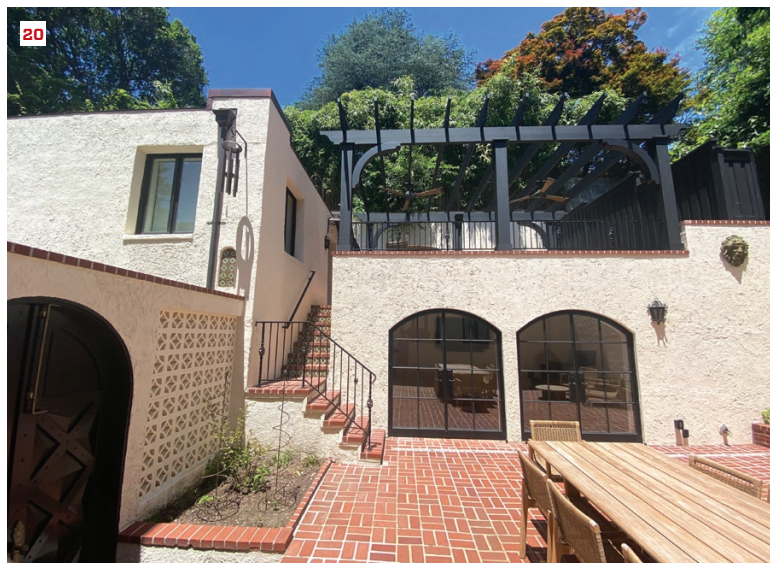
A linear drain (in the background) is being installed in front of the pair of arch-top doors, outside the new exercise room (19). The completed project (20).
